Disaster mitigation strategies for adobe houses: A case study of District Awaran, Balochistan, Pakistan

Mamoon U R Mengal, Waqas A Mahar

Department of Architecture, Balochistan University of Information Technology,
Engineering & Management Sciences (BUIITEMS) Quetta.
e-mail: mamoonmengal@gmail.com, architectwaqas@hotmail.com.

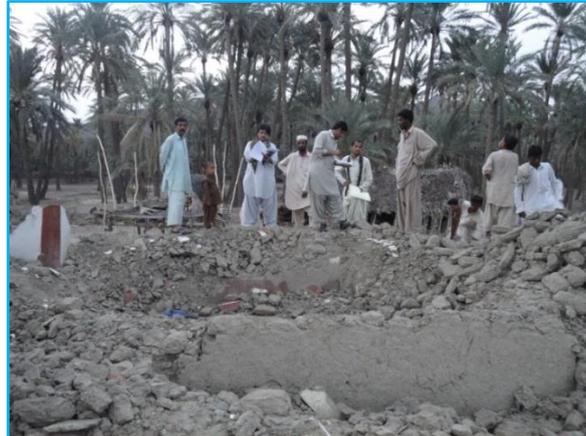
The team first arrived at Mangoli and it was then when they realized the scale of destruction. The village of Mangoli was completely razed to the ground except a few adobe huts. The villagers were using some of the tents provided by the earthquake relief as temporary shelters. They set up the tents along with the remains of their houses. The destruction at Mangoli can be seen in figure 3, survey team members are also busy in data collection.

Figure 3. Destruction at Mangoli

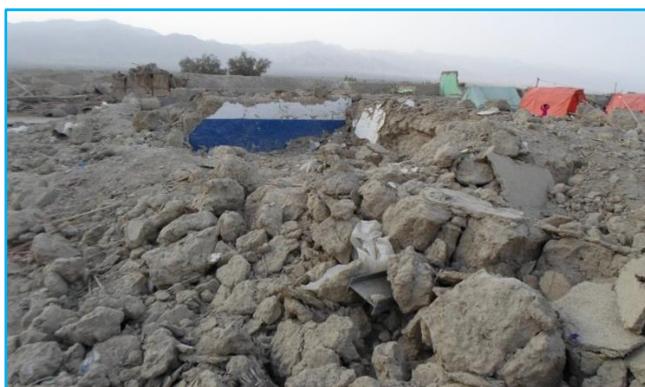
Figure 4(a). Damages at Gajjar town

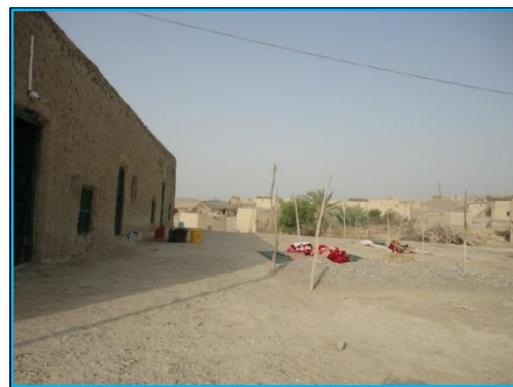
Figure 4(b). Houses standing at Kullar town

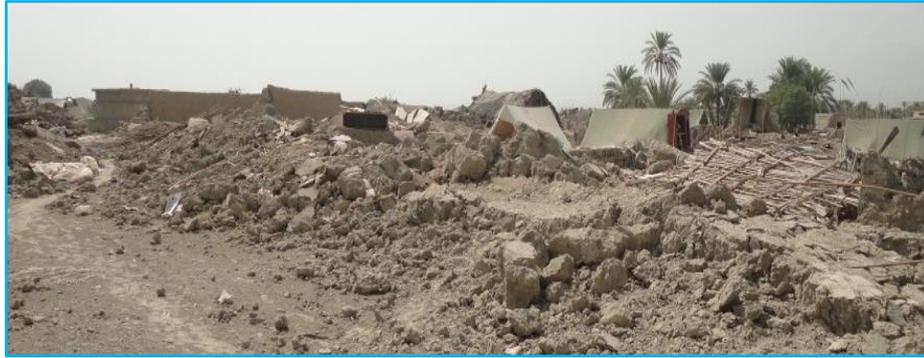
As mentioned before the second group moved to Nok Jo and Jabry, they planned to go up in north to record all the damages caused by earthquake. After arriving at Jabry the group realised that this is the last point where the earthquake affected the houses as the damages to houses at Jabry were rather little. However, the scenario in Nok Jo was totally different, as shown in figure 5. The entire houses were razed to the ground and only few straw huts survived the earthquake.

Figure 5. Earthquake damages at Nok Jo

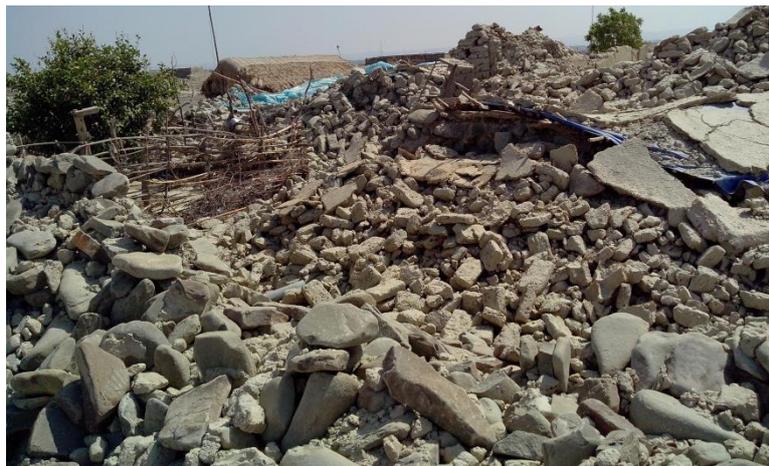
After completing survey at Kullar, Gajjar, Nok Jo and Jabry the team left to Awaran Tehsil. Here the first village visited by the team was Malaar which was entirely destroyed except some straw huts which withstand the earthquake. It was found that stone boulders were mainly used in Awaran Tehsil compared to mud bricks which were commonly used in Mashkay. The houses made of stone boulders not coped well with the earthquake which can be seen in figure 6. The team then continued the survey further south in the villages of Gishkore and Dandaar.

Figure 6. Destruction at Malaar
(stone boulders used in wall construction can be seen in the picture)

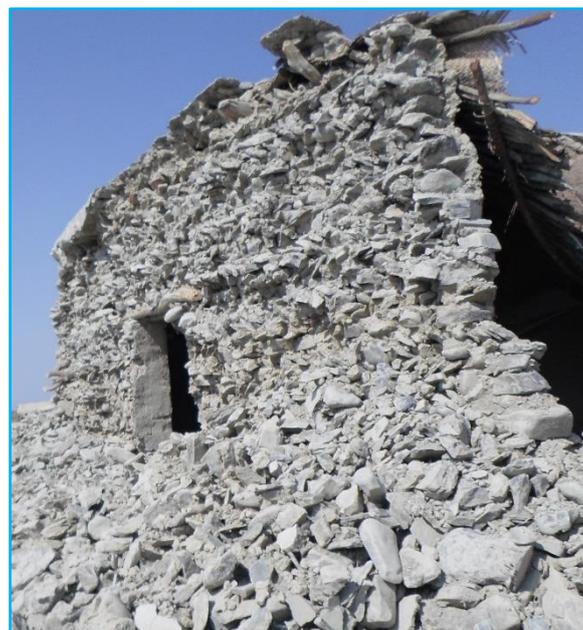
The use of stone boulders for the construction of walls was mainly seen in the south, such as in Gishkore and Dandaar areas. The stones were mainly round and of improper shapes or bounding,

excessive mud plaster was used for the construction of such walls. The walls have the same width as of other walls, i.e. 18” (45.7 cm) and constructed without using any stiffeners, figure 9(c).

Figure 9(c). Stone boulder walls

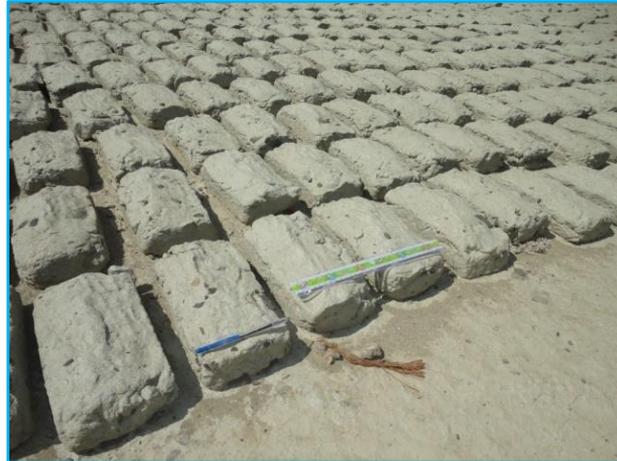
The mud bricks made locally and used for the construction of houses were of improper shape and form with round surfaces and uneven edges making it essential to use extra mortar during the construction of walls, figure 11. The material mix used for the brick making was not up to the standard as it contained boulders and organic materials, such as reed stalks etc.

Figure 11: Bricks placed for drying

It is necessary to make the brick of proper and even size. The soil should be first passed through the sieve to separate the gravels and small stones before formation of the mix. The proper moulds should be used to mould the bricks and then moulded bricks must be placed on even ground or surface to let it dry, figure 17(a) and 17(b).

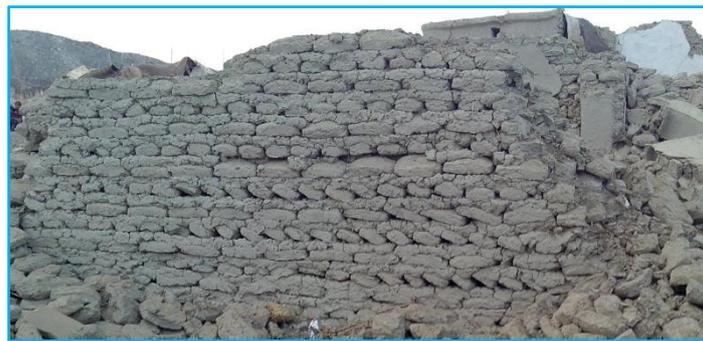
During the construction of a wall, the brick courses were placed without following any proper bond pattern, see Figure 12. Some bricks were placed slanted while some were placed vertically. Whatever, was the reasons for using bricks in such manner, it made the walls vulnerable to even a slight jolt.

Figure 12: A wall with the lack of bond

As mentioned in section 4.2 that the improper brick bond was also a cause of damages. The bricks should be properly bounded to strengthen the bond. The corner can be strengthened by using bamboos as reinforcement on the corner which is shown in figure 21.

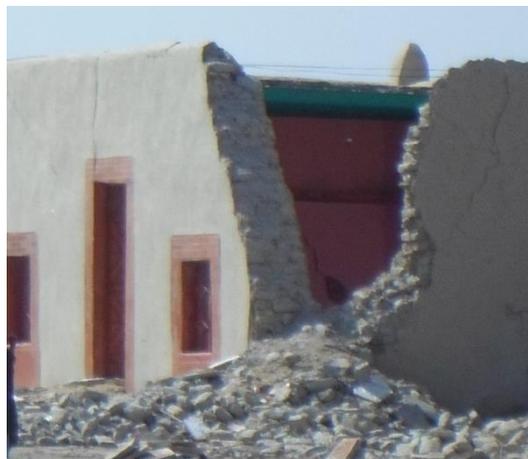
It was observed that in most of the construction, the corners were not strengthened and as a result they gave in easily when the walls started shaking, as shown in Figure 13, the wall is damaged at the corner.

Figure 13. Wall damaged due to weak corner

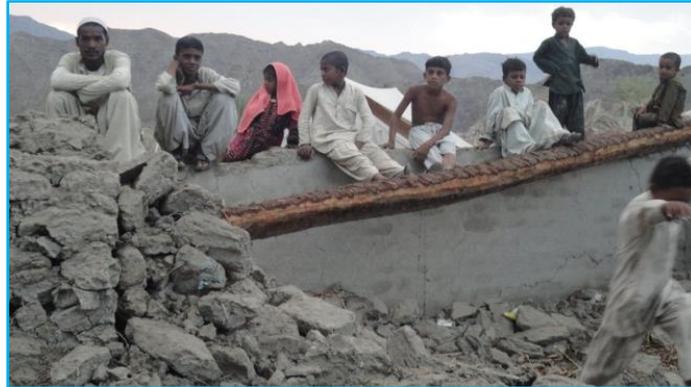
Heavy girders were used in majority of the houses without having any mechanism for the distribution of loads, see figure 14. As a result, the concentrated load from the heavy girder was applied to only a few bricks which failed easily. The heavy girders caused more structural damage and may also been responsible for any loss of life that occurred.

Figure 14. Heavy girders caused damage

Several buildings fail in the earthquake as the unevenly distributed weight of heavy roof pushes the walls in one direction. Light roofs reduce stress on walls in earthquakes. Lighter walls with a light weight roof can survive even severe quake vibrations with little reinforcement better than heavy walls and roofs. The adobe house shown in Figure 22(a) can hold up a light-weight roof. It must consist a special base and plastic mesh to reinforce the walls. The same size house shown in Figure 22(b) with a heavy-weight roof should have heavy earth piers at all corners to help brace the walls against the weight of the roof moving in an earthquake.

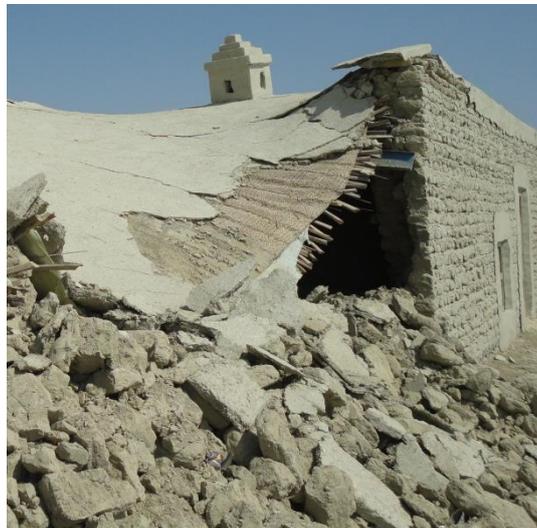
The roofs were placed on the walls, as shown in Figure 15, such that there were no projections on any side. As a result, when the walls even slightly moved, the roof came down pushing the walls further while doing so. As a result, the entire houses collapsed.

Figure 15. Lack of projections

The construction of roof using bamboo purlins is shown in the figure 23, the roof projections on all four sides can also be seen.

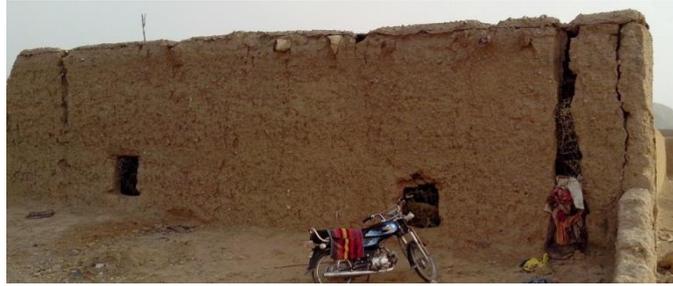
Most of the mud and mud brick walls were already weakened by the rainwater mainly due to spouts and not having the required projections to stop the rainwater penetration into the walls, as shown in Figure 16. This had made the walls weak and thus vulnerable.

Figure16. Damage caused by water spouts

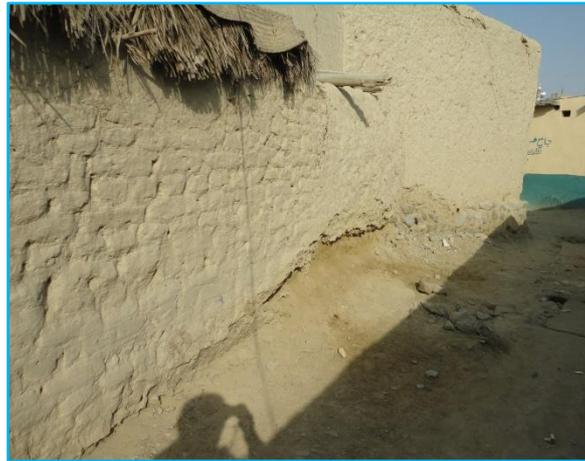
As water makes the foundation soil weak. In an area that experiences rainfall or snowfall, it is recommended to use a waterproofing layer at the plinth level before starting the construction of wall above the plinth and provide an apron and drain around the house to prevent runoff water that might wet walls or enter the foundation. In 2007, Awaran was highly affected by flooding which caused 20 deaths and more than 1800 houses were entirely collapsed (PDI, 2007). Figure 35 shows the effect of plinth decay due to water.

Figure 35. Plinth decay
