SDSS 2022  
The International Colloquium on Stability  
and Ductility of Steel Structures  
14-16 September, University of Aveiro, Portugal

# Technical Study of Kongo-Central Colonial Steel Houses Belonging to the DRC Patrimony

Aris Mpemba Nkole Kabongo<sup>1</sup>, Jean-Pierre Jaspart, Jean-François Demonceau

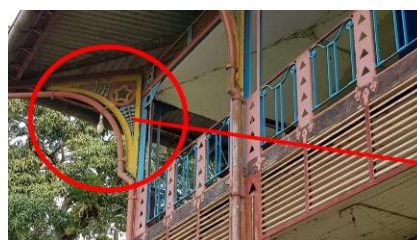
Through the performed analyses, it is demonstrated that, when the presence of the decorative haunches (see Figure 4) is not accounted for, the cantilever parts of the truss members, with large spans compared to the geometry of the members (see the static scheme in Figure 5), generate excessive internal forces at the level of the end supports of these members, as illustrated through the moment diagram in Figure 5 below obtained through a first order linear analysis.

Figure 4 : decorative element used as a haunches

Considering the presence of these decorative haunches, it is found that reasonable internal forces (see Figure 6) satisfying the strength and stability criteria of EN1993-1-1 [11] are obtained which demonstrates that the structural role of these decorative haunches is crucial for the resistance and stability of these roof beams.

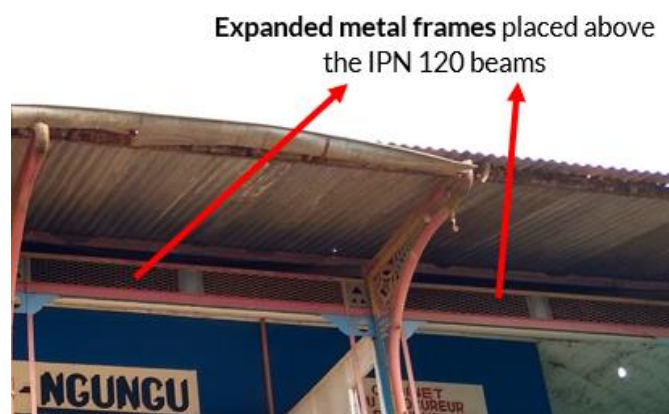
However, by analysing more deeply the beams at the top of the frames, it can be observed that expanded decorative stiff steel frames are present in these external frames (see Figure 7) with the effect of stiffening the joints at the extremities of the upper IPN 120 beams of these frames (see Figure 8). Considering the effect of these decorative frames, the analyses demonstrate that the external frames of the structure were stable during the construction phase.

Figure 7: view of the expanded decorative metal frames connected to the IPN 120 beams and the columns of the external longitudinal frames

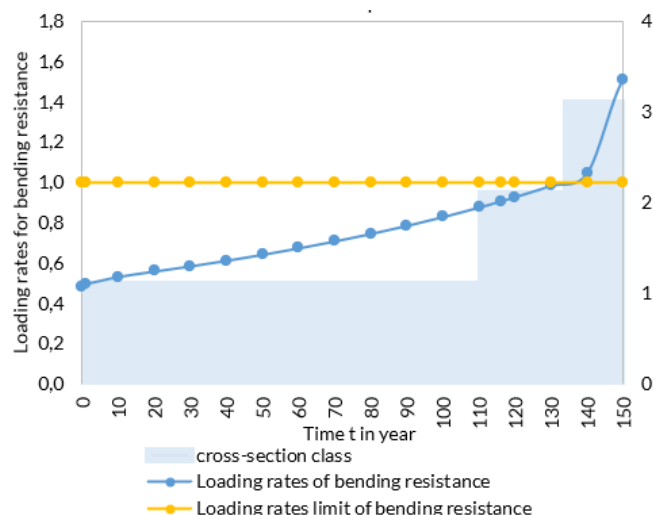
The verification of the cross-section strength is done in the same way as in Table 1. The evolution of the loading rate vs. time is provided in Figure 14. It can be observed that, as expected, the loading rate is increasing with time due to the decrease of the bending resistance of the corroded cross-section. The failure of the corroded cross-section under bending is reached for a lifetime of around 135 years considering the adopted assumptions.

Figure 14: Evolution of the cross-section bending resistance of the corroded IPN 120 profile vs. time

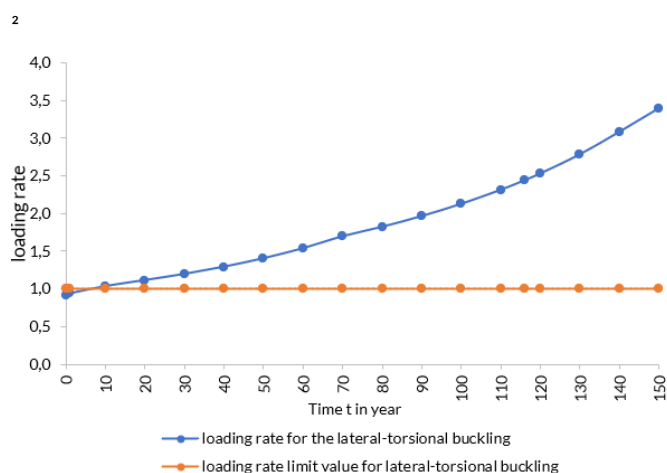
Figure 15 : Evolution of the lateral-torsional buckling resistance of the corroded IPN 120 purlin vs. time

By analysing the results presented in Figure 15, it can be observed that the resistance to lateral-torsional buckling is no longer satisfied after the sixth year since the loading rate exceeds 100% for the considered exposure conditions as described in §3.1. However, as mentioned in §3.1, some safe assumptions have been considered to evaluate the total corrosion attack coefficient and, so, the latter can be seen as overestimated. Accordingly, the prediction presented here can be seen as a safe estimation of the actual behaviour of the corroded members. However, as illustrated in Figure 16, lateral-torsional buckling is observed for some of the purlins of the studied structures which confirms the sensitivity of these members to corrosion effects.

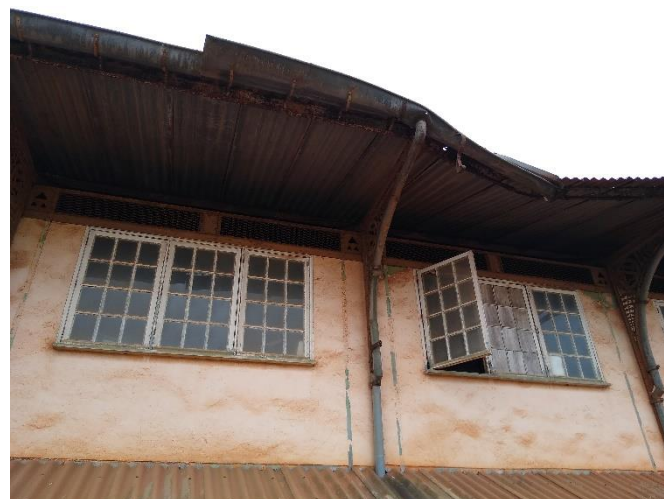
In the previous section, the resistance of the IPN 120 purlin was checked in its initial state. However, as observed during the onsite missions, the different load-bearing members are suffering from the development of significant corrosion.

Figure 16 : view of some deteriorated roof edge purlins of the courthouse building of Mbanza-Ngungu.
