Drying-up of a natural spring for ensuring stability of an artificial slope: is it sustainable development?

KEYWORDS: hydrogeology, geoelectrical tomography, impact of drainage, drying up a natural spring

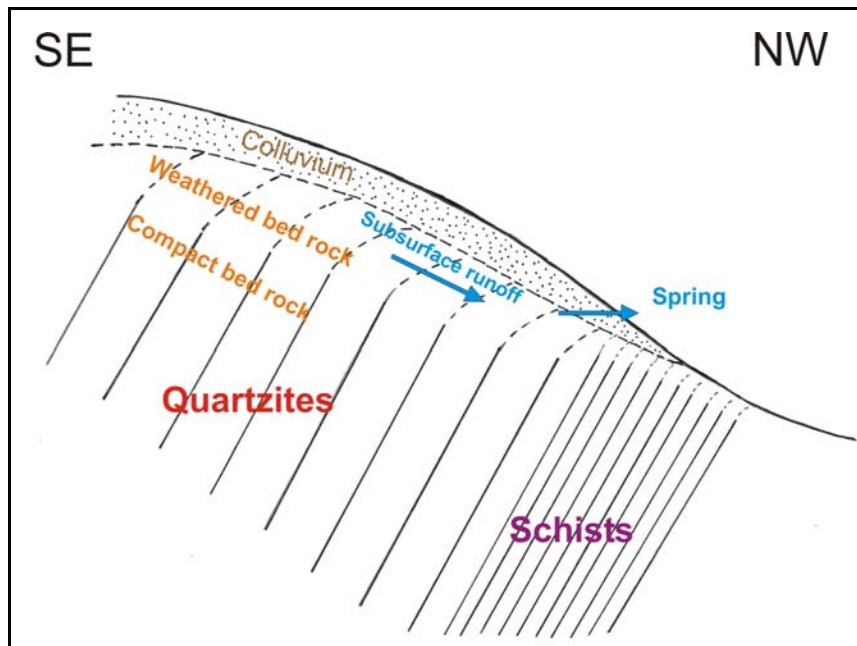
Figure 1. Schematic SE-NW geological cross-section normal to the layer direction and transverse to the valley.

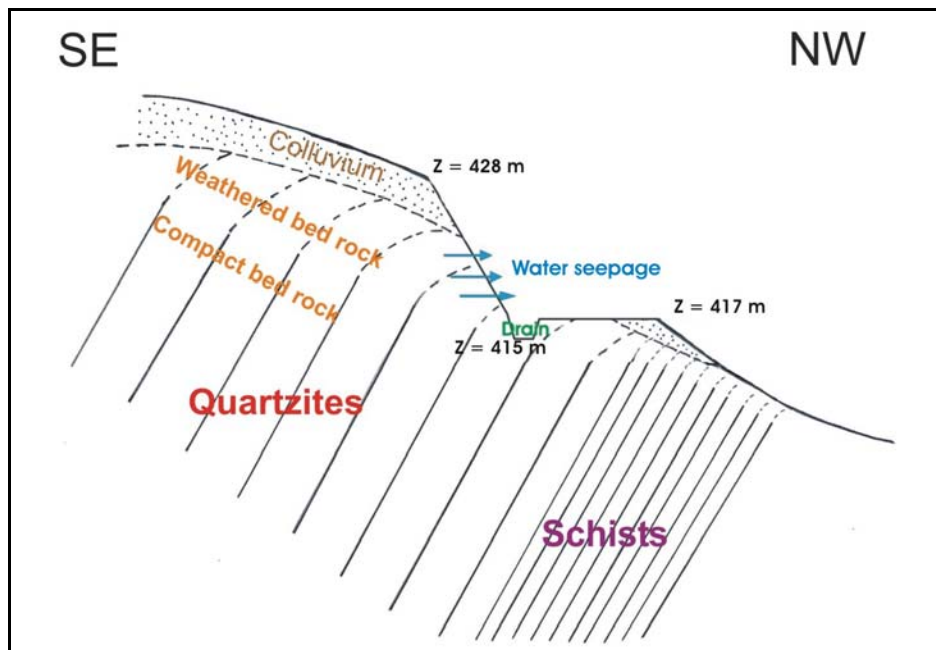
Figure 2. Schematic SE-NW transverse cross-section showing the reshaped slope and the position of the drain.

At the same time, the flow rate of a natural spring, located at a lateral distance of about 200 m from the drain on the same hillslope, brutally dropped and the spring eventually completely dried up. Previously, the averaged daily flow rate was comprised between 200 m³/day and 350 m³/day. The emergence of this spring was flowing at an absolute level of 422 m. Another spring is emerging further on the same hillslope at a distance of more or less 1 kilometer and at the absolute level of 405 m. The averaged daily flow rate of this last spring changed from 1330 m³/day to 1036 m³/day in fourteen days. Both of these springs were exploited by the local community for drinking water. A study was needed to determine the local hydrogeological context explaining the impact of the new drainage on the springs and to propose, if possible, sustainable alternatives.

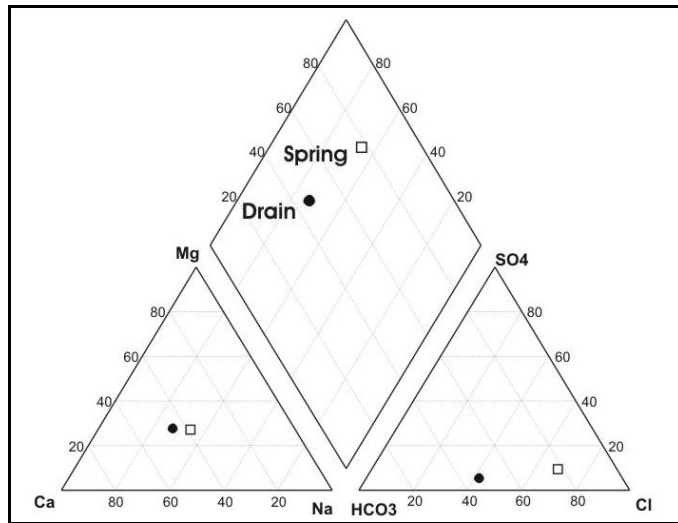
Figure 3. Piper diagram showing the relative hydrochemical characteristics of the groundwater in the drain and in the spring located 1 km further.

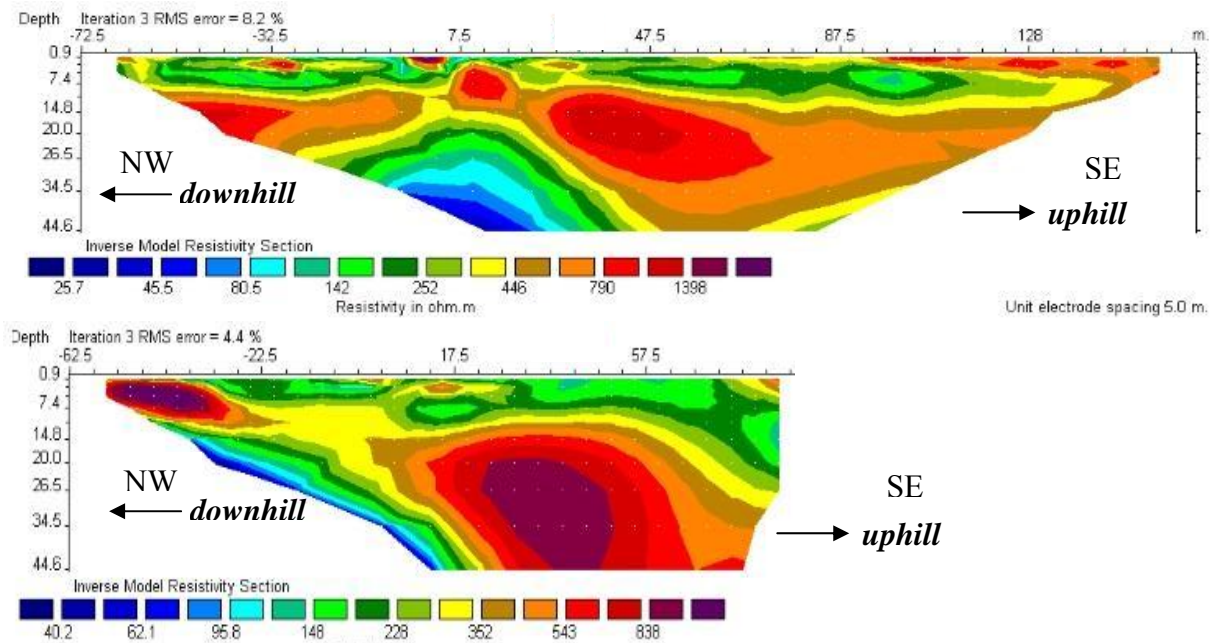
Figure 4. Modelled resistivity profiles near the dried spring (top) and near the drain (bottom).

On the first profile, a first horizon is characterized by apparent resistivities ranging between 100 Ωm and 300 Ωm . It corresponds to an unconsolidated layer. This unit is thicker uphill and a local thinning is observed very close to the dried spring in the hillslope : a bed of very resistive rock, probably quartzitic, is nearly outcropping. The incomplete second profile only investigates the downhill part of the slope. Nevertheless, both profiles seem to indicate a lithological change from a resistive material uphill to a conductive material downhill. From the seismic results, a longitudinal (along the hillside) cross-section can be interpreted as shown on figure 5. A first layer of unconsolidated granular material having a maximum thickness of 2 m is overlying a second layer that can be identified as a weathered bedrock. The interface between this weathered zone and the bedrock seems very irregular and globally describes a thickening in the direction of the drain.

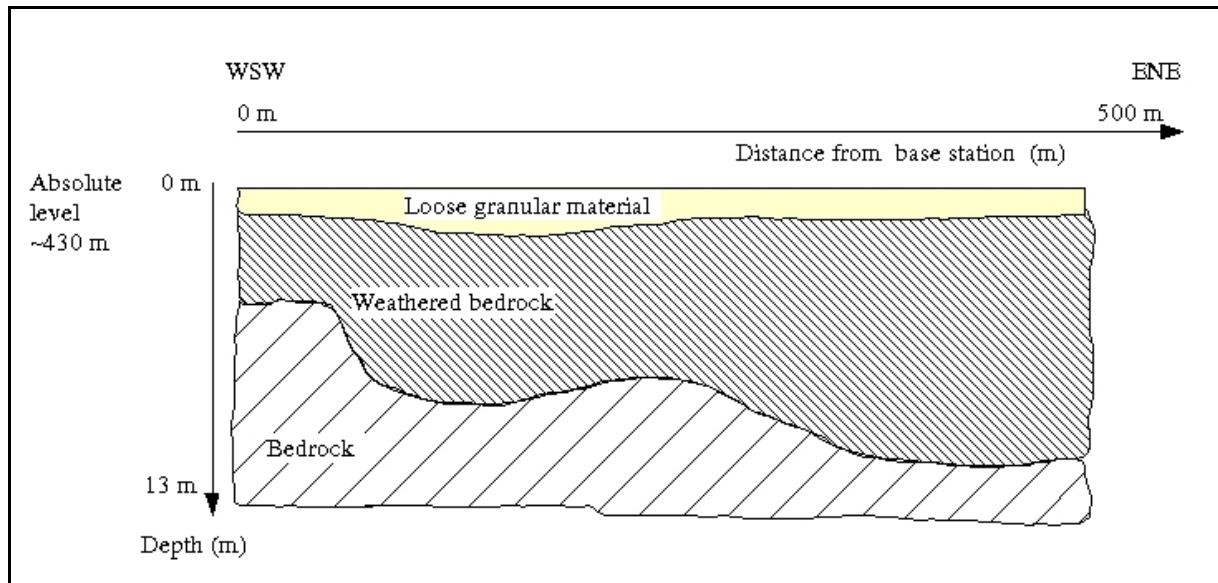
Figure 5. Interpretative profile from seismic results: a thickening of the weathered bed-rock is observed from the dried spring to the drain
