What potential does structural wood hold for reuse in urban housing in Liège?

A study of timber frames from the *Ancien Régime* (14th to 18th centuries)

Sustainable Built Environment Conference 2025

Ophélie Noël¹, Philippe Sosnowska², Sophie Trachte¹

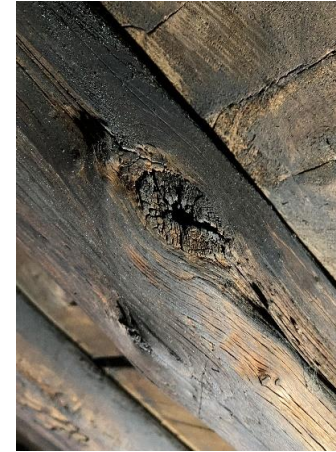
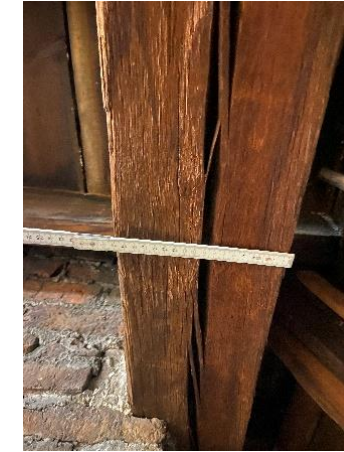
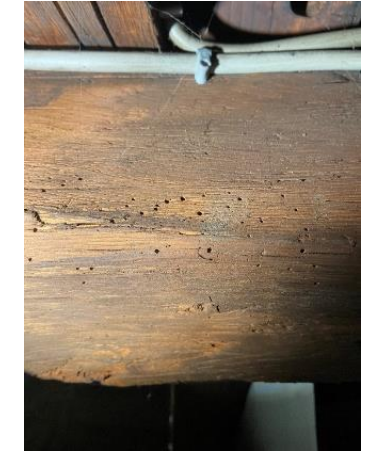
CRITERIA	DONCEEL HOTEL	PLACE EMILE DUPONT
NATURE, TREATMENT AND DIMENSIONS	16th century, oak, high quality wood, axe and saw marks and satisfactory strength	14th century, timber frame with rafters forming trusses, oak, high quality wood, chiselling mark, satisfactory strength
HEALTH CONDITION	No chemical substances, no fungi, wood-boring insect holes and no recent damp	No chemical substances, no fungi, wood-boring insect holes and no recent damp
STRUCTURAL CONDITION	Knots, longitudinal cracks at knots and deformations: creep	Knots, longitudinal cracks at knots and deformations: creep
ASSEMBLIES AND CONNECTIONS	Mortise and tenon and half-timber	Mortise and tenon, half dovetail and whistle end with wooden pegs
COMPARISON WITH TECHNICAL INVENTORY	Rafters: similar dimensions; post: value from the lower range of the inventory; purlin: similar in width but less high and headers: narrower	Rafters: similar but much wider; centers: similar but wider and armrests: similar but wider

Source : Personal photographs of knots, drying crack and wood-eating insect holes of Donceel hotel and Place Emile Dupont, Liège.

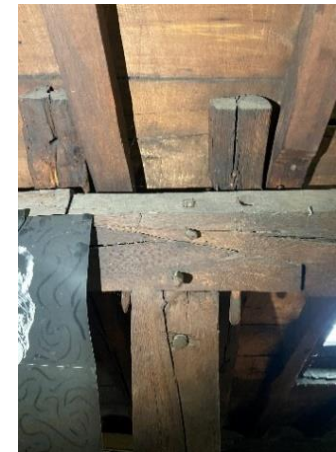
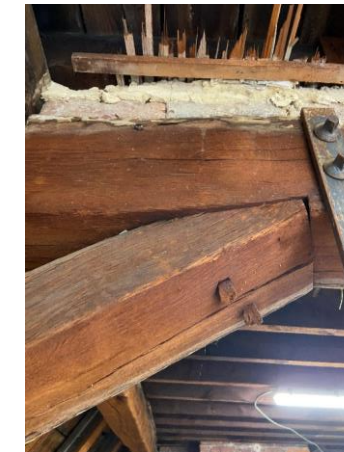
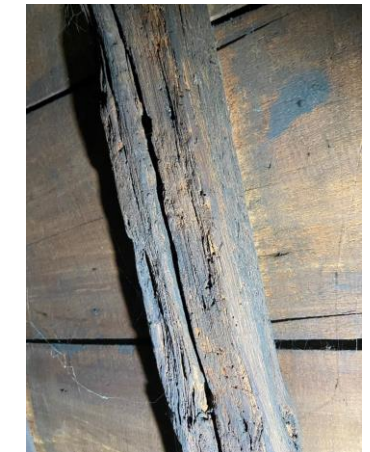
Source : Personal photographs of assemblies of Donceel hotel and Place Emile Dupont, Liège.

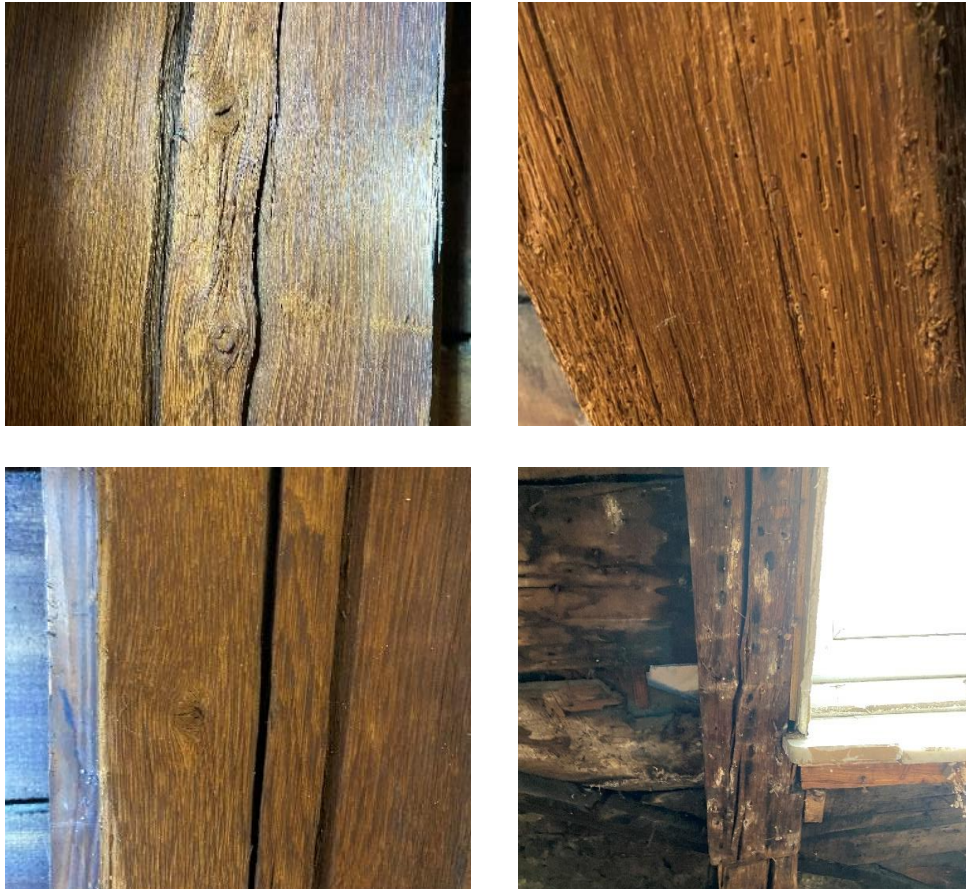
Source : Personal photographs of knots (1), drying crack (2 and 3) and wood-eating insect holes (4) of a Place Emile Dupont's rafter, Liège.

NATURAL WOOD DEFECTS	OBSERVATIONS	MEASUREMENTS
KNOTS	Yes, 5	1 : 1 to 2 cm 2 : 1 to 2 cm 3 : 2 to 3 cm 4 : 1 to 2 cm 5 : 2 to 3 cm
FACE CRACK	Yes, 8	1 : 70 x 1,5 cm 2 : 54 x 1 cm 3 : 110 x 0,8 cm 4 : 28 x 0,7 cm 5 : 18 x 0,6 cm 6 : 138 x 1,6 cm 7 : 20 x 1,3 cm 8 : 66 x 1,6 cm
SIDE CRACK	Yes, 3	1 : 40 x 1 cm 2 : 28 x 1 cm 3 : 38 x 1,2 cm
WOOD-BORING INSECT HOLES	Yes	circular holes between 1 and 3 mm
BOXED HEART	Yes	/
