IGAG/AIG REGIONAL CONFERENCE, 18th to 22nd Feb. 2011

Vulnerability mapping for sustainable hazard mitigation in the city of Bukavu, South Kivu DR Congo

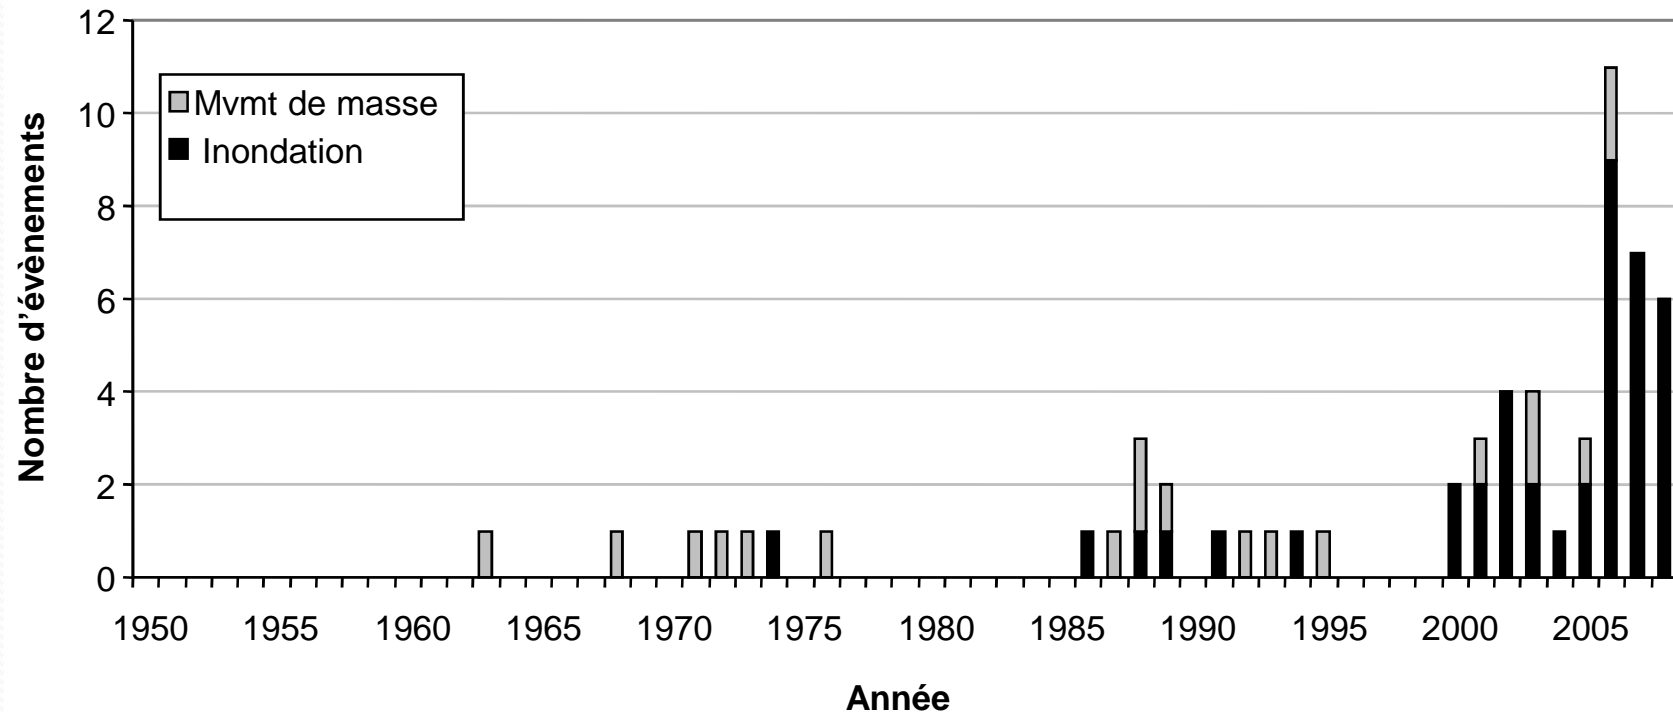
Figure 2: Number of Natural Hazards recorded in the great lakes region from 1950 to 2010 (Ine Vandecasteele *at al.*, 2009)

It has been noticed these last few decades an increase in natural disasters (mass movements and flooding) in the region of Kivu-Rwanda-Burundi in general (Fig. 2) and particularly in the province of South Kivu (Fig. 3).

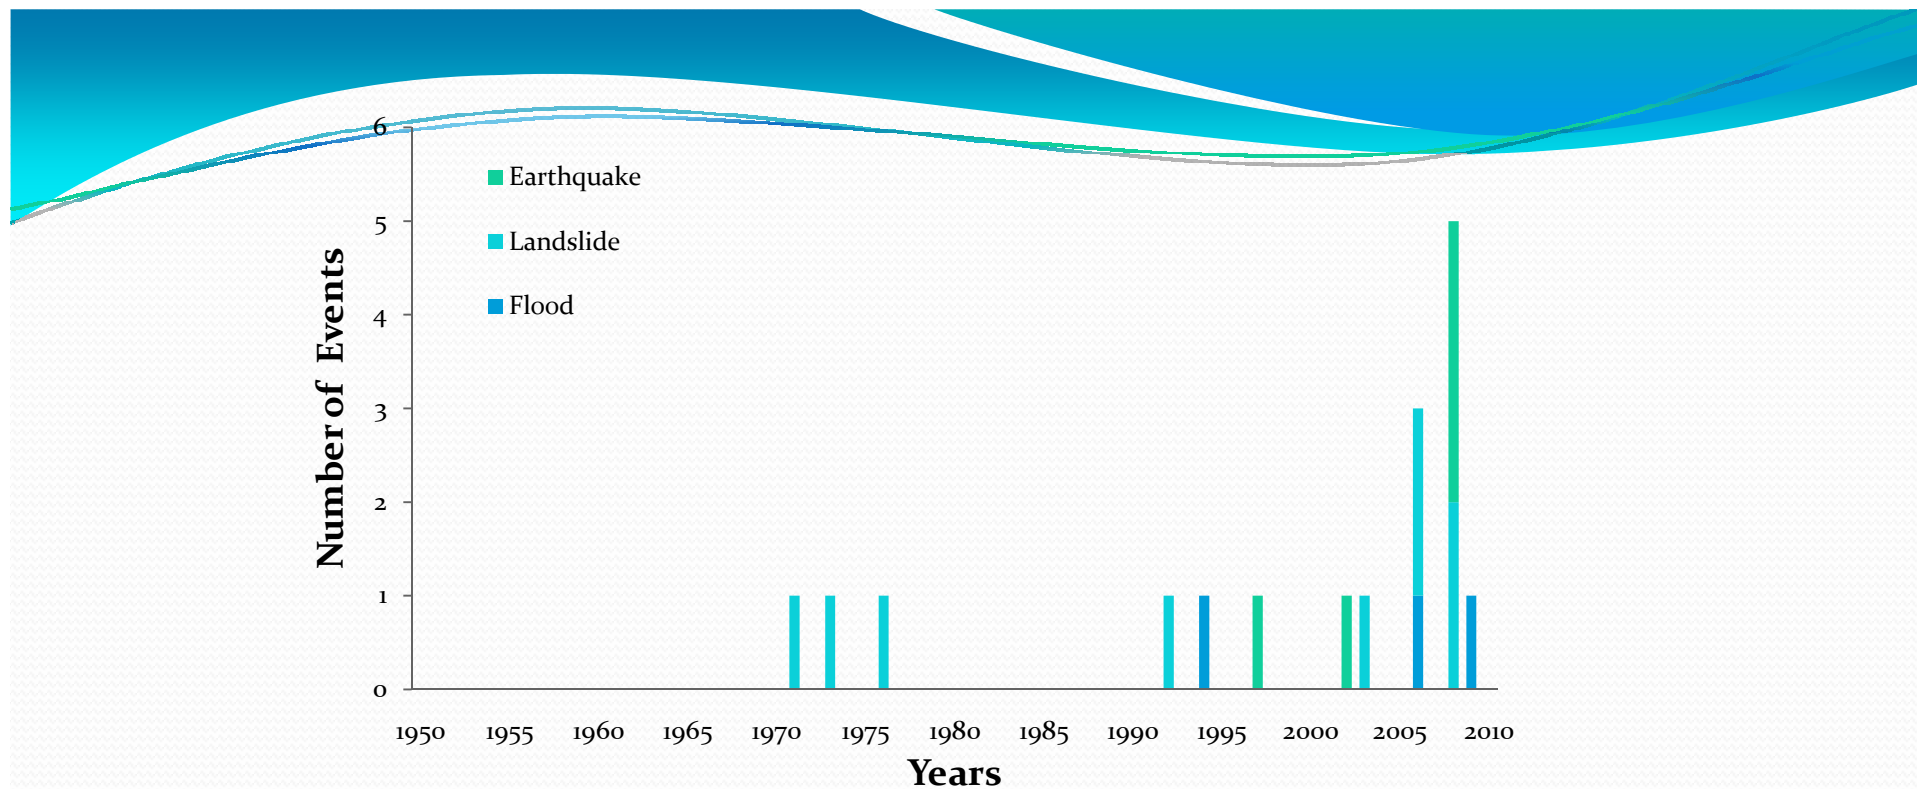
Figure 3: Number of Natural Hazards recorded in South Kivu from 1950 to 2010 (Data source: RMCA)

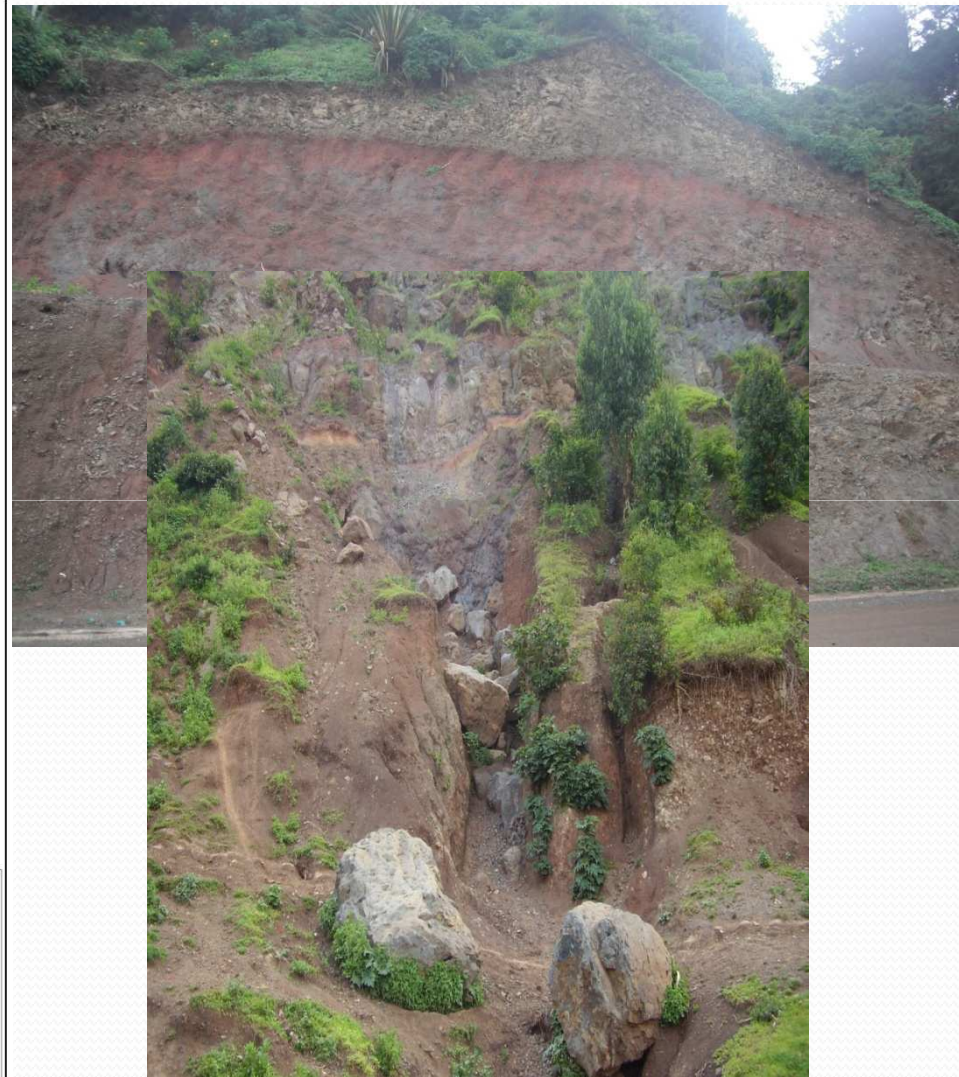
Figure 7: Rocks fall at Kasheke-Kadutu after the earthquake of 03/02/2008

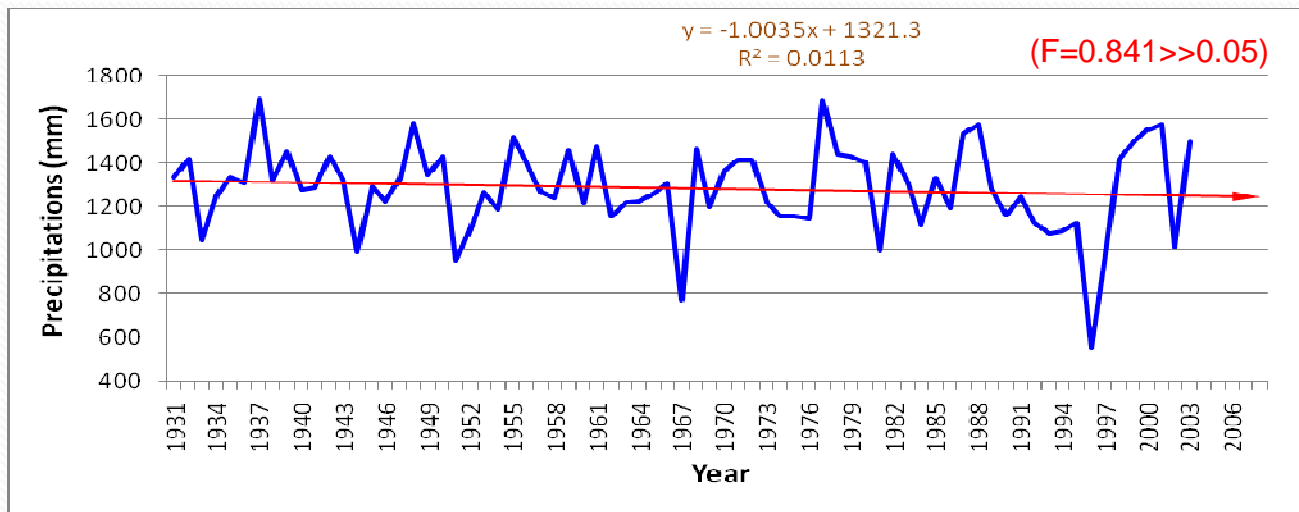
Figure 7: Annual Precipitation for Bukavu 1931 to 2003 (Source: Bukavu Station, N° 64180 (N° indicatif de l'OMM))

There is no significant increase or decrease in annual total precipitation for the period of 1931 to 2003 (fig. 7).

Precipitation data recorded at the meteorological station of Bukavu were analysed for the period of 1931 to 2003.

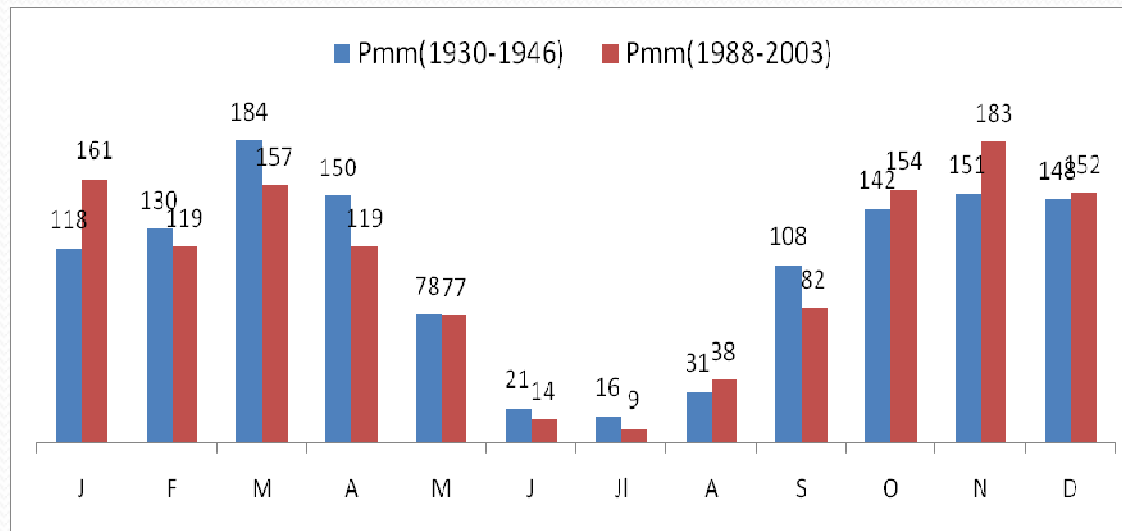
However, there has been a change in the monthly distribution of rainfall (Fig. 8), with significant increases in rainfall from October to January, and a decrease from February to July.

Figure 9 Monthly average precipitation for Bukavu, DRC, for the periods 1930-1946 and 1988-2003 (Ndyanabo et al. 2009)

This shows a trend of increasing seasonal variability in rainfall in the city. It has been noted by Muhigwa (1999) in the surroundings of Bukavu.

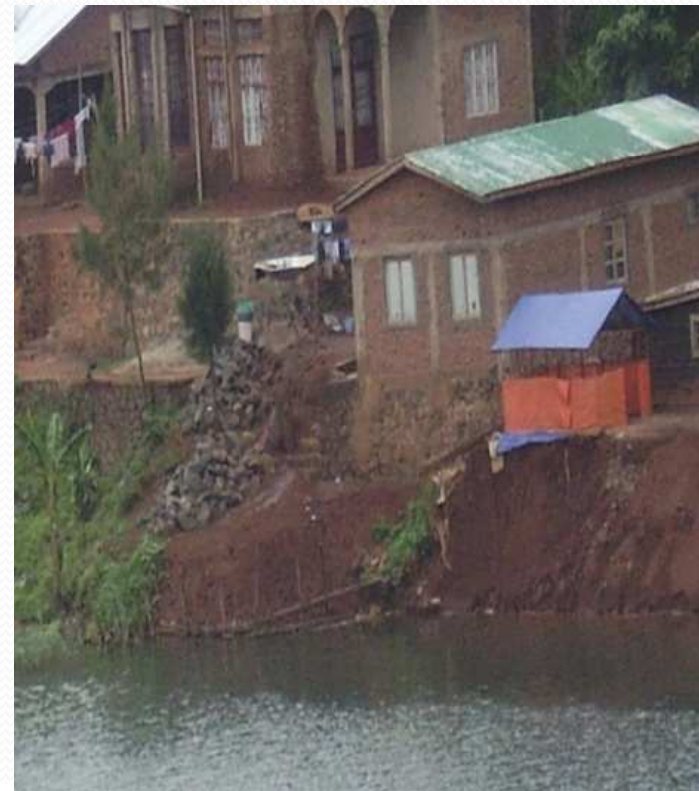
Figure 11: Landslide after the earthquake of 03/02/2008

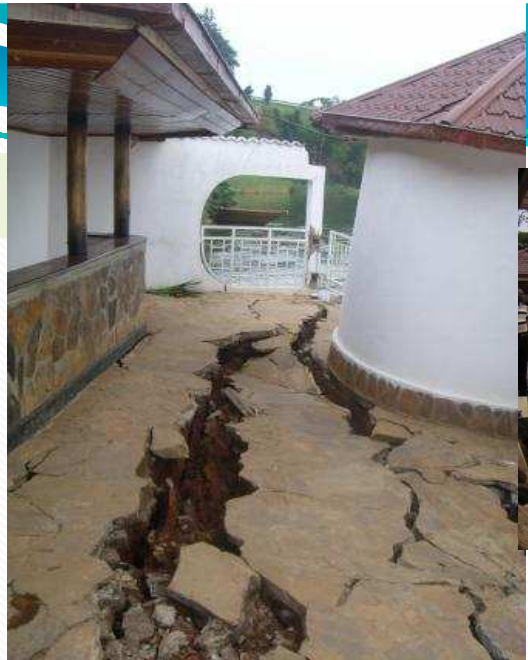
Figure 14: Subsidence at La Roche Hotel after the earthquake of 03/02/2008

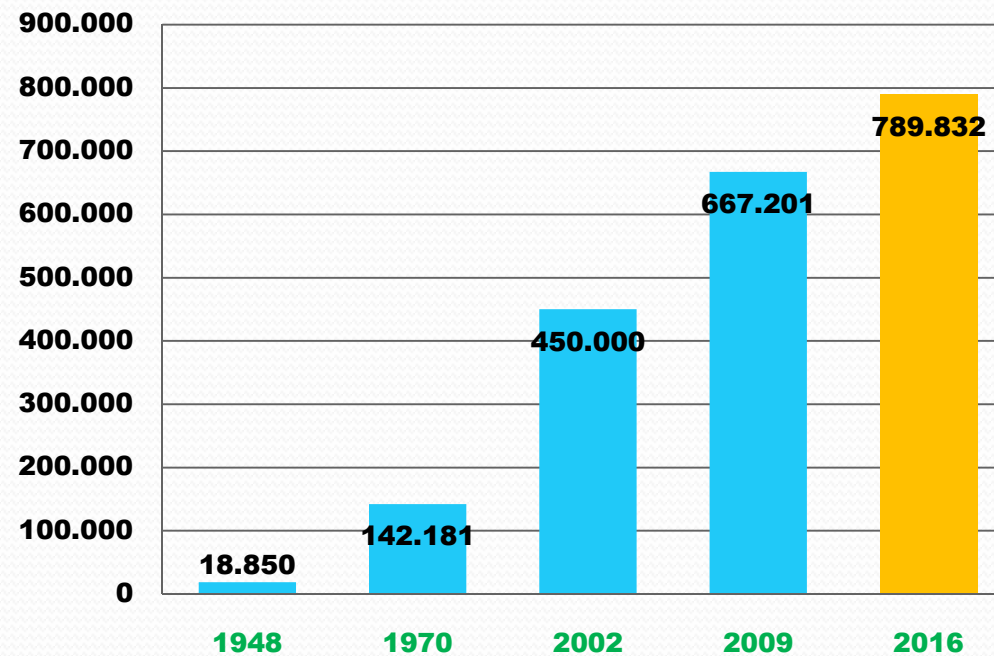
Figure 17: Evolution of people in the Bukavu city

Between 1970 and 2008 the population increased more than four times within a constant area of about 60 km²

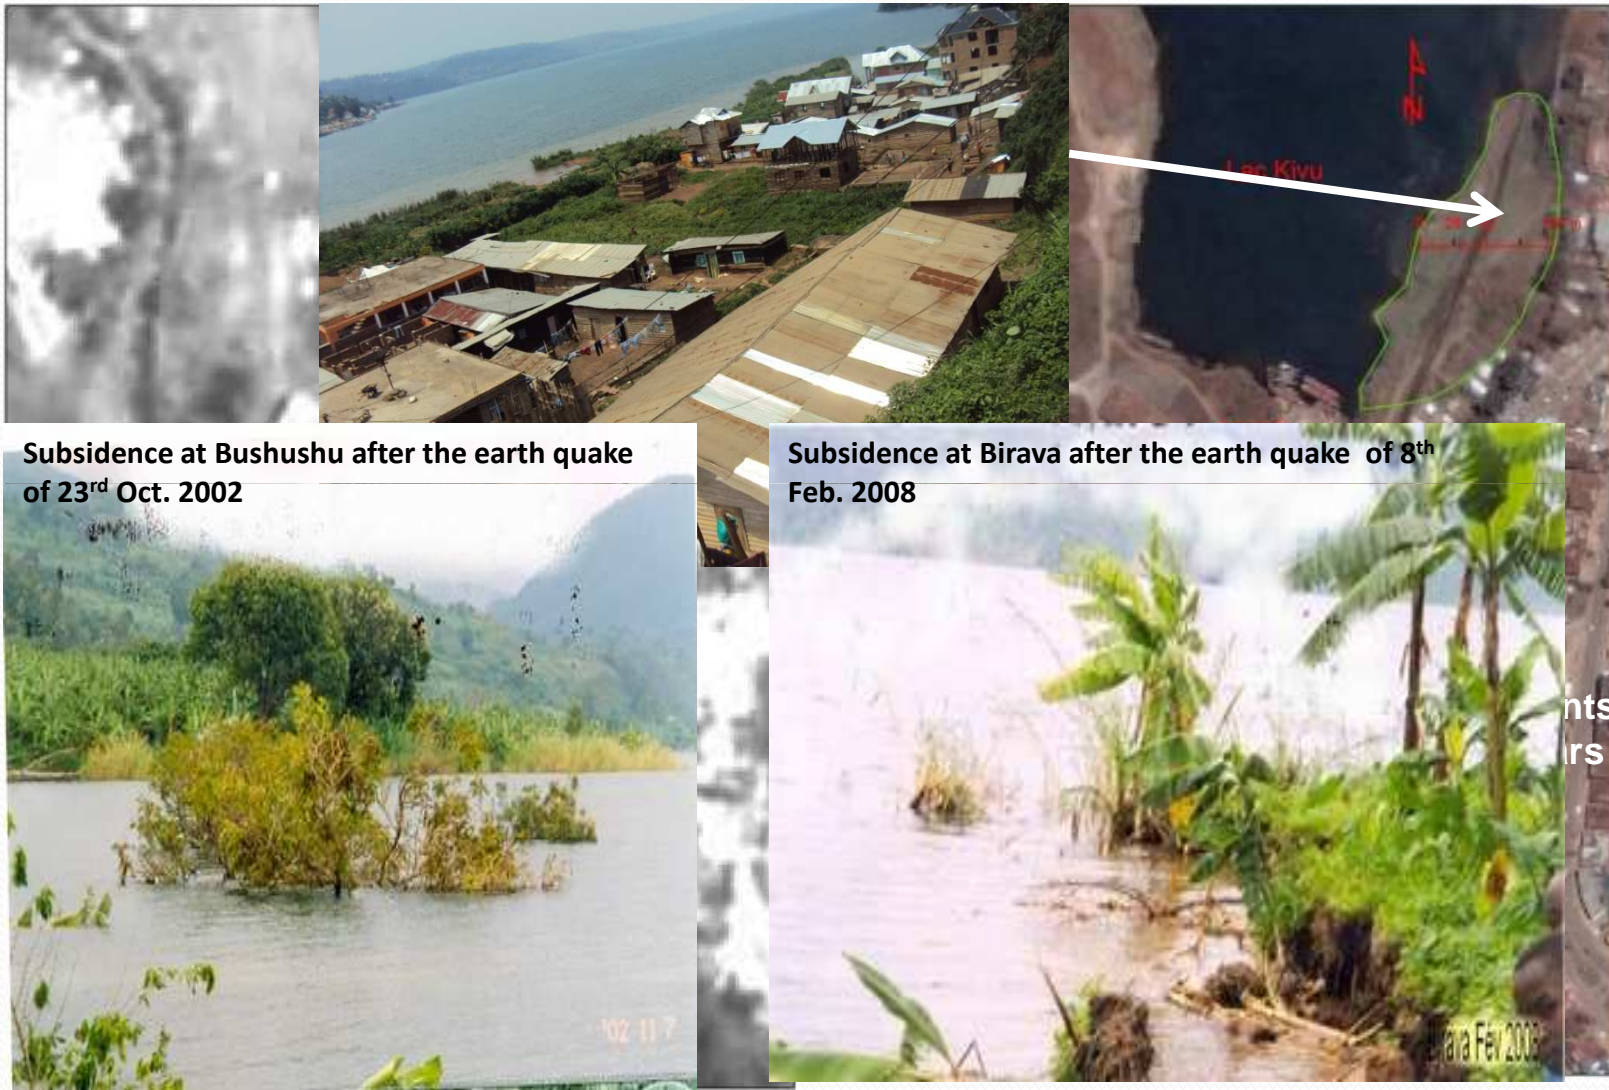
Subsidence at Bushushu after the earth quake of 23rd Oct. 2002

Subsidence at Birava after the earth quake of 8th Feb. 2008

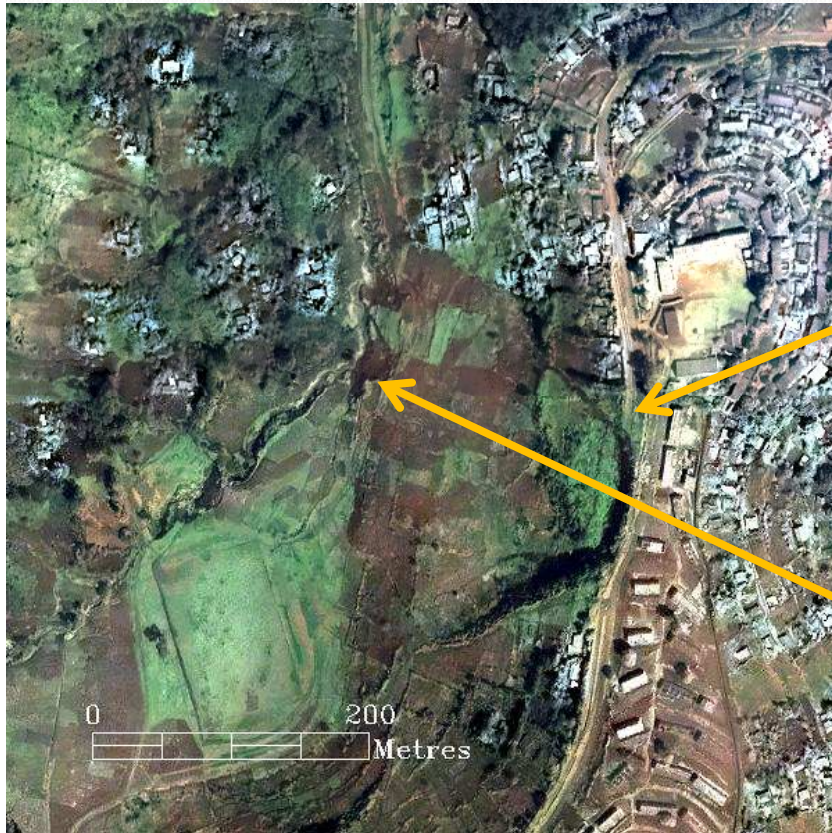
Interweaving of different factors: Water collector broken, earthquake, ground conditions

Figure 26: Landslide on Ikonos 2001

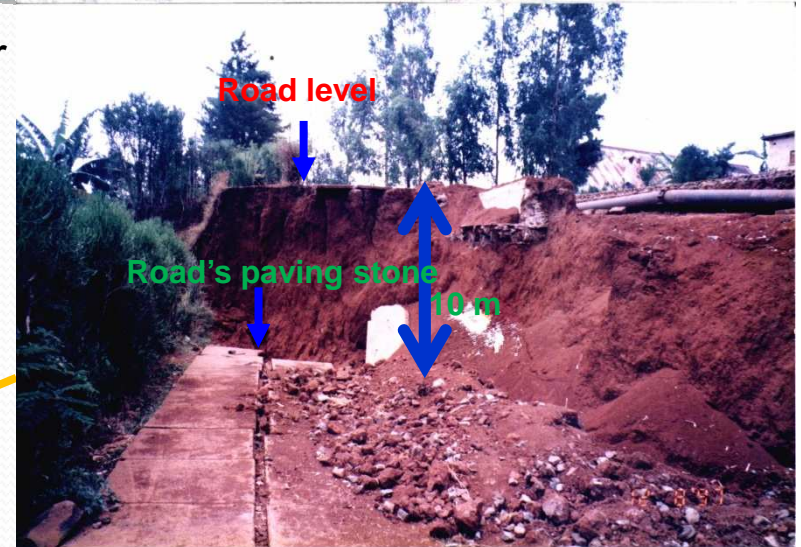
Figure 27: Landslide 1 day after event (12/8/1997)

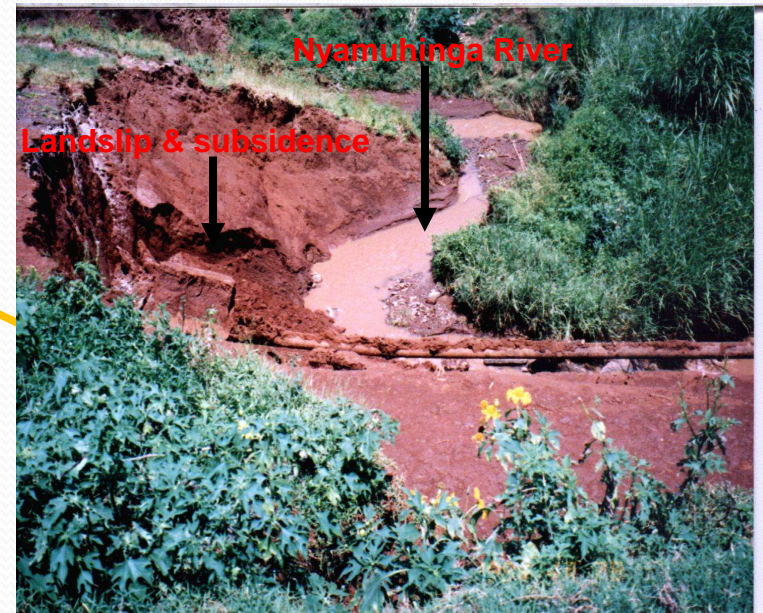
Figure 28: Landslide 1 week after event (18/8/1997)

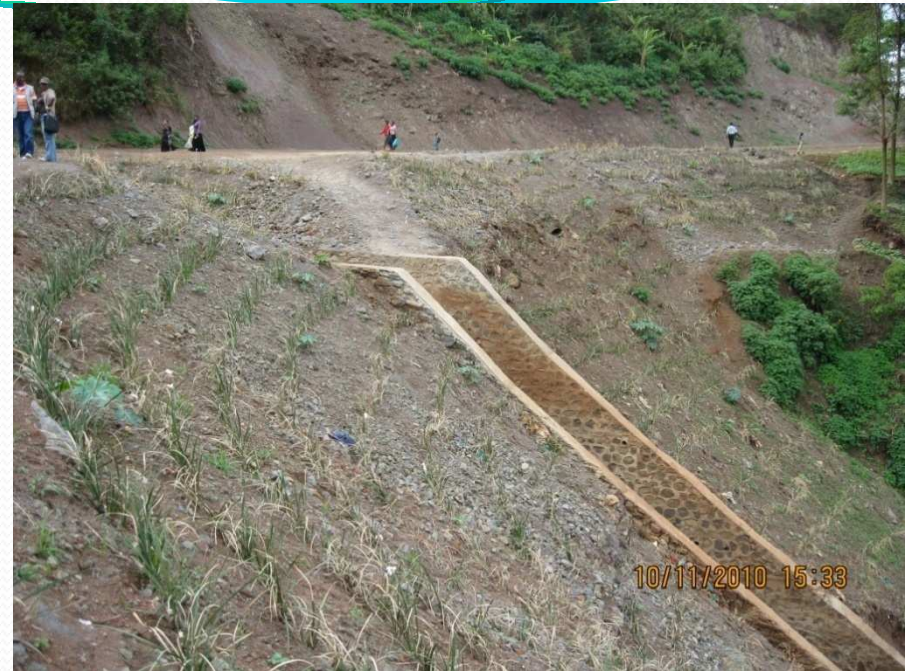
Drainage and slope stabilization in Bukavu

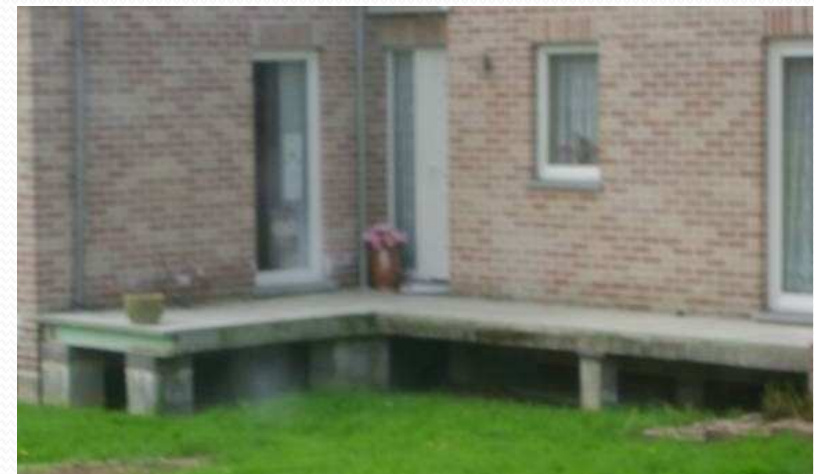
Gaps ventilated house in Belgium (Sadiki, 2009)
