Structural defects in residential buildings: A study of Quetta, Pakistan

Keywords: Housing survey, Structural defects, Residential buildings, Building safety, Quetta

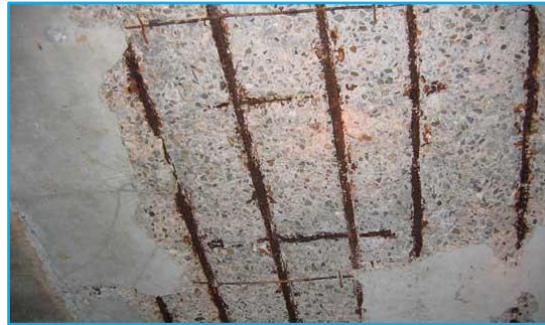
Such defects occur due to water seepage or water leakage from the roof slab. These defects cause bulging, pattern cracking, falling off clear cover from concrete which would expose the reinforcement. The reinforcement gets rusted by corrosion effect; water leakage may also react with adjacent walls which might cause plaster or tile delamination. The spalling of roofs is shown in Figure 1.

Figure 1. Spalling of roofs

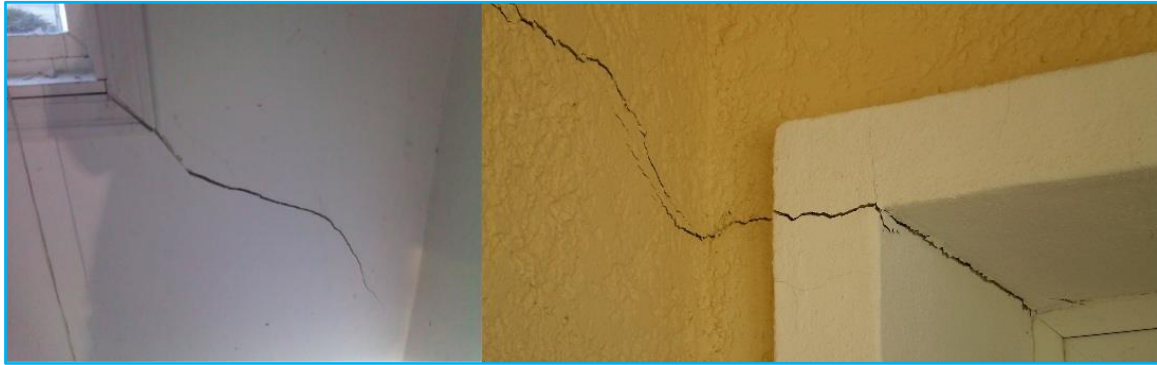
Structural cracks may occur due to several reasons including settlement of soil, foundation, overloading, poor design, and construction or use of substandard materials etc. The cracks shown in the Figure 3 produce cracks which penetrate through finishes into the bricks, long cracks across width of the wall, diagonal cracks at corners of window or door and cracks with rust staining.

Figure 3. Structural cracks found in doors and windows

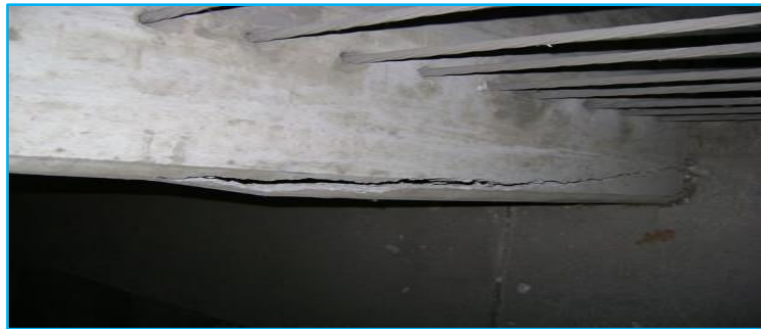
These cracks may produce due to same reasons as explained in 2.3. Cracks, shown in Figure 4 are formed in the columns and beams and produce spalling as well.

Figure 4. Cracks found in Beams due to excessive loading

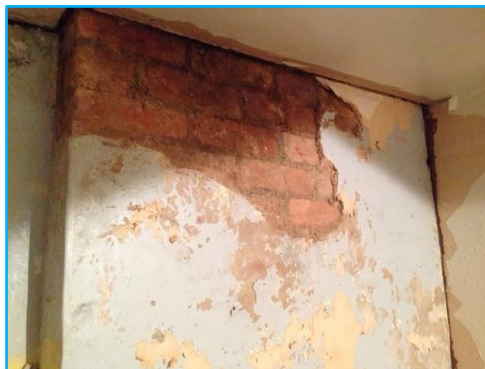
These defects may occur due to ageing, defective workmanship, thermal movement in expansion joints or by external factors such as falling parts as shown in Figure 5. This would result in de-bonding and delamination of finishes/ tiles from structure and when tapped with a hammer results in a hollow sound. Other defects are falling off and loosening of parts.

Figure 5. Falling off Plaster found in Walls
