# Wind-Induced Failure Analysis and Retrofit of an Existing Steel Structure

The “Dimitrios Vikelas” athletic center in Ermoupolis of Syros, Greece, consists of two buildings. Building B has a steel superstructure that was constructed approximately 35 years ago. It was initially used as a boat shelter and no design calculations were made. It contains steel columns with varying cross section heights. The spans are bridged via trusses and I-beams. Significant geometrical inconsistencies are noted among the existing steel connections and failures have been recorded as a result of buckling in several beams and bracings during the service life of the athletic center. The current study presents an investigation performed in order to diagnose building structural problems and propose strengthening and intervention measures. The goal of this study was to improve the load-carrying capacity of the structure in order to comply with the current design codes. Moreover, enhancement of the dynamic properties of the strengthened structure was demonstrated using modal analyses. The structural behavior was determined in a more precise manner via non-linear wind time-history and incremental static ana

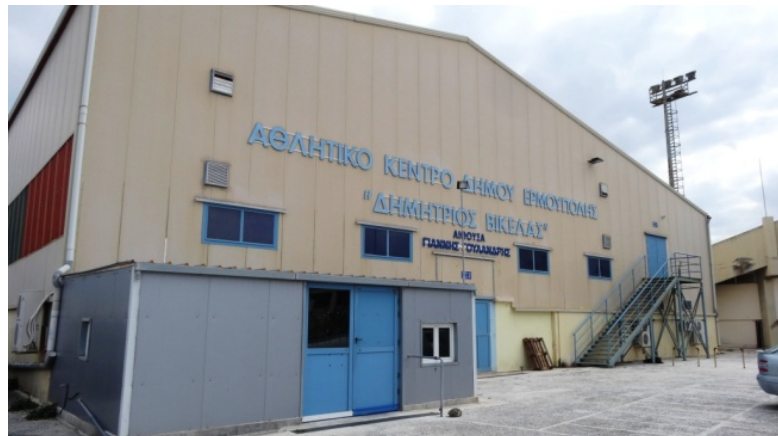
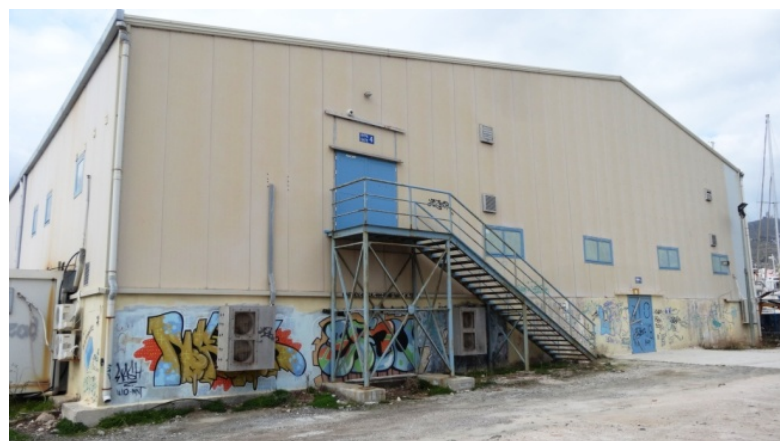
**Figure 1.** Views of the (a) west and (b) east sides of the building.

Building B of the "Dimitrios Vikelas" athletic center (**Figure 1**) is located in Ermoupolis in Syros, Greece. It was constructed in the 1970s and is located 30 m from the open sea, where it was initially used as a boat shelter. Today, it is used as an indoor volleyball facility. Since various structural damage has been observed, Maraveas C. & Associates P.C. was hired to perform a structural assessment of the building and propose strengthening measures.

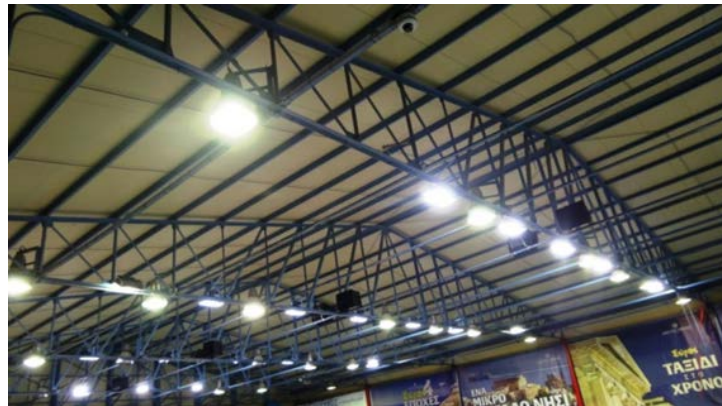
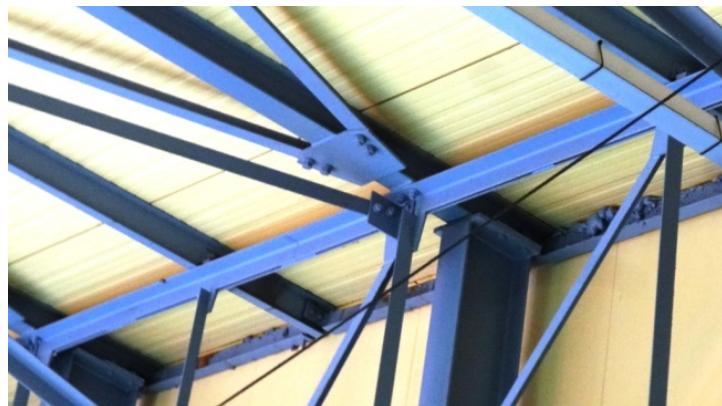
**Figure 2.** (a) Overall view and (b) structural details of the steel lattice roof.

Vertical and horizontal bracings from the double angle sections are located at the end openings of the longest direction of the structure. Furthermore, insignificant secondary H-type beams are located between the columns of the frames while the trusses are connected in the longitudinal direction through I-type purlins and L sections at the top and bottom chords respectively. Finally, gable columns with sections ranging from IPE200 to IPE330 are used to support the large areas at the east and west sides of the building. S235 structural steel is used for all the existing steel members.

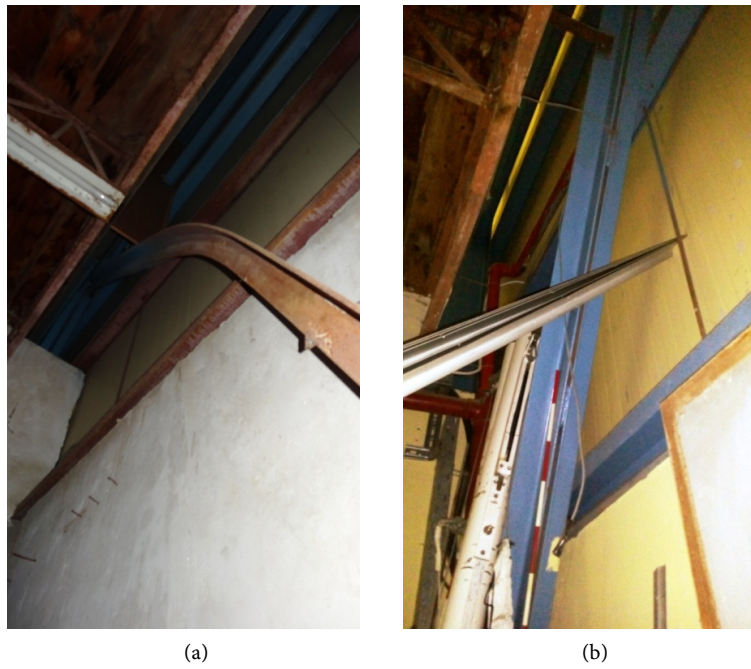
- 1) Extended buckling deformation of the  $\Lambda$ -type vertical bracings to the south (**Figure 3(a)**), as well as of the connecting beams between the IPE360 columns at +8.70 m (**Figure 4**).
- 2) Column-baseplate connections with major corrosion effects and insufficient stiffener thicknesses (**Figure 5(a)**).
- 3) Significant cracking effects at various locations along the perimeter of the brick wall. In particular, shear cracking expands to the concrete foundation wall on the north-east corner (**Figure 5(b)**).

**Figure 3.** Vertical A-type bracing on the southern section of the building: (a) the corroded portion with major second-order deformation and (b) the undamaged portion.

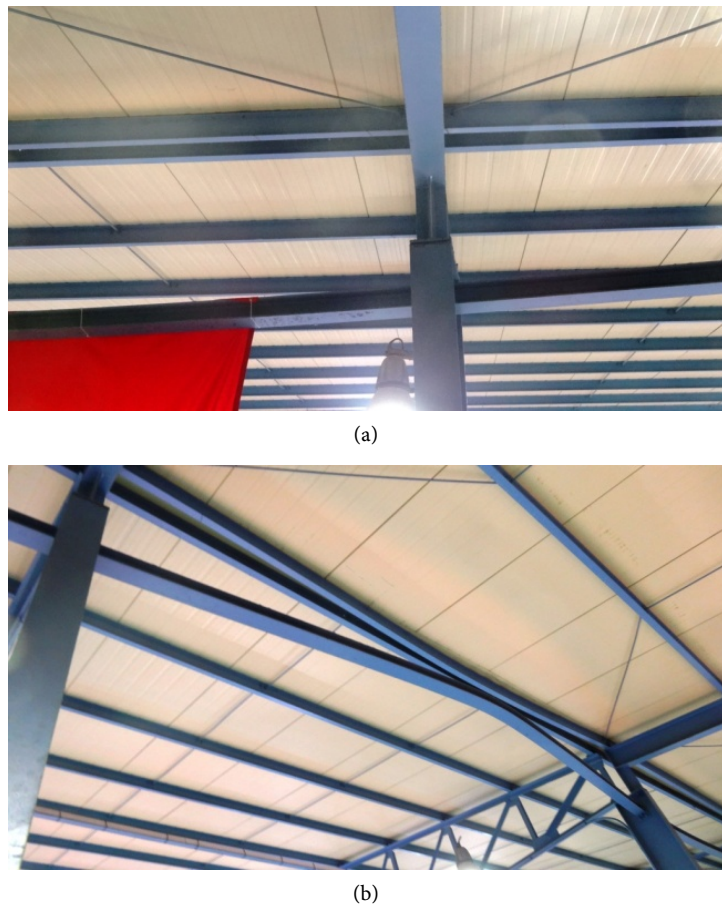
**Figure 4.** Steel elements with major second-order deformations.

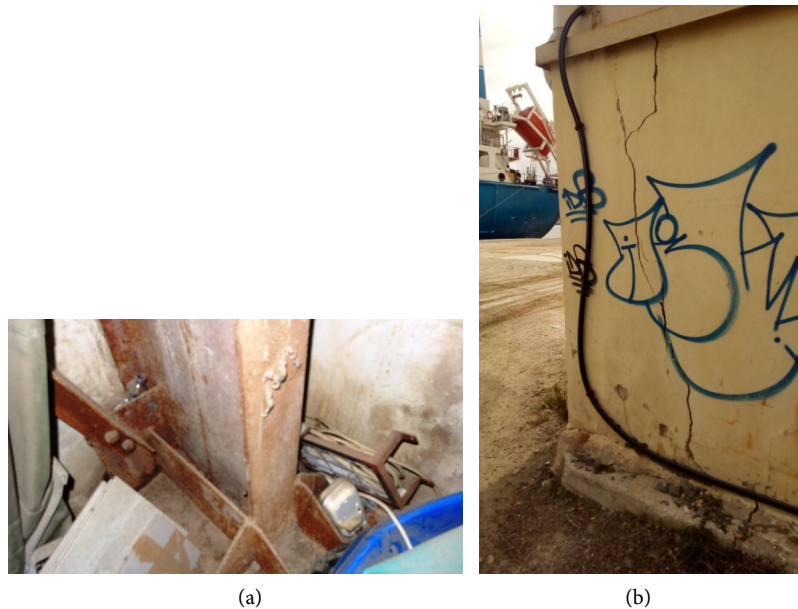
**Figure 5.** (a) Column base with significant corrosion and (b) brick wall with a large crack.

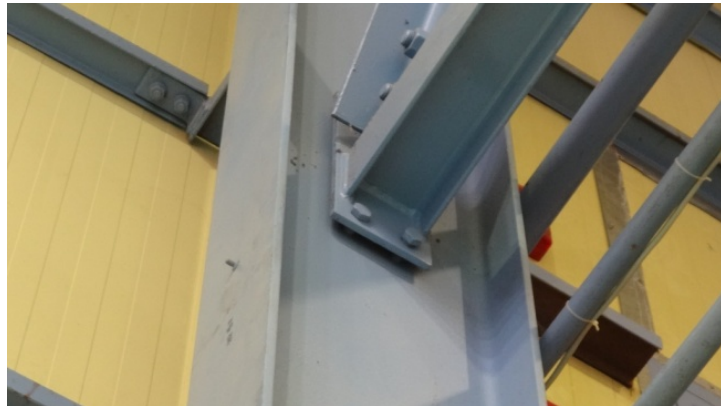
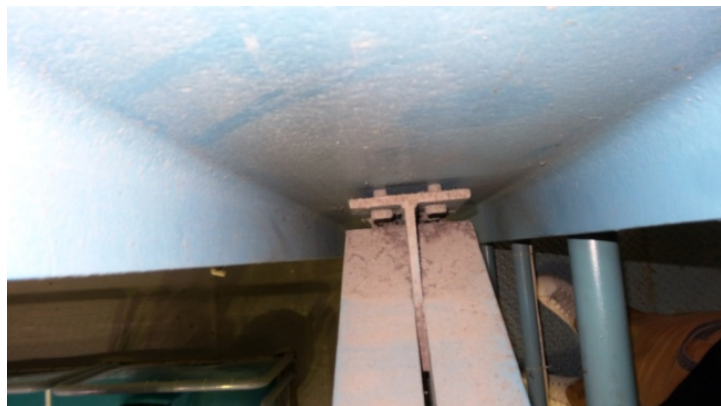
4) Relaxed bolted connections at elements of major importance (*i.e.* vertical bracings), as well as relaxed anti-sag bars at the roof (**Figure 6**).

**Figure 6.** Relaxed bolted connection.

Further minor but important restoration techniques should be implemented. They include tightening of bolts and anti-sag bars, surface treatment for corroded members that are not to be replaced (e.g. surfaces of columns near the base). Special treatment for foundation inadequacies is required as well. In particular, portions of the foundation beneath the gable columns (at both the east and west parts of the building) should be strengthened so that they can receive bending moments. The latter recommendation is illustrated in **Figure 16(a)**, where H-type steel beams are used as provisional column supports for an adequate length in both directions.

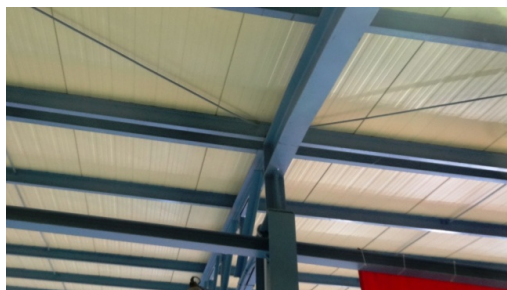
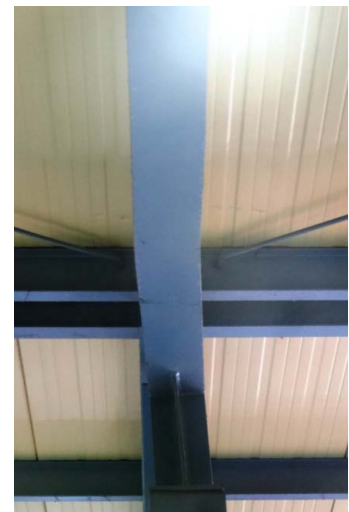
5) Major torsional deformation of vertical primary elements with insignificant torsional stiffness (**Figure 7**).

**Figure 7.** Insufficient beam-column connection.

5) Replacement of vertical elements at the end of the IPE360 column (**Figure 7**), which is predicted to provide a stiffer beam-column connection.

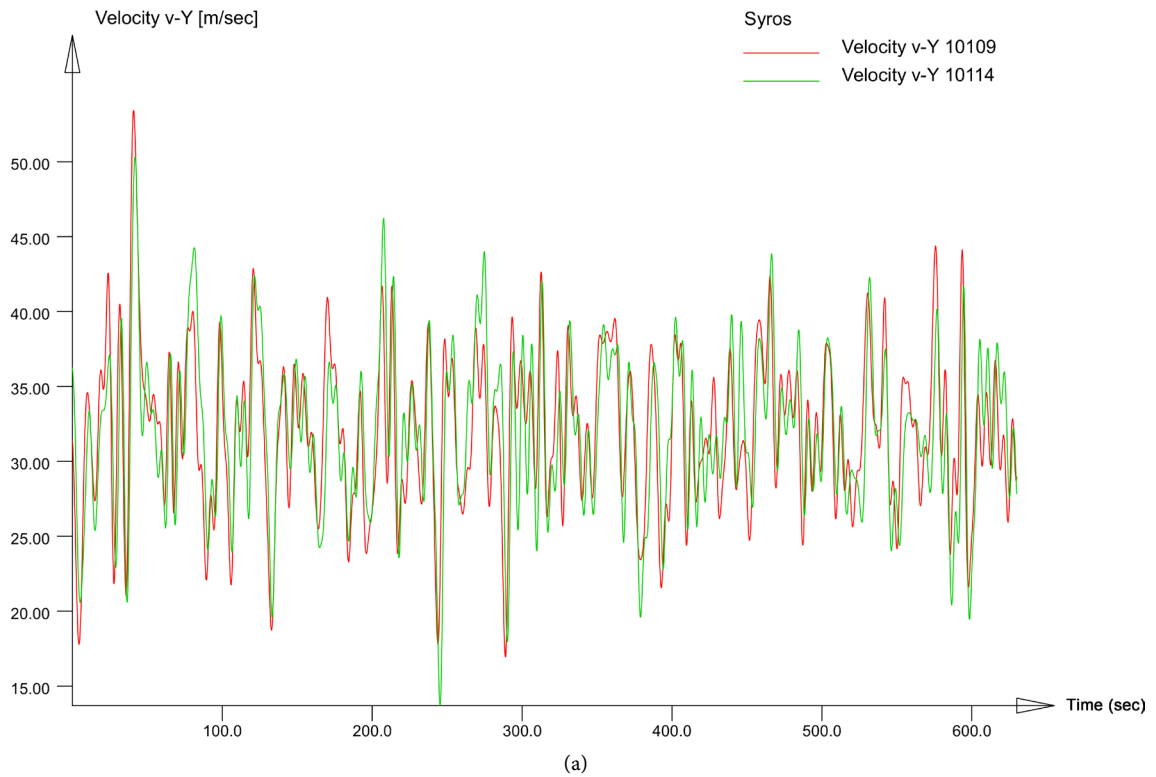
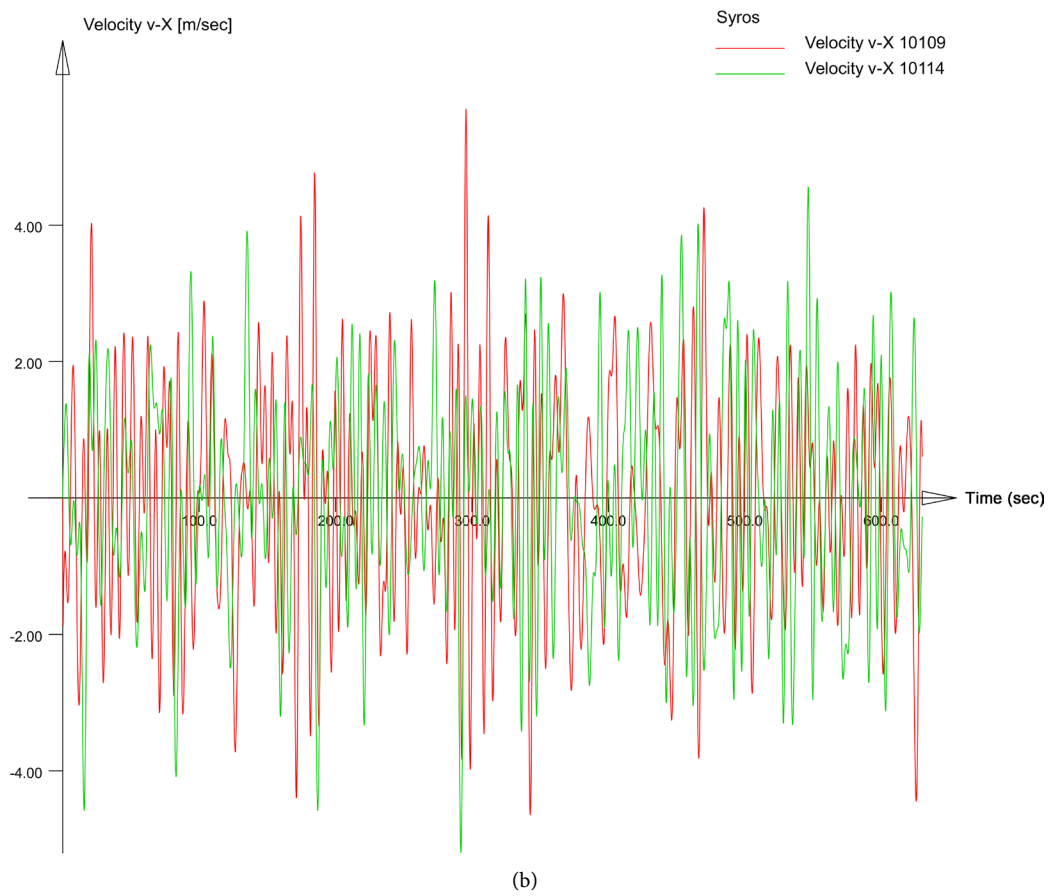
The wind profile corresponds to that of a coastal area with a mean wind velocity of approximately 33 m/s operating for 10 min (similar to the wind profile defined in EN 1991-1-4). The time-histories for structural elements at heights of 5 m along the long and transverse directions of the structure are depicted in **Figure 8**. These artificial random records—which are created through Sofistik [20]—facilitate the design process against wind loading to a great extent, since transient dynamic analyses allow the determination of the structural response including any material or geometrical non-linear effect.

**Figure 8.** Velocity time-history samples for the a) longitudinal and b) transversal wind directions.

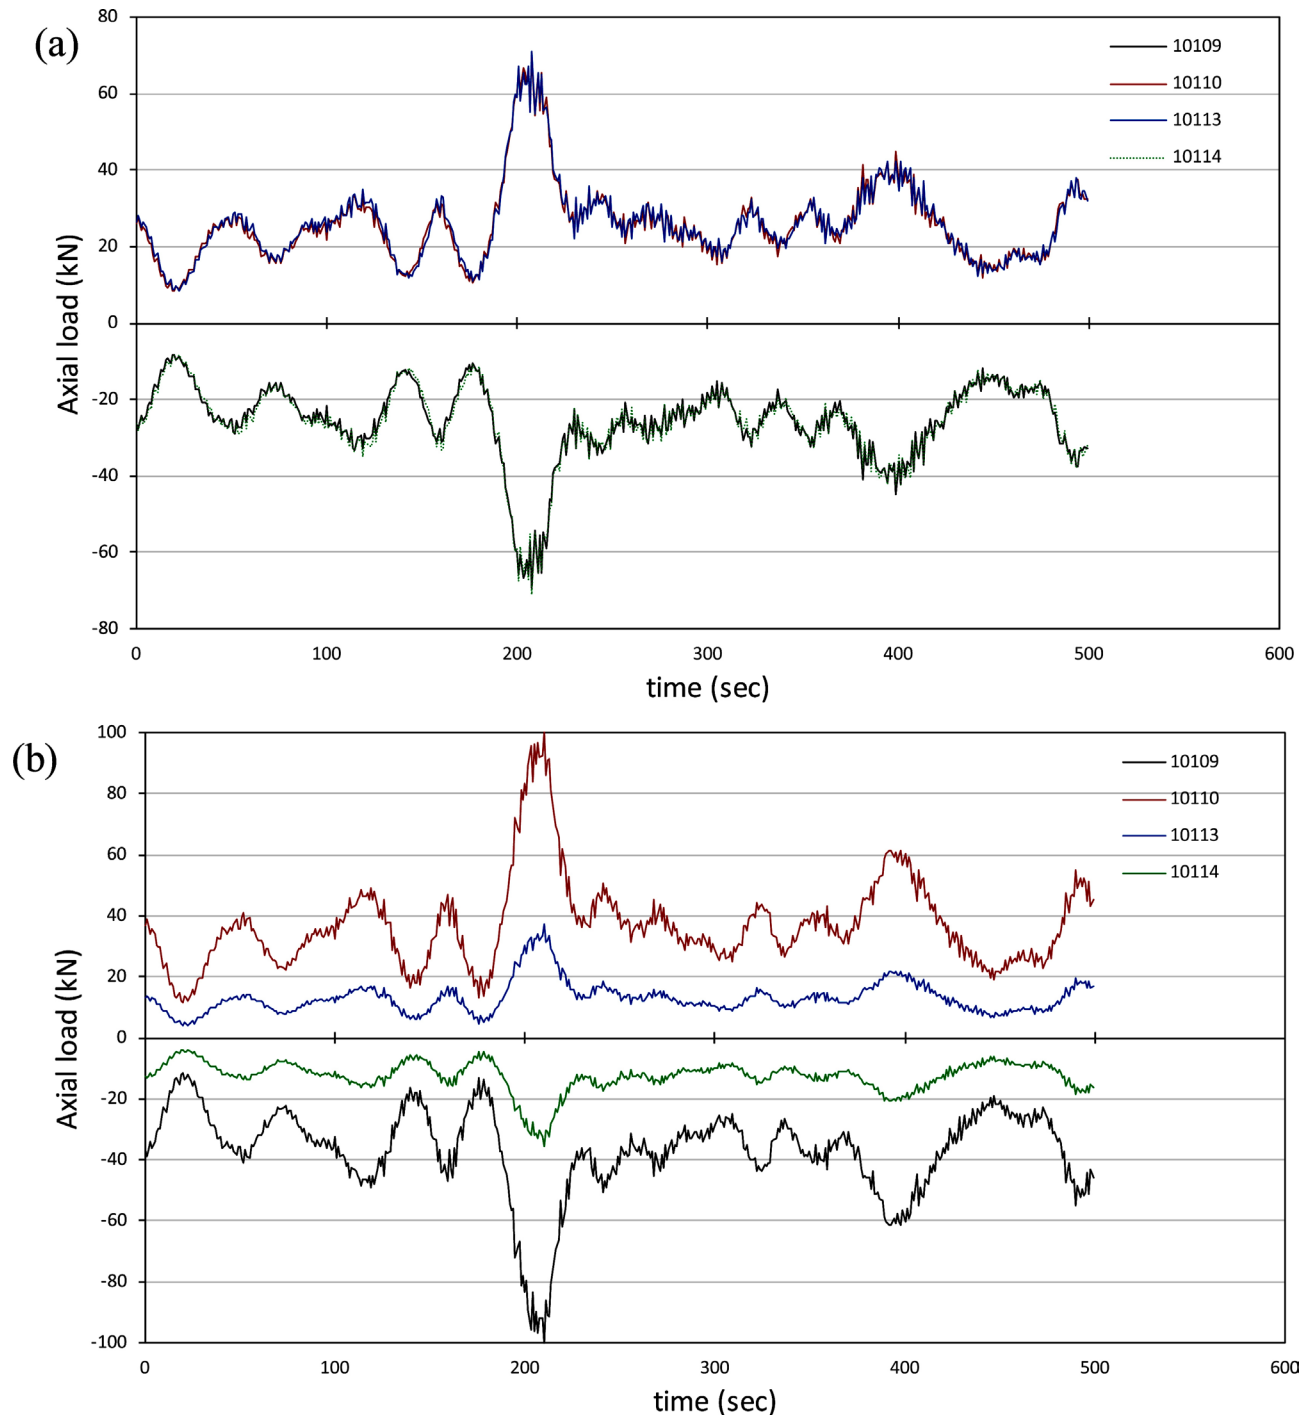
The results of the time-history dynamic analyses are shown for the selected beam elements in terms of axial force in **Figure 10(a)** and **Figure 10(b)**. The two figures respectively address conditions that exclude and include geometrical imperfection from the buckled L-section. The latter case can be referred as the “imperfect” one. A thickness reduction of 1.0 mm due to corrosion is also included in this case. One can clearly observe relief of the damaged and tensile (member No. 10113) members. In contrast, the east pair of bracings displays additional axial force, which reveals a more unfavorable design status (member

Nos. 10109, 10110). The axial forces are differentiated by approximately  $\pm 45\%$ .

**Figure 10.** Axial load histories for  $\Lambda$ -type vertical bracings with (a) perfect and (b) imperfect structures.

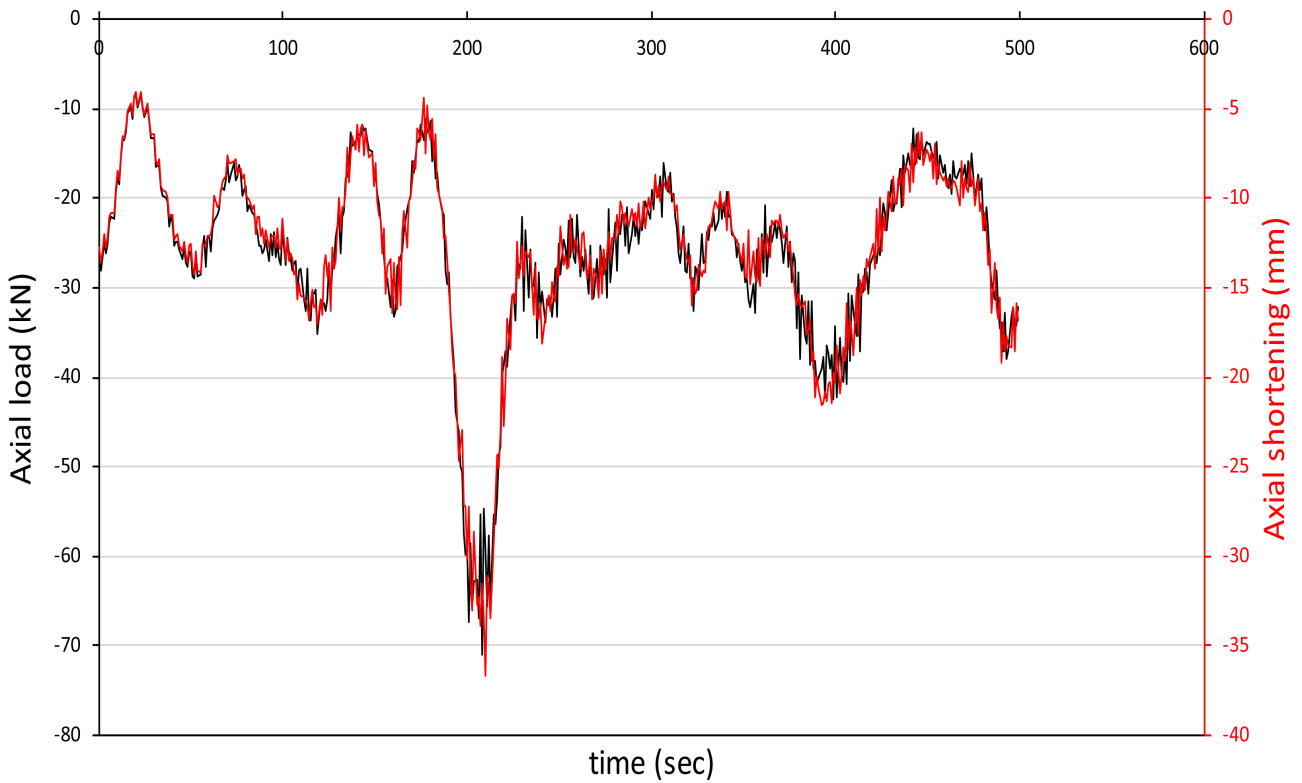
The axial force and dynamic histories, as well as the axial displacement history determined via the dynamic analysis, are shown in **Figure 11**. The maximum recorded load is 71.0 kN, which corresponds to an axial shortening of 31.6 mm. The shortening itself ranges from 4.0 to 36.7 mm. Considering only the axial load produces a surprising outcome since the maximum developed compressive force does not exceed the buckling capacity of the corroded bracing. However, a design Engineer should cautiously consider the most critical qualities, which are the motive for a displacement-based analysis.

**Figure 11.** Axial load and displacement response of element No. 10114.

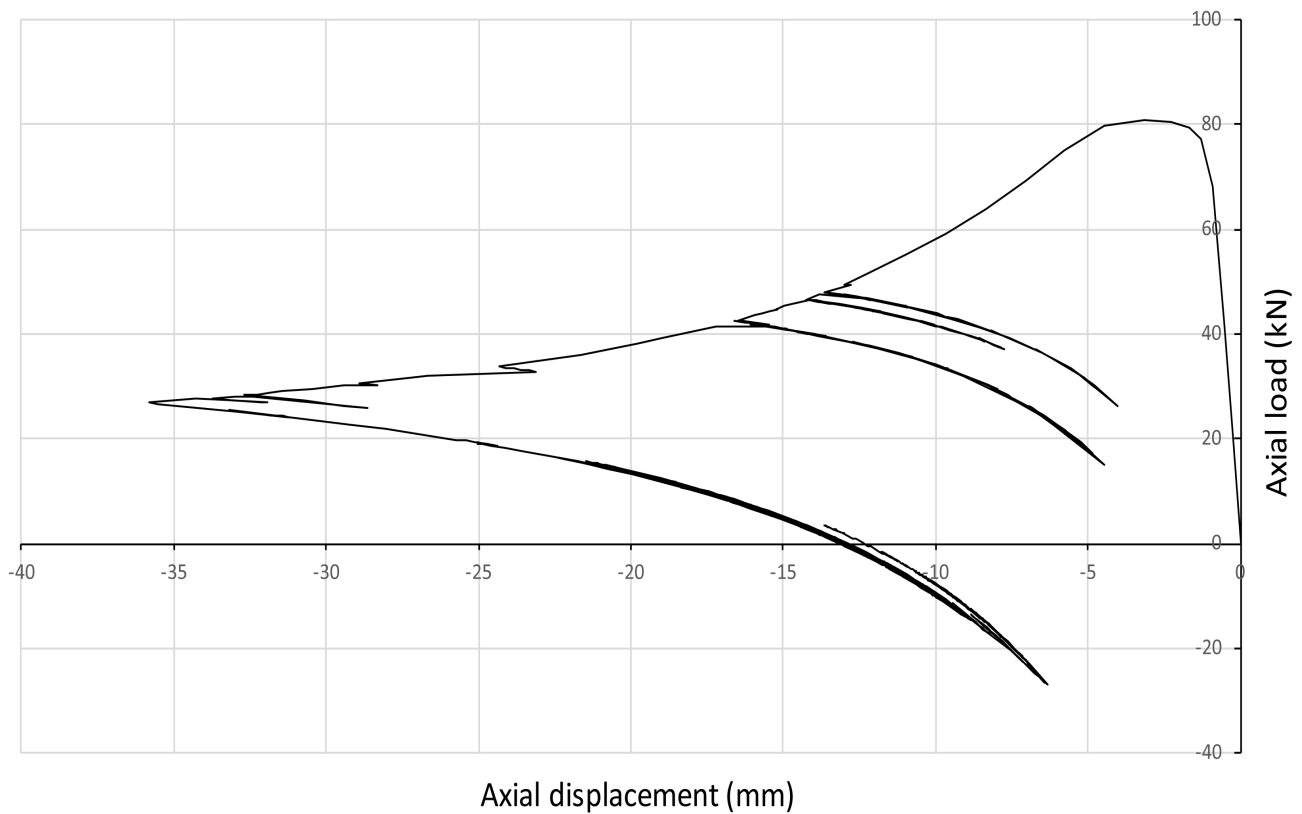
The buckling response—shown in **Figure 12**—was identified after importing the exact function of the axial displacement from the wind history analysis into Abaqus as boundary condition amplitude. The maximum buckling capacity attained is greater than 81 kN, which is larger than 71 kN. Nevertheless, buckling phenomena have occurred due to significant shortening of the beam. In addition, the axial stiffness of the buckled beam is confirmed using the post-buckling curves. In particular, the stiffness (which is detected at the onset of a new compression region) is nearly equal for all the subsequent loading paths after the first buckling occurrence (axial displacement of 3 mm).

**Figure 12.** Response of the corroded buckled bracing, as determined using Abaqus.

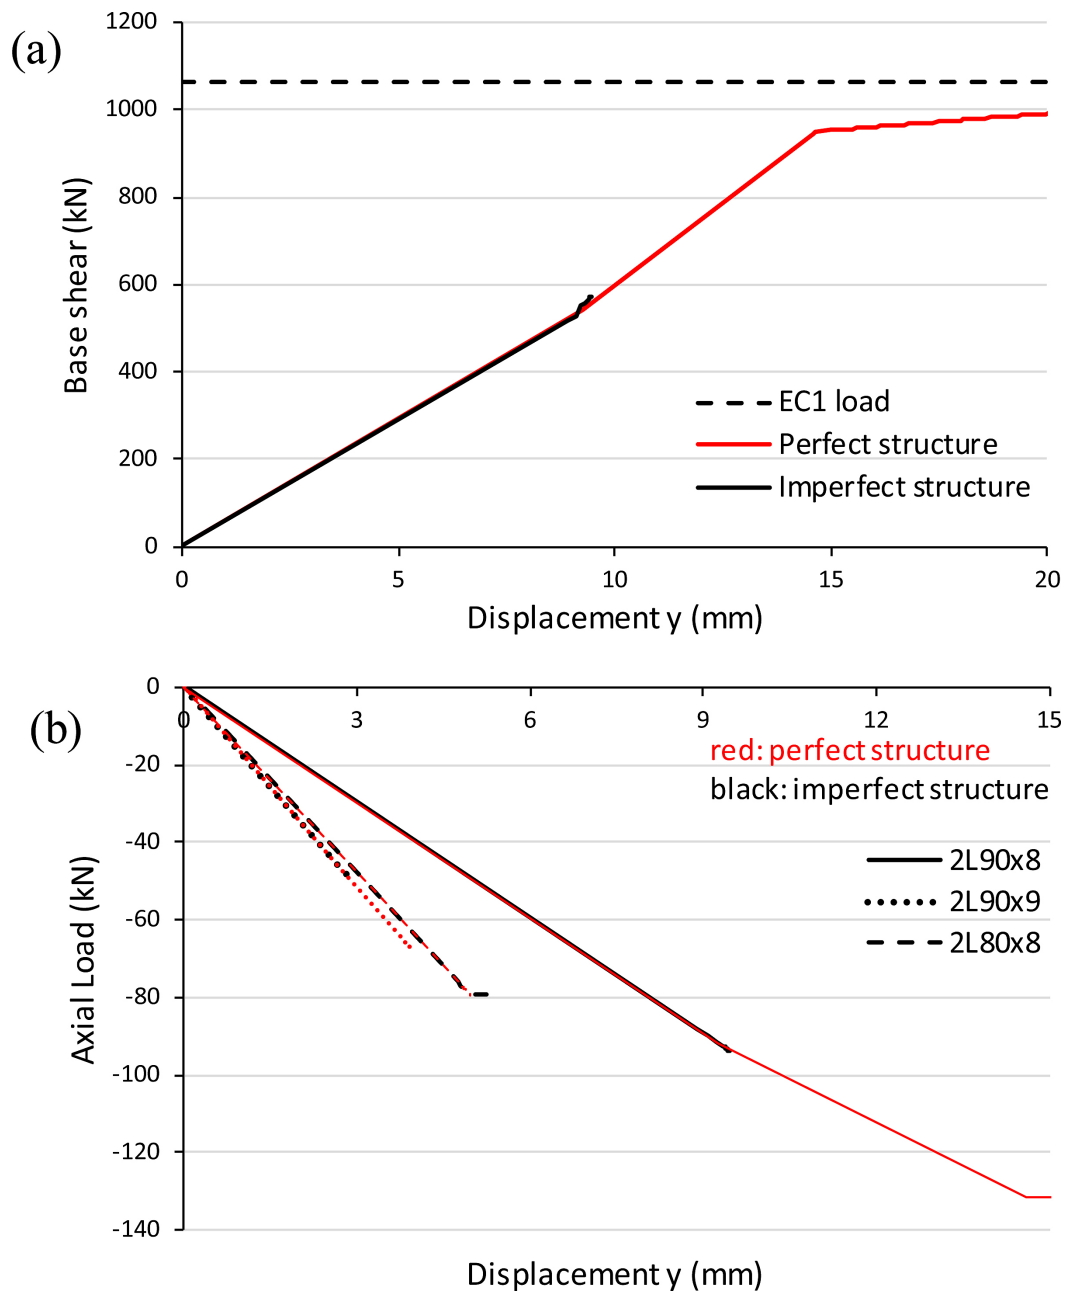
The capacity curves shown in **Figure 13(a)** capture the total response of the

structure, while the dashed line defines the minimum requirement that the structure should have met. After considering imperfections, *i.e.* excessive deformation of the damaged bracing, the bearing capacity is only 58% of that of a perfect sample. Nevertheless, the latter capacity does not satisfy the Eurocode requirement in terms of total base shear force. Furthermore, the axial load-displacement curves of the major vertical bracings are compared in **Figure 13(b)**, while the selected

**Figure 13.** Comparison of the (a) capacity curves and (b) axial load-displacement paths of vertical bracings within perfect and imperfect structures.

imperfection is neglected during the pushover analysis. The double equal angle cross-sections  $L90 \times 8$ ,  $L80 \times 8$ , and  $L90 \times 9$  correspond to the existing bracings of the north, south, and Section 1.1 views, respectively.

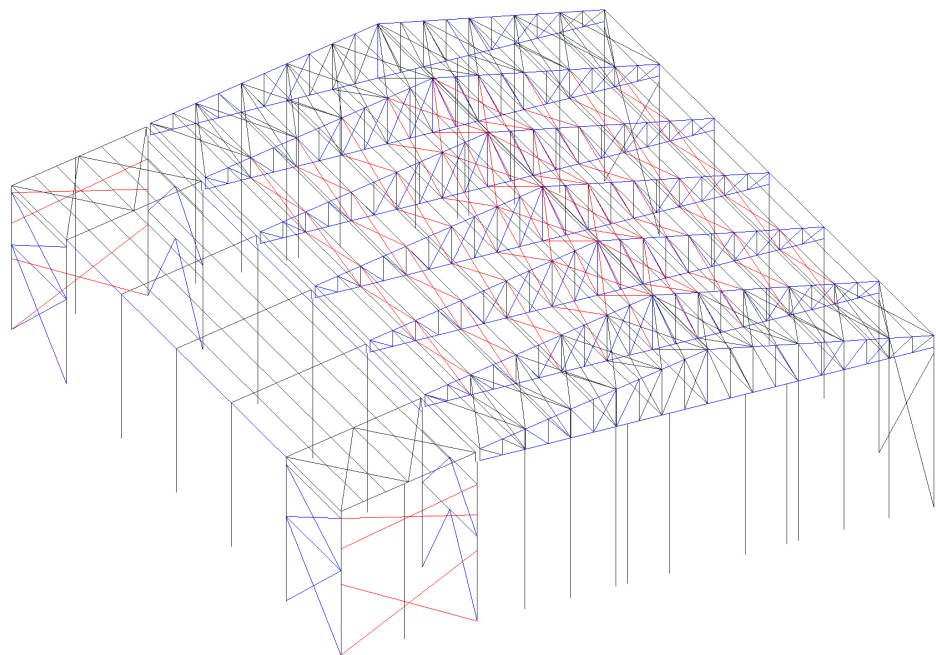
**Figure 14.** Three-dimensional view of the structural modifications (blue for replacement or strengthening, red for member addition).

**Figure 14** shows the type and extent of interventions recommended for the main steel structure. Replacement and strengthening of the truss roof are illustrated in blue, while red is used to indicate member additions. The same conventional symbolism has been adopted for **Figure 15**. Unfortunately, some serviceability constraints (equipment, etc.) prevent the use of a more orthodox X-bracing configuration in the east and west views (outer red vertical bracings in **Figure 14**).

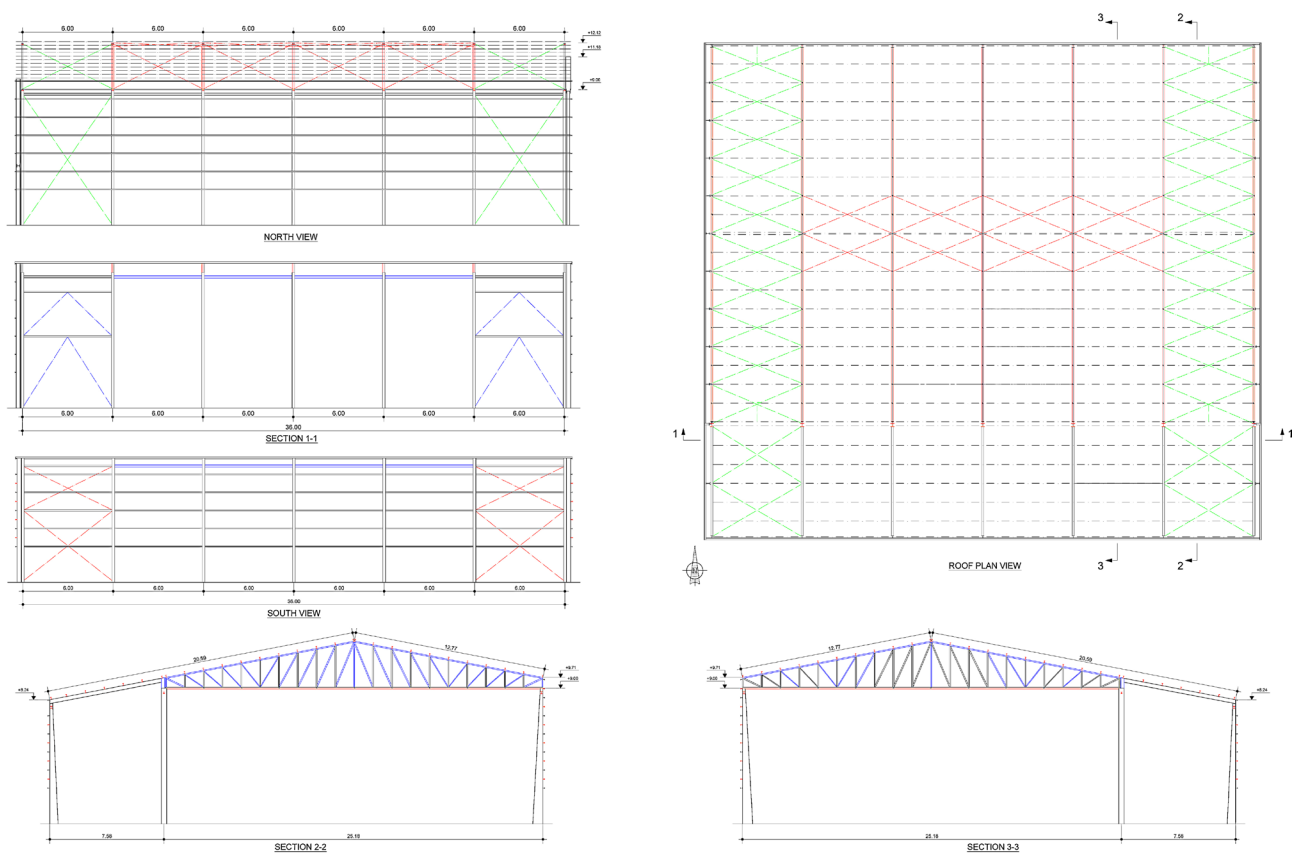
**Figure 15.** Schematic view of the strengthened structure (green for existing bracings, red for proposed modifications, and blue for strengthening).

- 1) Addition of horizontal X-bracings near the roof ridge (roof plan view in

3) Replacement of insufficient vertical bracings using the same or different configurations (examples from the south and north sides of the building as well as Section 1.1 can be observed in **Figure 15**).

4) Replacement of distorted members such as H-type connecting beams in Section 1.1 of **Figure 15**.

6) Strengthening the cross-sections of the main chords of the lattice roof using thin-walled hollow sections; strengthening of specific truss members by adding second angle sections (Sections 2.2 and 3.3 in **Figure 15** and details in **Figure 16(b)**).

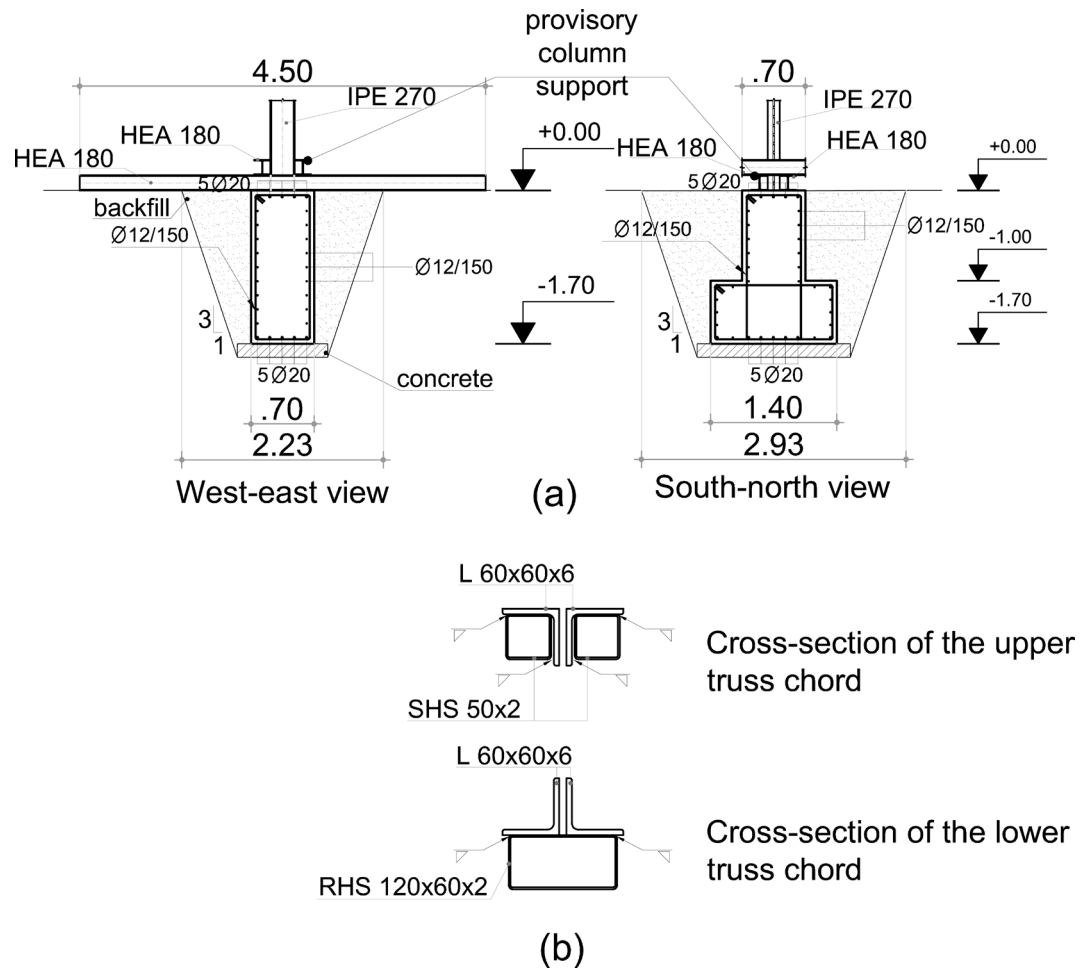
**Figure 16.** Schematic view of strengthening details for (a) the foundation and (b) the truss chords.

A detailed schedule of strengthening of the truss chords (point “f” of the strengthening proposals) is attached in **Figure 16(b)**. The new hollow sections will be properly welded under the existing angle members since the purlins and the web members used for the upper and lower chords of the truss, respectively, preclude any other recommendation. Finally, it is important to maintain a light-weight design in order to optimize the bearing capacity of the lattice structure.

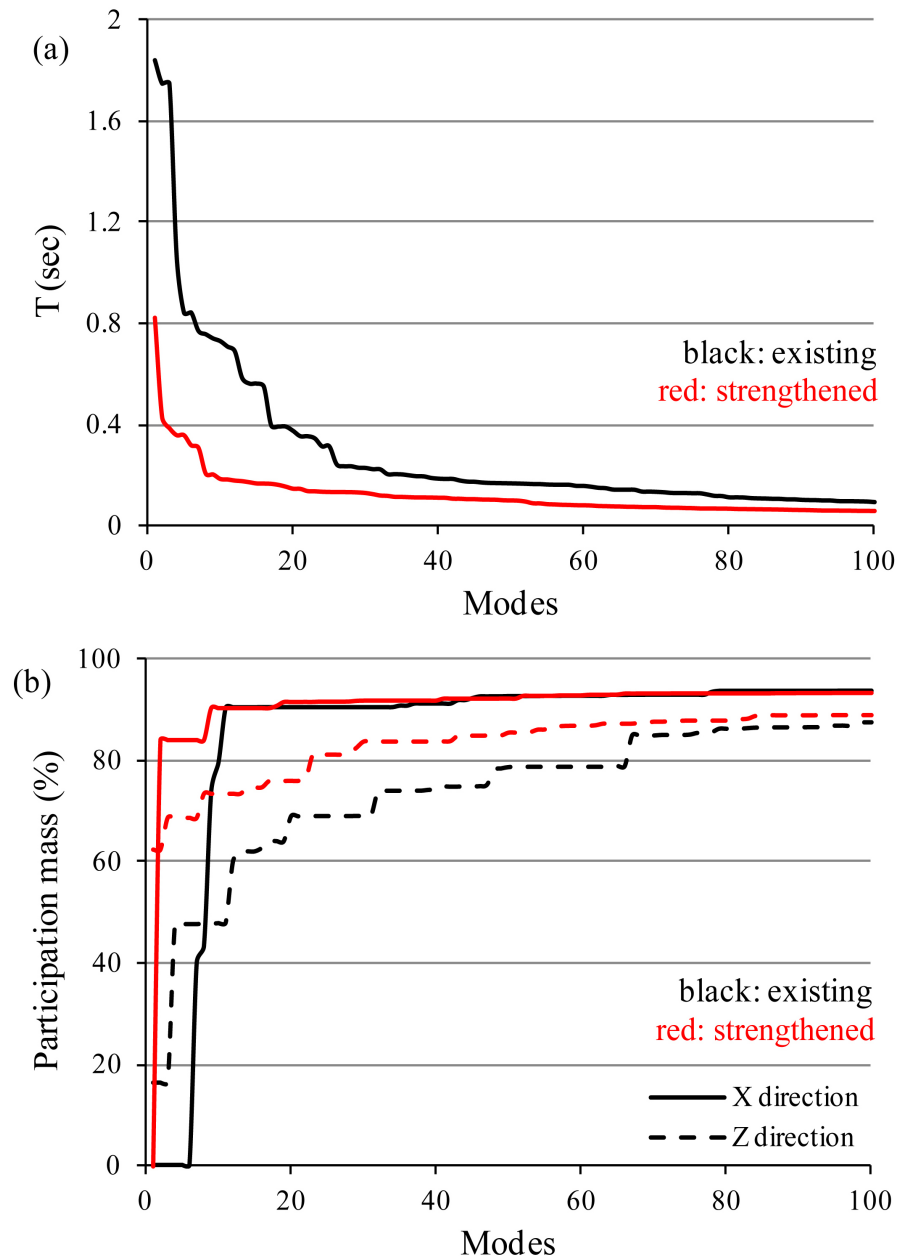
Modal analyses have been performed to compare the existing and strengthened structures. The results shown in **Figure 17** demonstrate clear improvements to the dynamic characteristics of the structure. In particular, the mass participation is increased to 62% and 84% in the long and transverse directions (along the Z- and X-axes, respectively), compared to 31% in the unstiffened structure. The corresponding periods decrease from 1.07 s to 0.82 s and from 0.74 s to 0.43 s along the Z and X directions, respectively, after the proposed retrofit. The aforementioned mode shapes for the long and transverse directions are compared in **Figure 18(a) & Figure 18(b)** and **Figure 18(c) & Figure 18(d)**, respectively. Additionally, **Figure 18(a) & Figure 18(c)** and **Figure 18(b) & Figure 18(d)** correspond to the existing and strengthened structure respectively.

**Figure 17.** Comparison of the dynamic characteristics of the existing (black) and strengthened (red) structure (solid and dashed lines for the X- and Z-directions respectively).

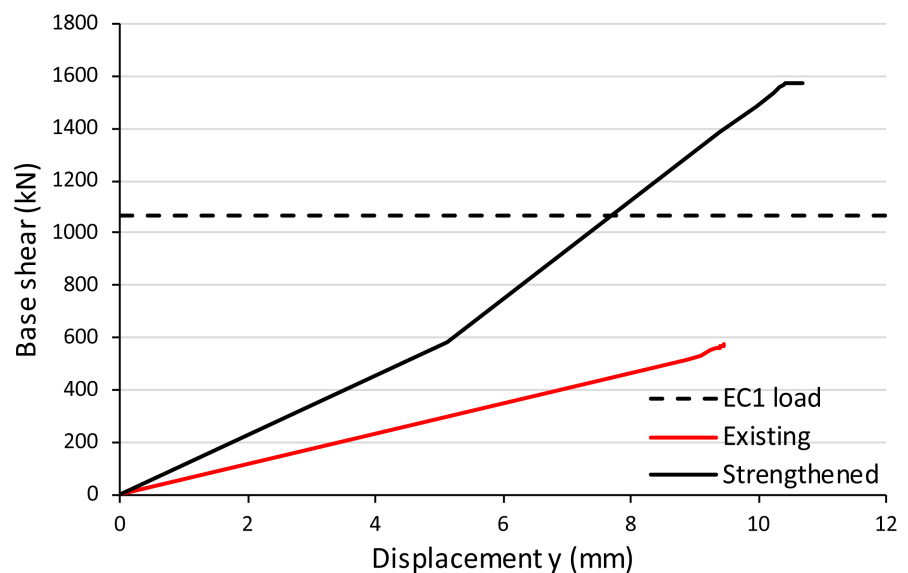
For the sake of completeness, the capacity curve of the proposed modified structure was established and compared to that of the existing structure. The procedure presented in Section 2.3.1, is repeated in Sofistik using the enhanced properties of the new and strengthened members. **Figure 19** shows the new curve that indicates a total base shear force enlargement from 571 kN to 1571 kN. For the case of the strengthened structure (black colored line) it's easy to notice an inflection point which is experienced at the first (predefined) incremental step of the chosen load pattern, beyond which the stiffness is further enhanced.

**Figure 19.** Comparison of the capacity curves of the existing and strengthened structures.
