# Between Carpentry and Joinery

Wood Finishing Work in European Medieval and Modern Architecture

**Edited by Pascale Fraiture, Paulo Charruadas, Patrice Gautier, Mathieu Piavaux, Philippe Sosnowska**

**Royal Institute for Cultural Heritage**

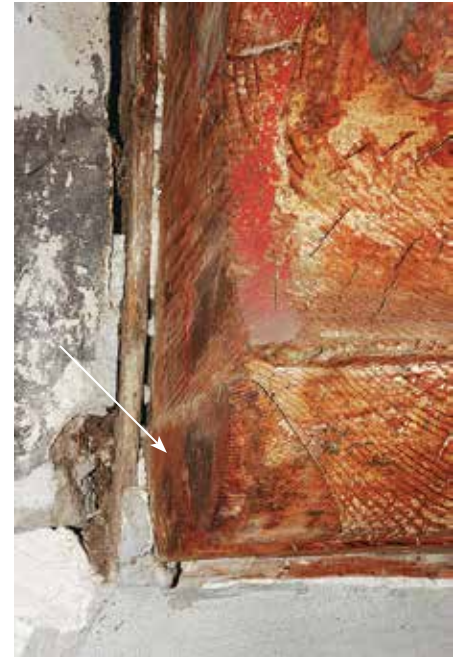
1.6

Fig. 1.6. Repair of a wane ridge of a corbel. Livrée de Viviers, Avignon (department of the Bouches-du-Rhône).

The final treatment of the surfaces did not remove, however, the wane (*flaches\**) left by squaring or splitting the edges of the wood elements. These curved edges could negatively affect the aesthetics of some prestigious works. In a concern for detail, the *fustiers* had recourse to different solutions to correct or hide these defects. Such edges could simply be placed as the upper edges of the beams, keeping the squared parts most visible from the floor of the room covered. The wane could also be hidden behind mouldings or joint trimming (*closoirs\**) attached to the upper edge of the beams. In some cases, the painters took advantage of it by outlining the wane in patterns as if they were bev-els (*chanfreins\**) where the colour would emphasise their presence. When these defects posed real problems for the finishing of the most delicate pieces, the *fustiers* added small pieces of wood to compensate for the curving due to the wane, creating perfectly sharp edges (fig. 1.6). These grafts were typically attached by one or two nails but, with time, could become separated from their support. Small repairs were also made where wood fibres had been torn due to the presence of a knot, probably during sawing. Instead of removing the detached wood piece, the craftsmen smoothed and nailed it again to hide the defect. The care given in the preparation of the surfaces of wood pieces is close to the work of joinery. Such attention to detail is even more marked in the construction of the moulded elements.

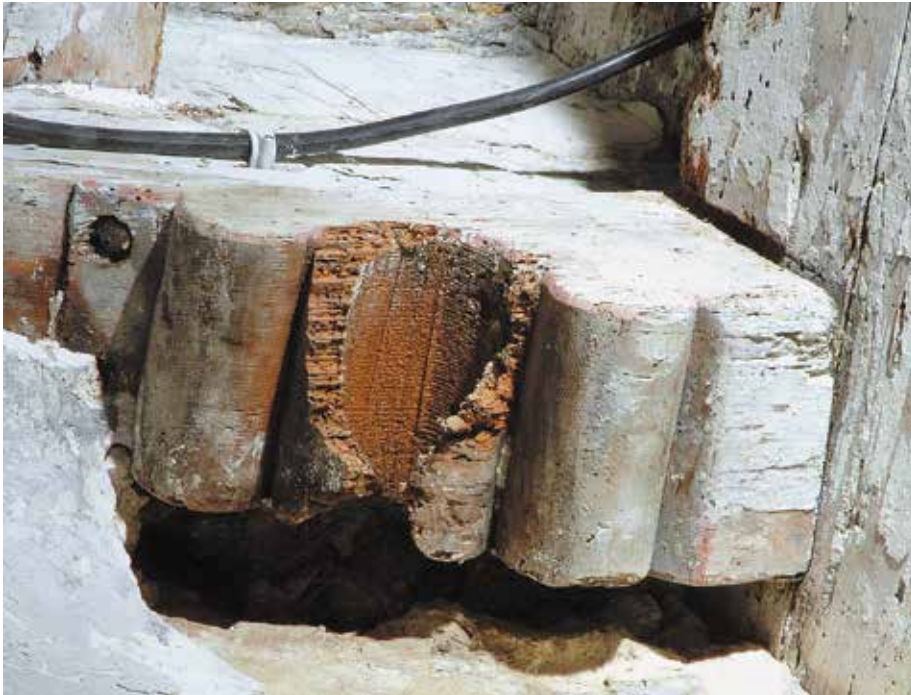
1.8

Fig. 1.8. Gouges made with a saw. Château, Le Thor (department of the Vaucluse).

In the early 15<sup>th</sup> century, wood corbels placed below the floor beams were the most finely crafted (fig. 1.1 and 1.7). Generally more developed than those of stone, they underline the beams for 30-50 cm in front of the perpendicular wall. They show quite elaborate moulding work, using a succession of tori and grooves (convex and concave mouldings). Trace-wear analysis indicates that making these shaped decorations at the ends of the corbels was done with two tools. The most common technique was to progressively hollow the wood with a chisel and gouge as seen, for example, in the concave striations left within the grooves of the corbels of the Livrée Ceccano in Avignon (1333-1335). More surprising are traces of sawing discovered inside overpassed grooves of the corbels of a beam (1360d)<sup>10</sup> at the Château of Le Thor (fig. 1.8). Here, the *fustiers* used a very narrow-bladed saw so that it could turn along the curve of the profile. These were probably striations left by a scroll saw with a handle equipped with a fine supple blade and held in a frame in the form of a U.

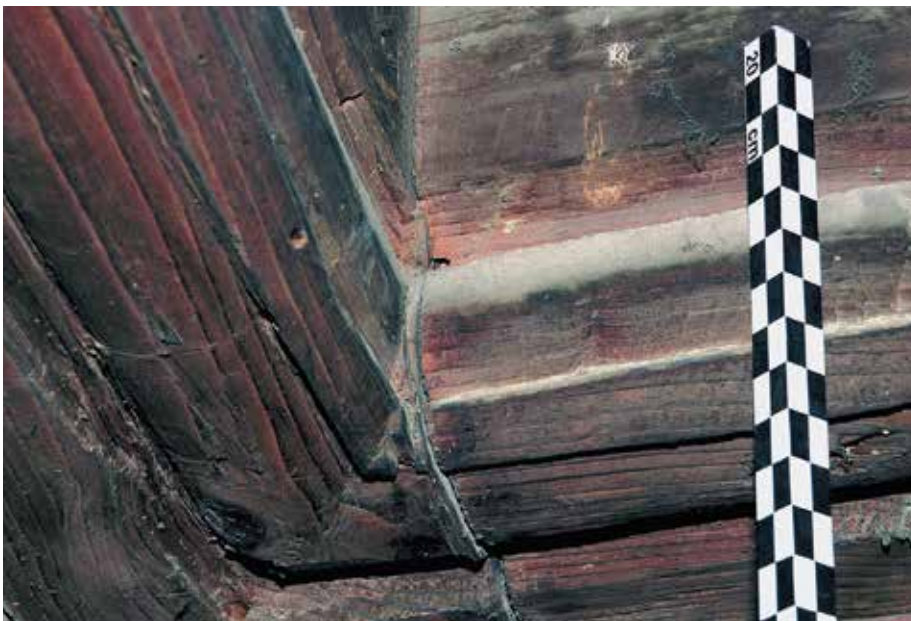
1.9

Fig. 1.9. Small wooden wedge (slat) inserted at the junction of two moulded rafters. Hexagonal room (room no. 49), Château, Tarascon (department of the Vaucluse).

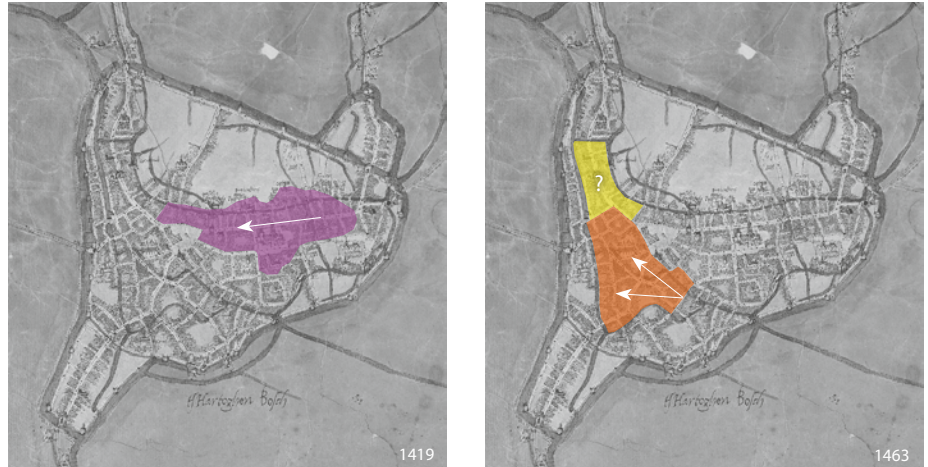
Fig. 2.3. Frequencies of dendrochronologically dated houses by decade up to 1700, showing the timber's dendrochronological date in blue, and in red the probable construction time of the houses two years later.

The lack of 14<sup>th</sup>-century timber may in part be explained as the result of two major fires, first in 1419 and again in 1463 (fig. 2.4). The survey dates might lead one to conclude that the impact of the second fire far exceeded that of the first. However, the extent of the fires appears to have been similar. The larger number of newly built houses after 1463 was in fact the result of municipal policy. Almost immediately after the second fire, regulations were introduced to promote reconstruction. In addition, house owners were given ten years to replace thatch with hard roofing materials (Vink, 2013: 21-23). To facilitate this process, grants were provided to alleviate the cost of slate or tiles. Surviving accounts

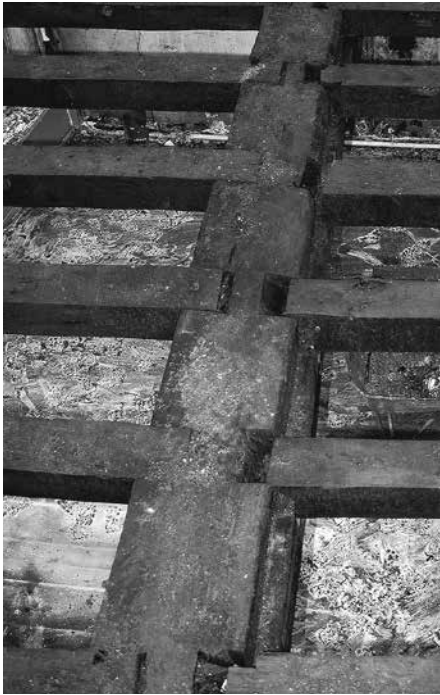
**Fig. 2.9.** Detail of the first floor structure in the front part of the house at Vughterstraat 122-124 (1566d ± 6) and drawing of notched joists with: a) no lip; b) recessed lip; c) dovetail lip; d) half dovetail lip; e) full dovetail. Image: courtesy of the Municipality of 's-Hertogenbosch SO/BAM; drawing: author

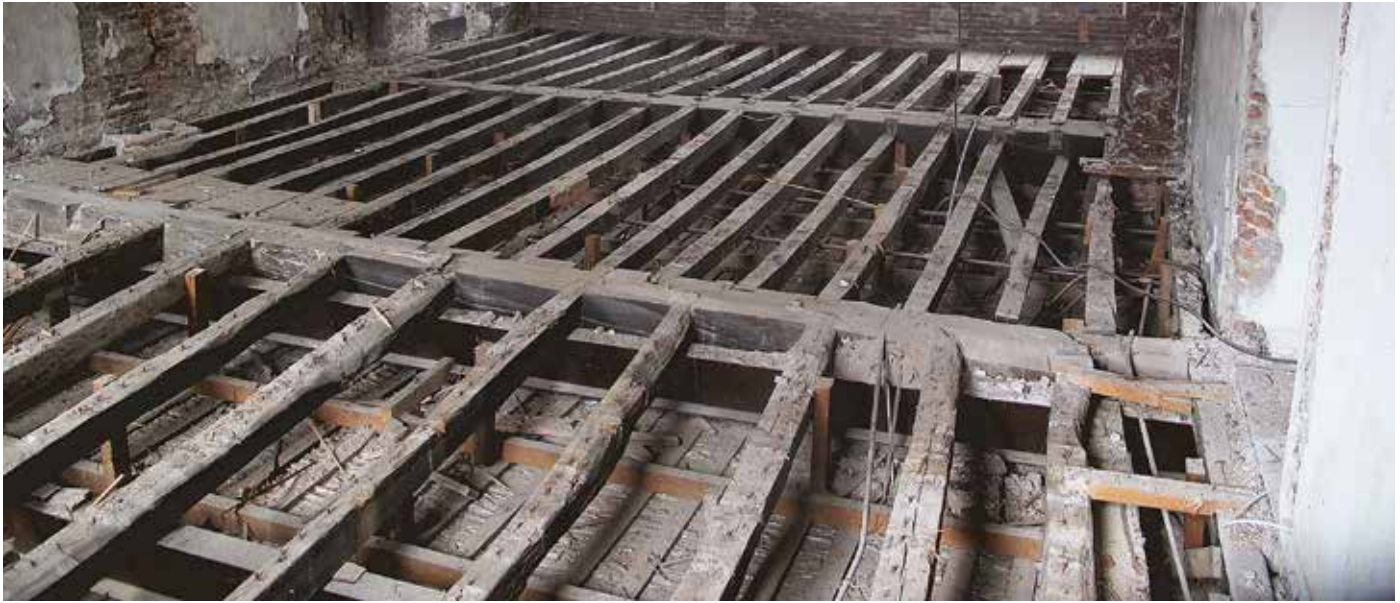
2.12

Fig. 2.12. View of the upper floor structure in the front part of the house at Kerkstraat 71 (1552d ± 2), looking towards the front. The section over the inside hearth contains fewer joists, and these are made of squared trunks. Image: courtesy of the Municipality of 's-Hertogenbosch SO/BAM

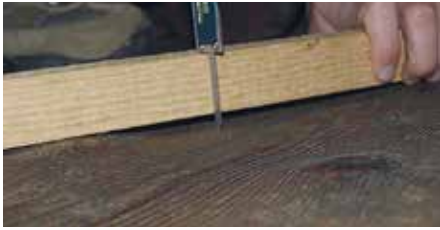
3.3

Fig. 3.3. Measurement of abrasion, defined as the height difference between the knots and the surface of the boards.

Moreover, for 21 buildings, the degree of abrasion was measured. This was defined as the difference between the height level of the knots, which are harder than the wood and have little or no abrasion, and the surface of the boards (fig. 3.3). Several measurements per room were made on different boards and averaged.

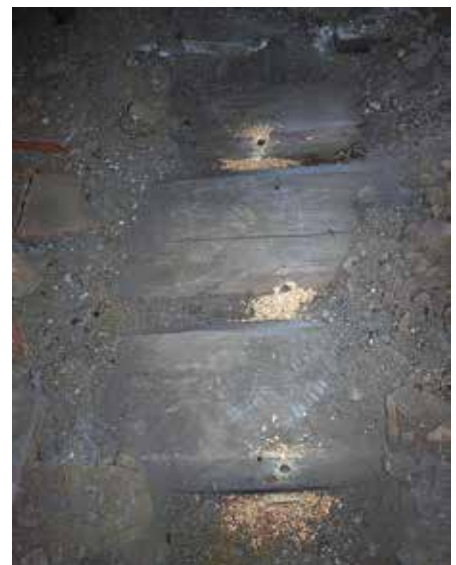
3.9

Fig. 3.9. *Doppelbaumdecke*, where the ballast was partially removed (after coring).

3) *Doppelbaumdecke* (fig. 3.8): Partly hewed logs bridge the walls, lying side by side. The entire ceiling is covered by the logs, no boards being necessary (fig. 3.9). However, this type of ceiling requires a lot of timber. The beams are connected to each other with pegs, which give the name to this type of construction (*Doppel* is the old German word for 'peg'). The logs are usually hewn and flattened on the lower side and partially on the vertical sides – ensuring a closed, even surface for the lower side, which was then often covered by mats of straw and plaster.

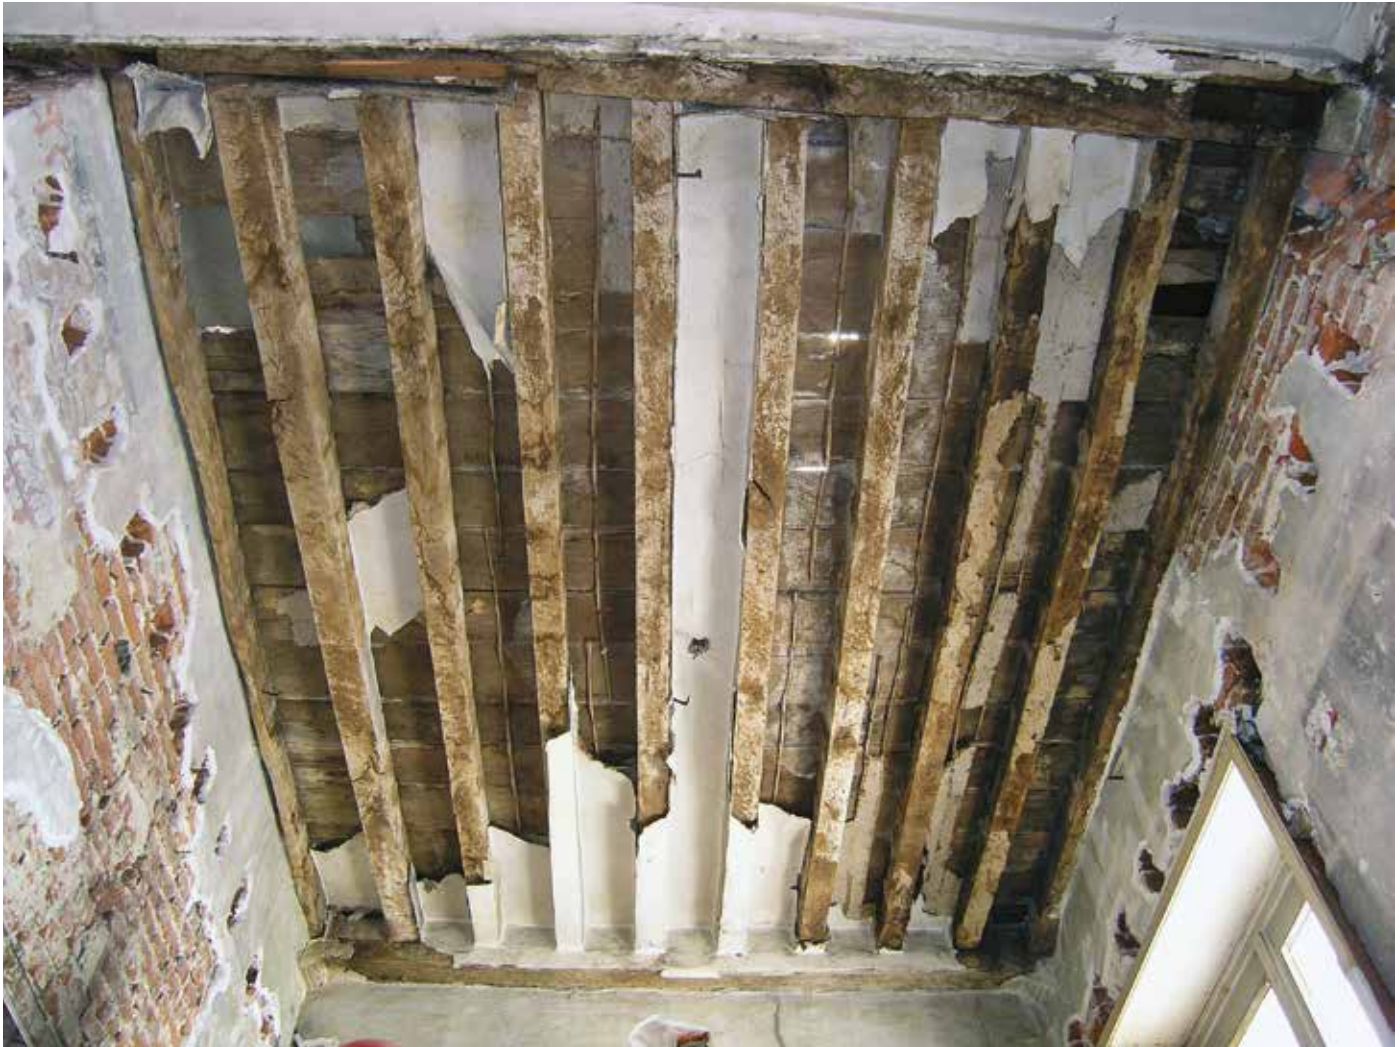
4.2

**Fig. 4.2.** Site of the Hôtel de Merode, Brussels: view of a ceiling with visible joists covering the 1<sup>st</sup> storey. Photo: P. Sosnowska © DMS/RMAH

According to Roubo, the installation of wooden floorings is part of the joinery arts, and more specifically the fixed joinery of assemblage (Roubo, 1769: 1). The definition proposed by the author raises the difficult problems of the division of the execution of floorings between carpentry and joinery. Such precepts in Brussels should be qualified as multiple conflicts in the 15<sup>th</sup> century between the corporations of joiners and carpenters have been documented (Janssens, 1988: 22-24). Indeed, the professions regularly departed from their respective spheres of activity, carpenters acting as joiners, joiners becoming carpenters (Paquay, 2002: 385). To resolve these disputes, the Magistrate of the city promulgated a series of ordinances with a list of works proper to each corporation.<sup>8</sup> For example, it was forbidden for joiners to build staircases, doors, windows, ceilings, etc.<sup>9</sup> In this specific case, the term ceiling (*plafond* in French, *solre/solringe* in Middle Dutch; Verdam, 1932: 556; gtb.inl.nl),<sup>10</sup> refers to both the area of circulation – the flooring – and the covering of a room – the ceiling. No semantic distinction was thus made between these two structures. This duality ultimately expresses a quite material reality, that of the non-existence of a structural difference between a floor covering and a ceiling, the latter being only the under-surface of the first (Pérouse de Montclos, 2011: 272). We note, in fact, that until the early 18<sup>th</sup> century, ceilings with ‘exposed’ joists were the most common in the ordinary Brussels houses (fig. 4.2) (Sosnowska, 2013: 163-165).

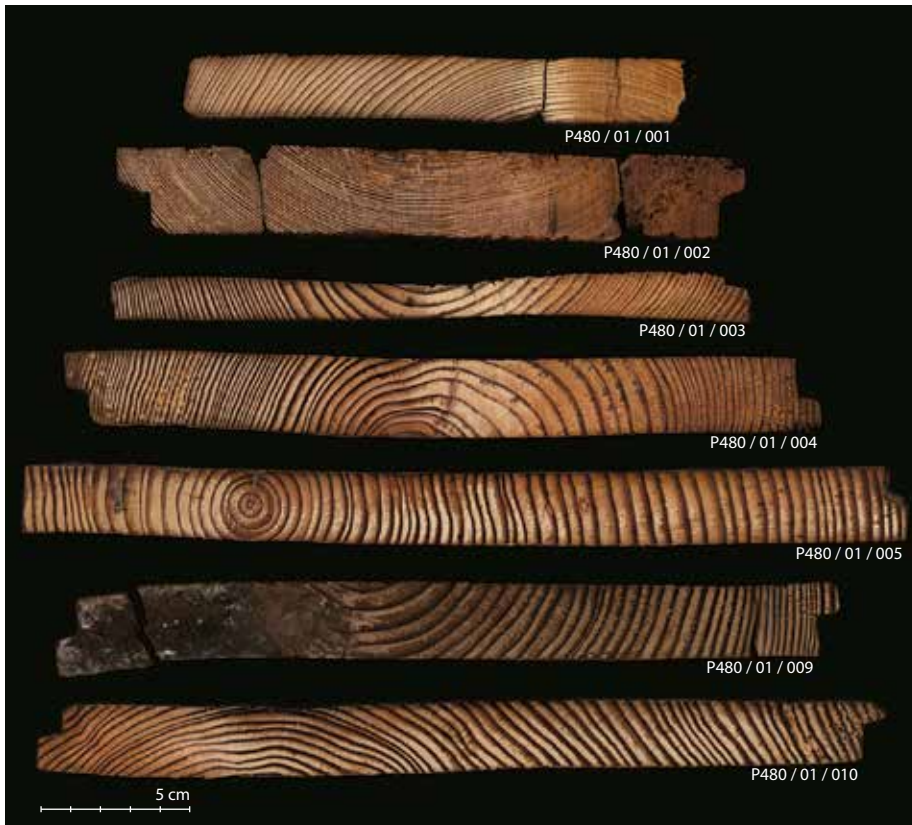
**Fig. 4.4.** Scan of the samples of planks from the Hôtel La Traviata, Brussels: rapid growth rhythm; planks cut by through-and-through sawing (the orientation of the tree rings indicates the original position of the planks which come from the entire log, at different distances from the tree's centre); assemblage with S-profile. Scans: S. Crémer and P. Fraiture

An additional constraint results from the number of tree rings present on the planks. This depends in part on the growth rhythm of the tree since, with equal dimensions, a plank with rapid growth will have fewer rings than one with slow growth (fig. 4.4 versus 4.5), and in part on the original position of the plank in the trunk, since a plank from near the centre of the tree will include more rings than one cut along the outer edge of the tree (slab boards) (fig. 4.5, sample no. P482/01/005). The only sample available for the Maison Dewez contains only 40 rings, due to rapid growth. Since a reliable date for a single sample requires a minimum of 80 or 100 rings, the chance of obtaining a valid result for this site is practically impossible. More generally, of the 46 Scots pine planks retained for the analysis, only eight had more than 80 rings (table 4.2).

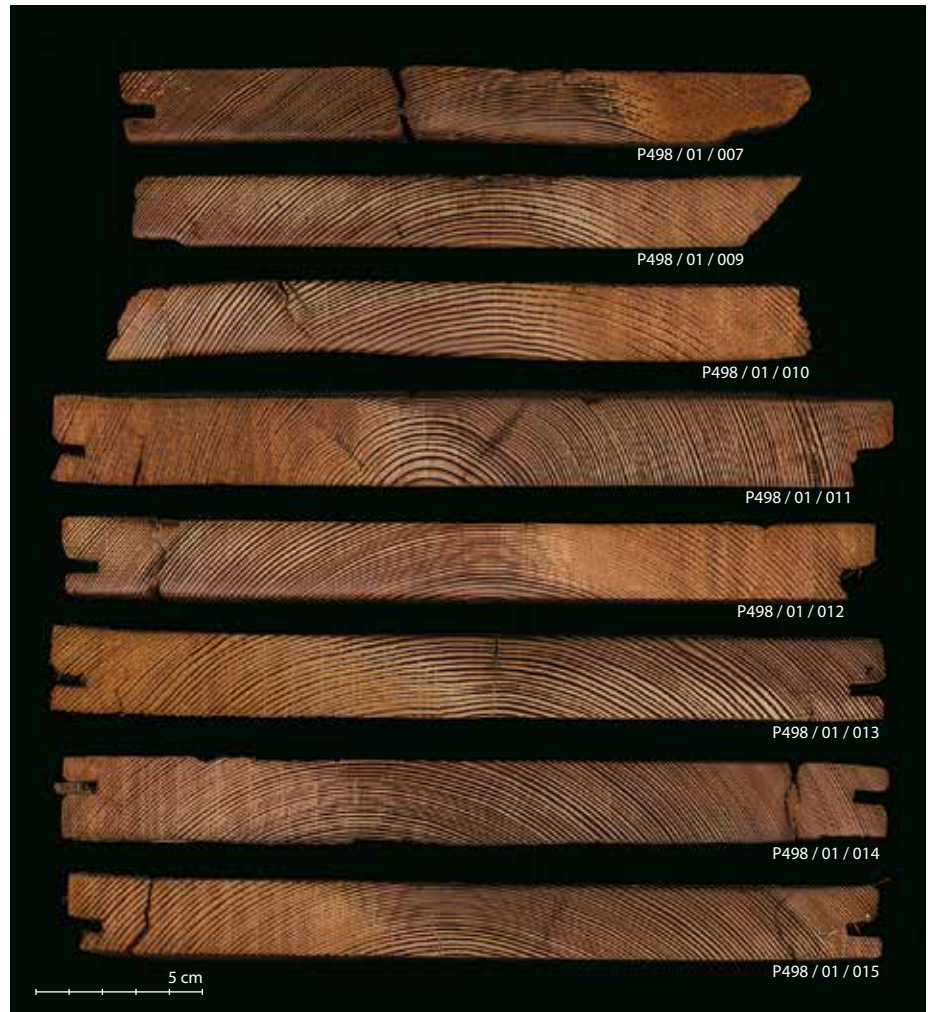
4.6

**Fig. 4.6.** Scan of the samples of planks from the site of the Musée du Béguinage, Anderlecht: extremely slow growth rhythm; planks produced by through-and-through sawing, originating from the entire log, at different distances from the tree's centre; slip tongue-and-groove assemblage profile. Scans: S. Crémer and P. Fraiture

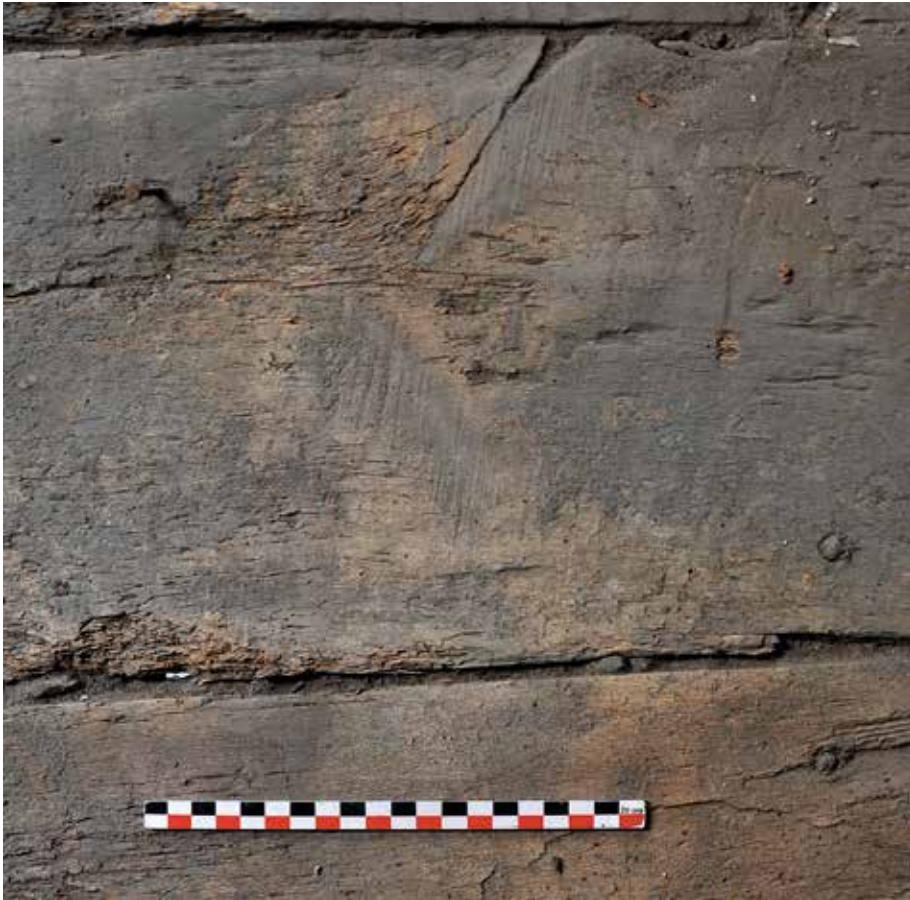
4.15

Fig. 4.15. Site at Place du Grand Sablon 49, Brussels, storey under the rafters: detail of the upper side of the floor covering showing oblique saw marks. Photo: P. Sosnowska © DMS/ULB

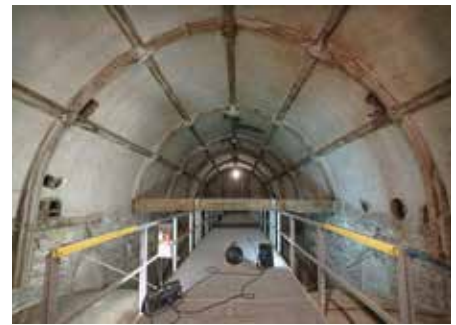
7.2

Fig. 7.2. The 17<sup>th</sup>-century stuccoed barrel vaulted attic above the current nave of the church. View from the west. Photo: K. Keutgens, B. Delmotte and P. Duerinck

The structure studied in this article is invisible from the church interior. A 17<sup>th</sup>-century stuccoed barrel vaulted attic is hidden above the current cross-ribbed vaults of the nave (fig. 7.2) and can only be reached by a narrow stair tower situated north of the main tower (fig. 7.3).

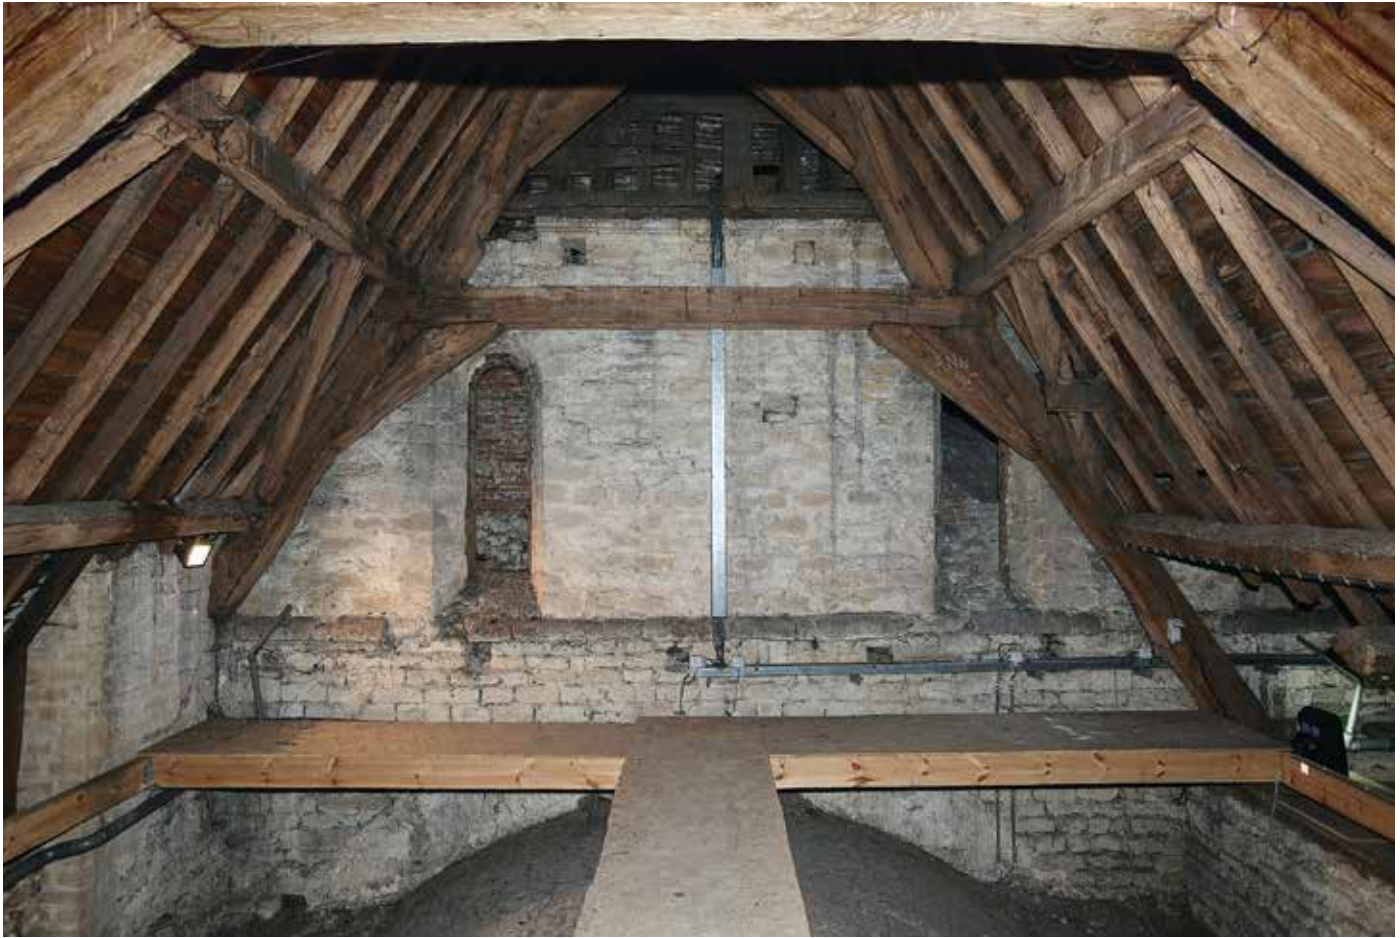
7.5

Fig. 7.5. North transept, bays 5 and 6. Photo: K. Keutgens, B. Delmotte and P. Duerinck

On the (formerly exterior) north wall, the negative traces of the inclination of a former saddle roof can be observed (Lemaire, 1905: 133) (fig. 7.5). This was the roof of a post-Romanesque north transept. The term 'post-Romanesque' is used as it was impossible to date the phase more accurately. However, the roof is assumed to be older than the Gothic stone vault in the choir, which is known to have been executed in 1567. While building the transept, the lower parts of the two windows were partially filled with stone. This post-Romanesque north transept had a plastered surbased wooden barrel vault. Remnants of the plaster layer, indicating the form of the vault, are still visible on the north wall.

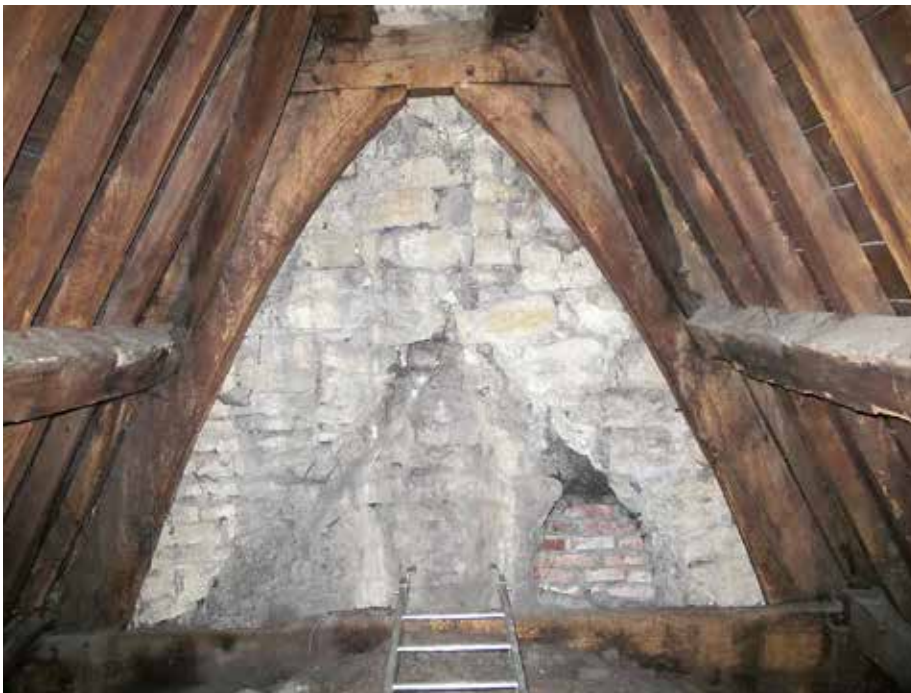
7.6

Fig. 7.6. East or tower wall: imprints of saddle roof of Romanesque church. Photo: K. Keutgens and B. Delmotte

The eastern or tower wall of the attic above the stuccoed vault shows the imprints of the former saddle roof of the middle aisle of the Romanesque church, again with an inclination of approximately 45° (fig. 7.6). The constructive elements of the roof, probably in wood, were fixed into a slit in the stone wall, once more by means of lime mortar.

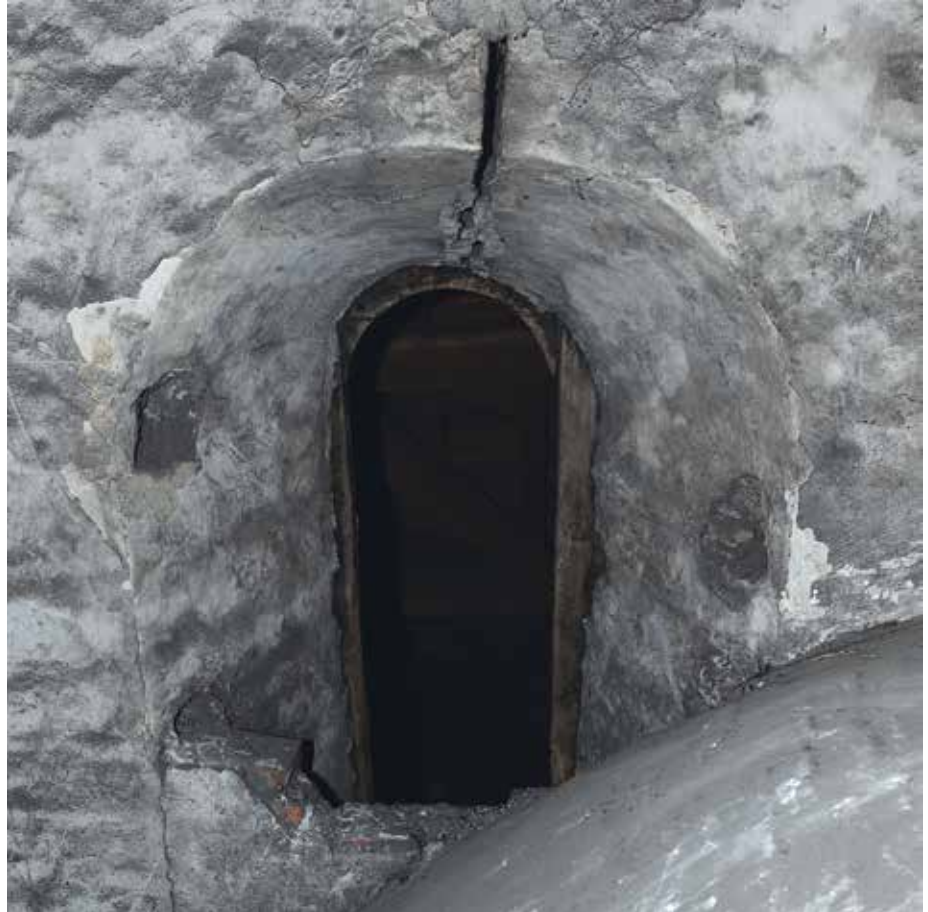
Fig. 7.7. Romanesque window, interior view. North wall, bay 3. Photo: K. Keutgens, B. Delmotte and P. Duerinck

The remains of the window frames in the walls of the nave of the former Romanesque church show typical features of early joinery (Lemaire, 1905: 131-132; Leurs, 1922: 198; Lemaire, 1952: 164). They are manufactured very simply with two stiles joined with four rails. These are half-lap joints or T-halving joints, each secured with one tapered dowel. As such, they can be considered archetypes of window joinery (fig. 7.9). There are no jamb-rails as in modern window frames, as the function of repelling water was performed by the stone-masoned reveals. The rebates, to hold glass panels, were made on the outside of the frame. This retains the remains of hand-forged nails, which, as assumed, served to hold and position leaded glass panes.<sup>5</sup>

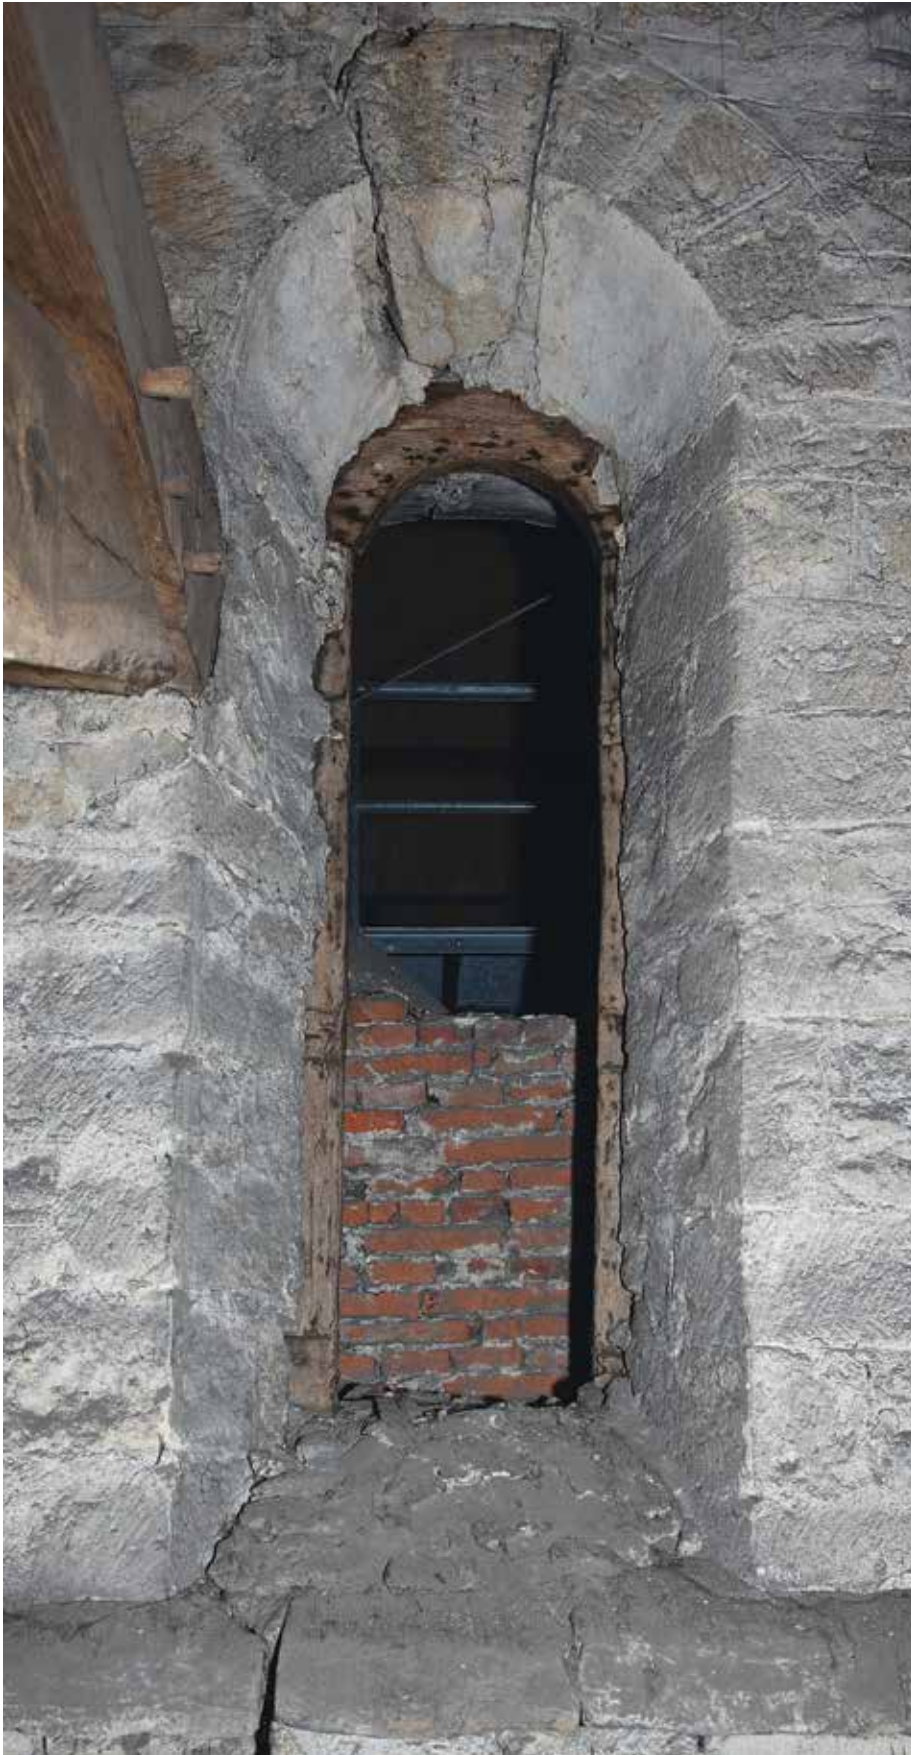
7.8

Fig. 7.8. Romanesque window, exterior view. North wall, bay 3. Photo: K. Keutgens, B. Delmotte and P. Duerinck

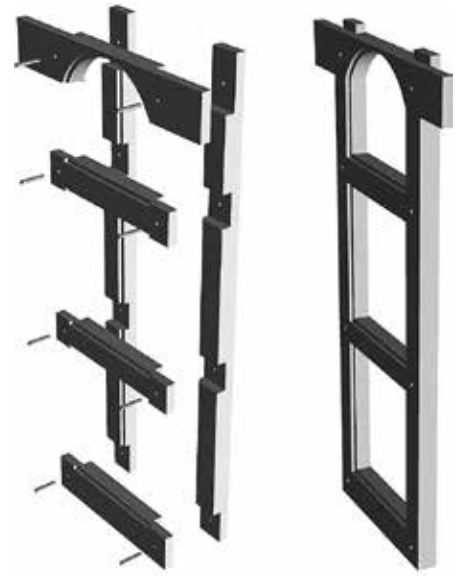
7.9

Fig. 7.9. 3D digital drawing and exploded view of window joinery. Drawing: C. Indekeu

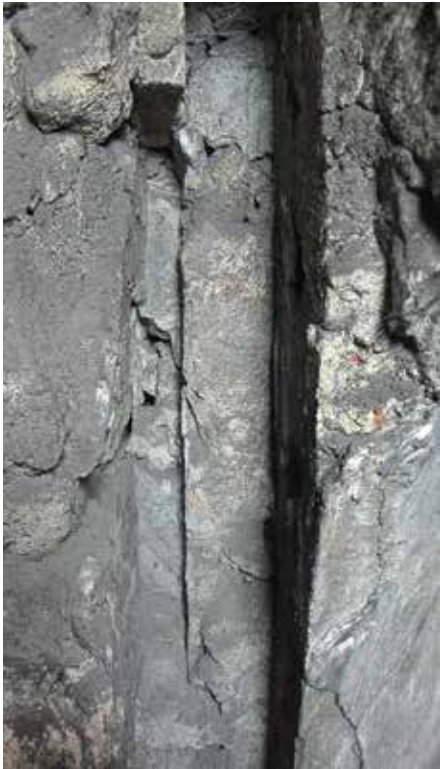
7.10

Fig. 7.10. Groove (top rail) in north wall (bay 1) in which window joinery was fixed with lime mortar. Photo: K. Keutgens and B. Delmotte

The manner that the frame was embedded in the up-going masonry is typical of the construction of wooden window frames during the Romanesque period. The Romanesque window joinery was consolidated with lime mortar into the grooves (fig. 7.10).<sup>6</sup> Such negative witnesses show interesting details concerning the original joinery itself. In order to enhance solidity against the pressure of the wind, the top rail was constructed to extend further from the frame than the reveals and fitted deeper into the wall. This is clearly shown in the lateral nudes in the middle of the thickness of the wall. Since parts of the walls (in bay one) were demolished during later alterations, it can be observed where and how far this top rail extended from the frames into the walls. This feature also occurs in other Romanesque window joinery in the Netherlands and Belgium (van Der Wal, 1968). One detail that has not yet been explained is the presence of peg holes in the top rails. It can be assumed that they held small half round panels to hold the glass panes.

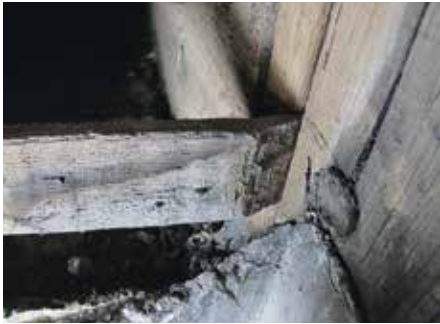
7.12

Fig. 7.11. Post-Romanesque roof (second roof) boarding on middle aisle, view from north transept. Photo: K. Keutgens and B. Delmotte

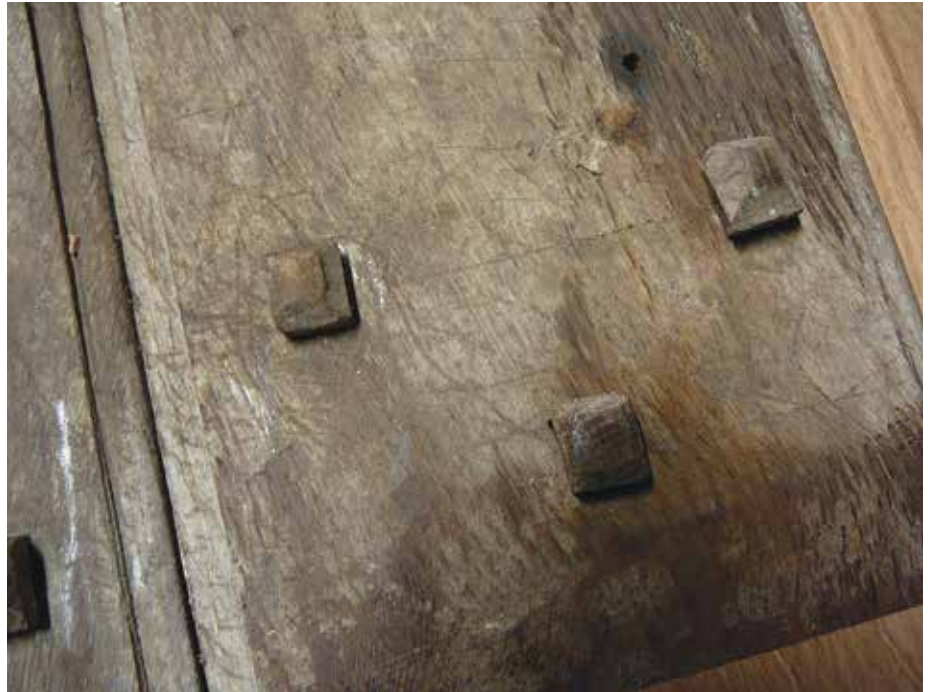
8.4

Fig. 8.3. Wooden nails with small wedges and traces of red paint. © V. Bernard, CNRS

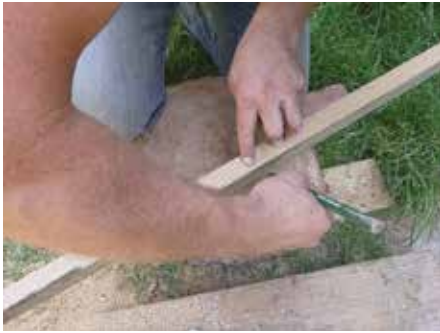
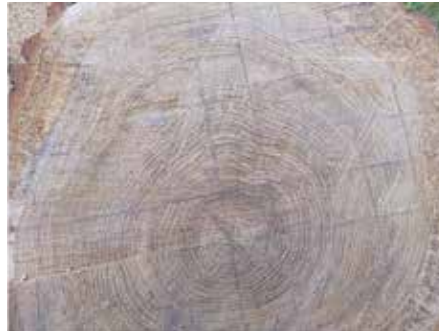
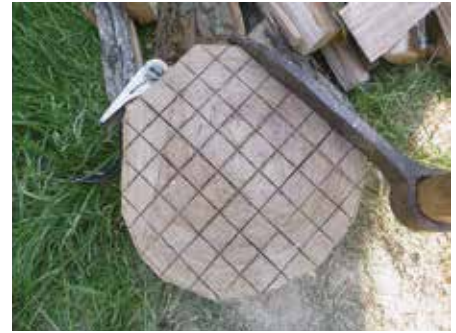
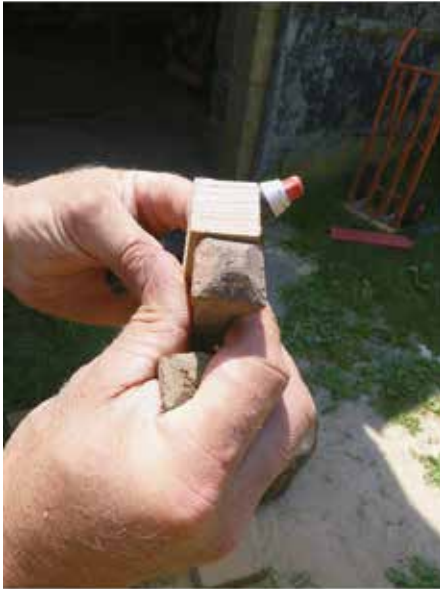
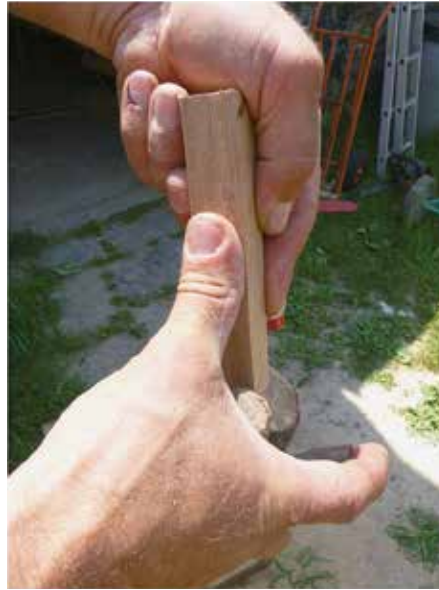
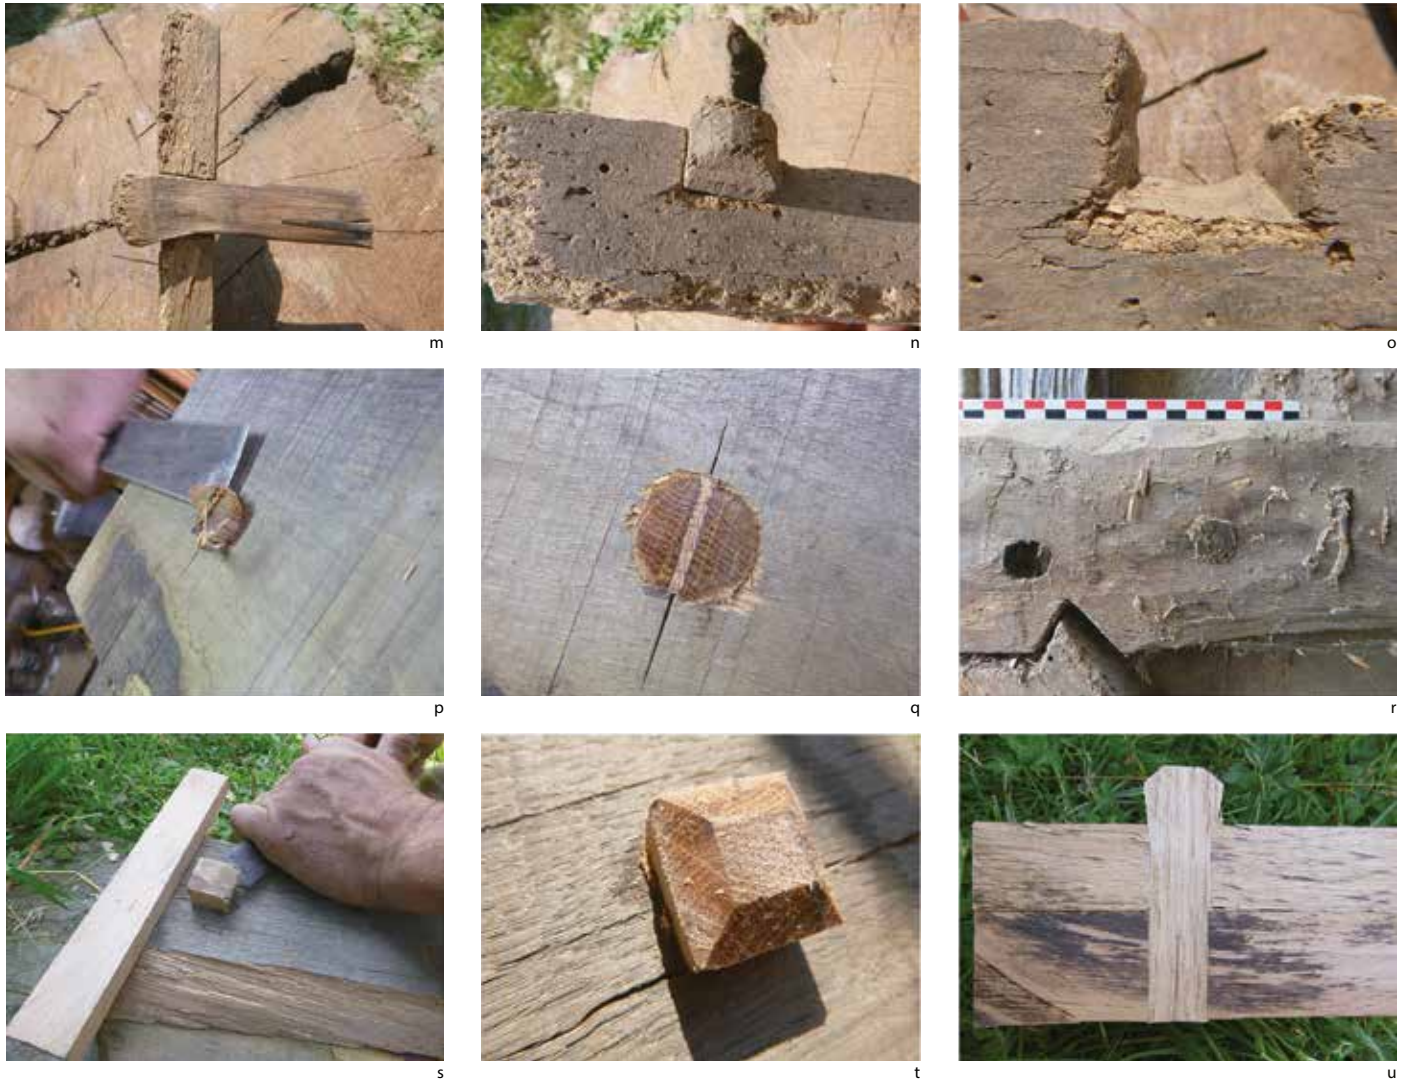
8.6

**Fig. 8.6.** Operational sequence for the production of a wooden nail: a) drawing of pegs on a fresh oak section; b) detail of the drawing; c) splitting knife in action for the production of pegs; d-e) marking of reference points using an old nail and thumb measuring; f-h) a shaving horse in different manufacturing steps of the nail; i-j) the nail in place; k-l) preparation and installation of the locking wedge; m-o) archaeological examples showing the square location for the nail head; p) chisel cleaning of the nail end; q-r) traces of splitting of the nail end before insertion of the locking wedge (q) on experimental and (r) archaeological artefacts; s-t) finishing the nail head; u) sectional view of the nail and its small wedge. © B. Bethencourt, Utensia; V. Bernard, CNRS

Experimental archaeology demonstrates that pegs were made with a draw-knife from freshly cut oak, wedged in a shaving horse on which different markings allowed control of length and thickness during the whole operation, which took about three minutes (fig. 8.6). Other marks are possible: an inch corresponds to the basic measure of the nail head width which could be controlled at different stages of the work by means of the joiner's thumb.

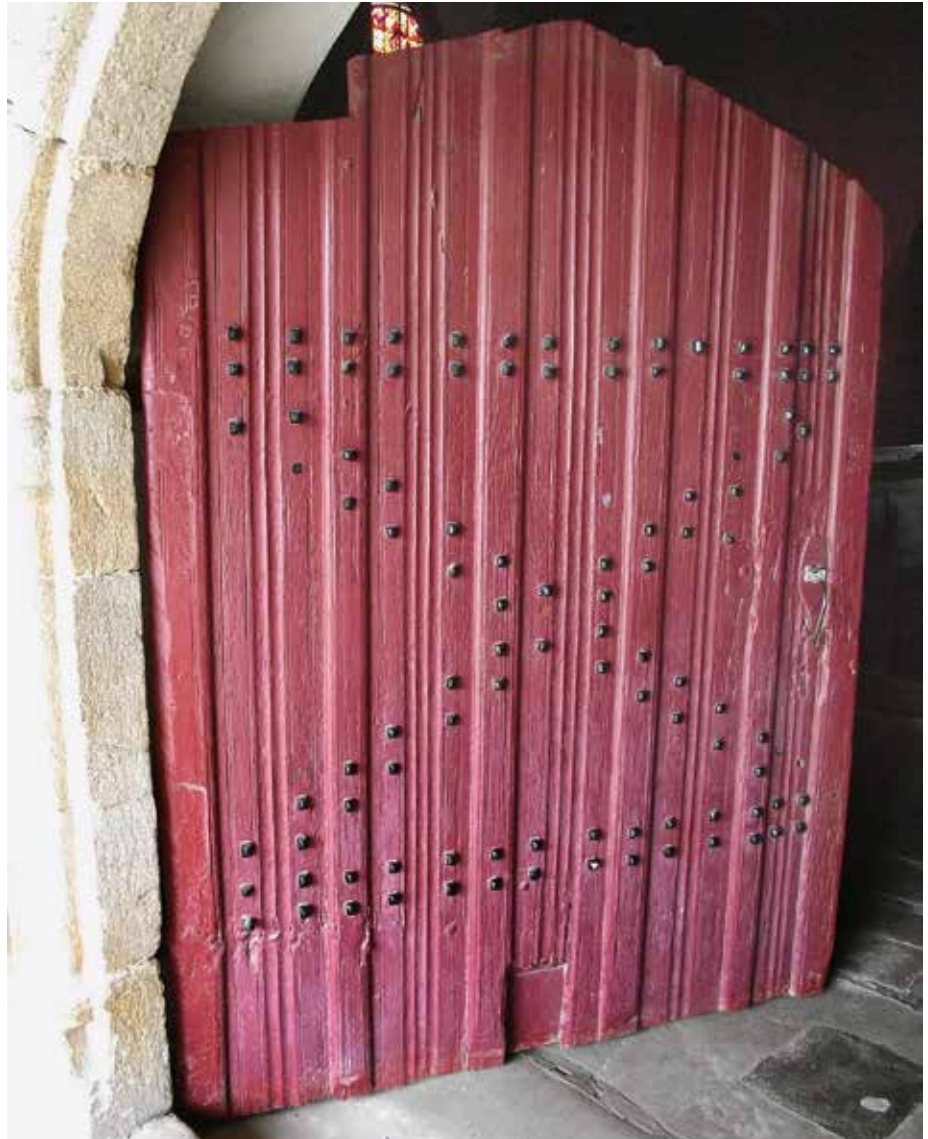
Fig. 8.7. Typo-chronological evolution of wooden nailed doors. © V. Bernard, CNRS

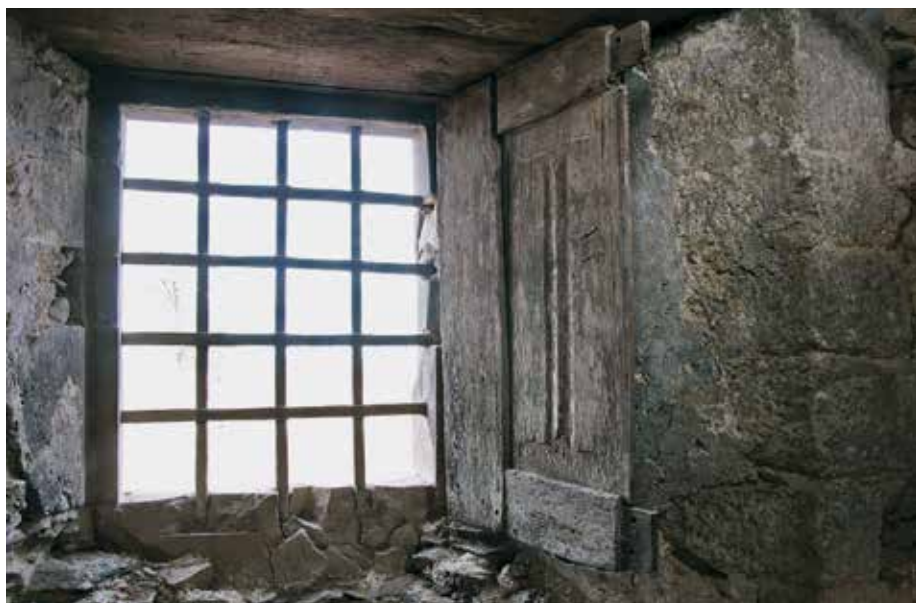
8.9b

Fig. 8.9. Manor at Torcé, Brittany: a) linen-folded wooden nailed shutter; b) sober wooden nailed shutter  
© A. Marais, Dendrotech

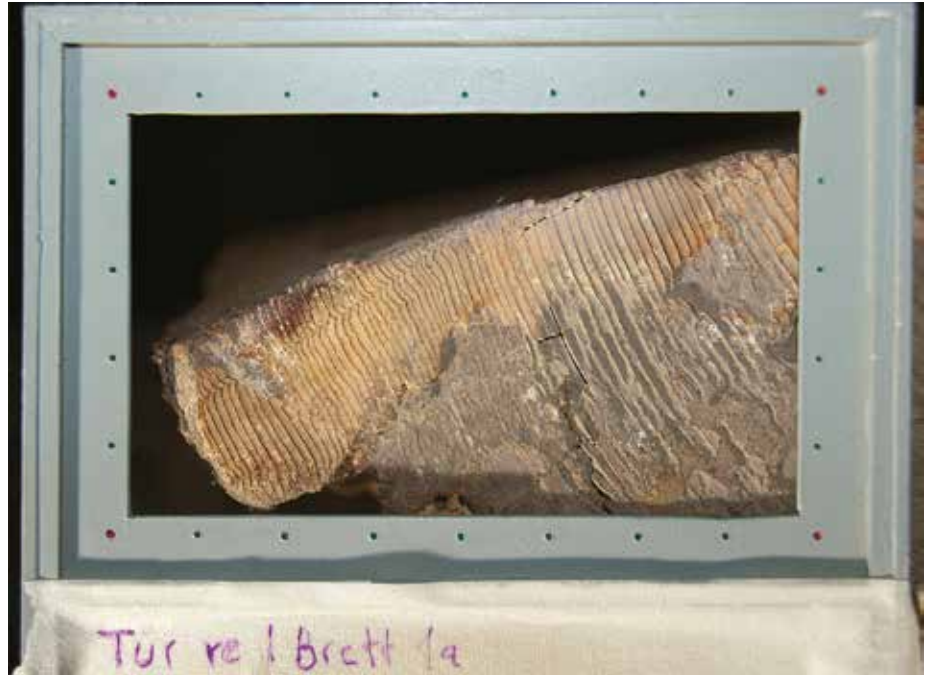
9.3

Fig. 9.3. Reference frame for calibration of photos used for digital recording for dendrochronology.

For sanding, a small precision bore grinder with a spindle collar 20 mm in diameter was used. The sanding paper (grain size 120, 240 and 600) was glued to the collar. After sanding, the sample was photographed using a scaled frame to make calibration possible for tree-ring measurements (fig. 9.3). This reference frame also helped to maintain a constant distance between the object and the lens. In some cases the sampled board was too big for the frame; for these, several photos were taken which were later overlapped digitally. The photos were made with an Olympus E-420 digital camera using a lens with a focus length of 25 mm, causing the least possible distortion. The distance of approximately 120-150 mm between the object and the camera was determined by the lens and the size of the reference frame.

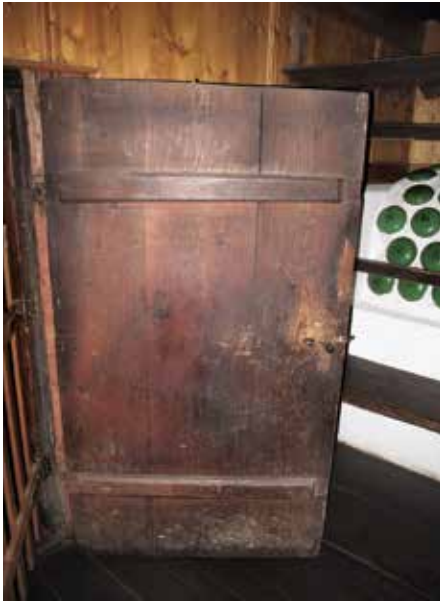
9.5

Fig. 9.4. Door types found during the investigation of rural buildings.
