# Between Carpentry and Joinery

Wood Finishing Work in European Medieval and Modern Architecture

**Edited by Pascale Fraiture, Paulo Charruadas, Patrice Gautier, Mathieu Piavaux, Philippe Sosnowska**

**Royal Institute for Cultural Heritage**

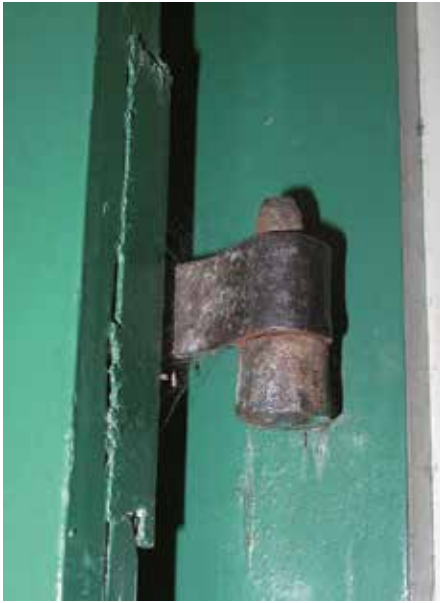
9.8

Fig. 9.8. Example of a metal hinge from the Austrian Open Air Museum Stübing.

For residential buildings, all doors except one opened inwards, while stable doors all opened outwards and 70% of all doors had hinges on the left side (seen from the direction in which the door opens). 80% of the doors had metal hinges (fig. 9.8), while 20% had a wooden pivot (fig. 9.9). Interestingly, the wooden pivot was not the oldest type of hinge in Stübing: these were found on doors dated 1510, 1836 and 1858 whereas metal hinges occurred on doors throughout the time range studied (1442 to 1909).<sup>2</sup> It has also been observed that metal hinges occurred in both alpine and non-alpine regions; our dataset doors with a wooden pivot are all from alpine locations in.

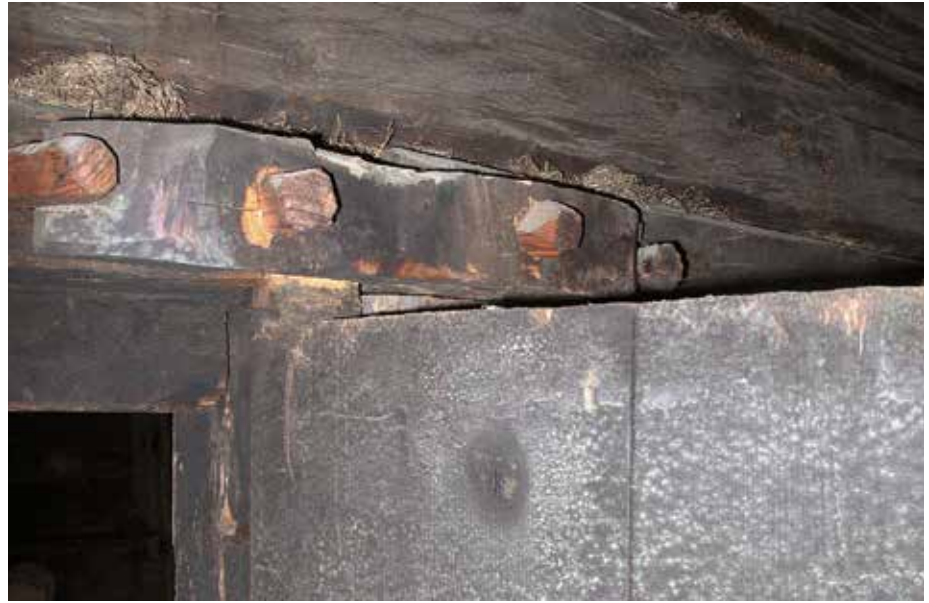
9.9

Fig. 9.9. Wooden pivot acting as a hinge from the Austrian Open Air Museum Stübing.

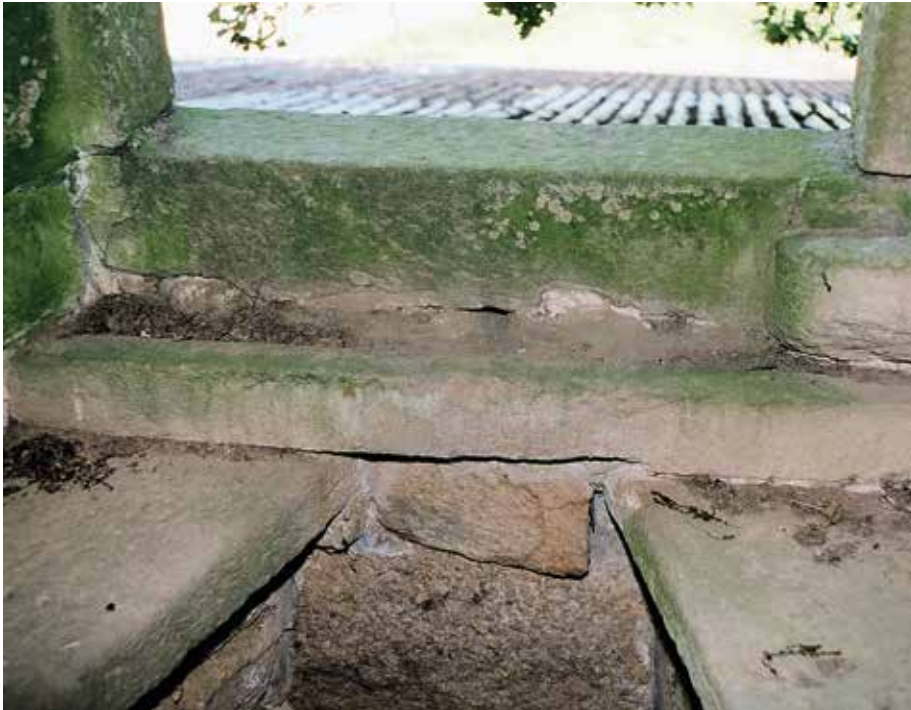
10.7

**Fig. 10.7.** Manor of Kermeno in Moréac (department of Morbihan): detail of the window sill with an interior channel evacuated by a rainwater spout.

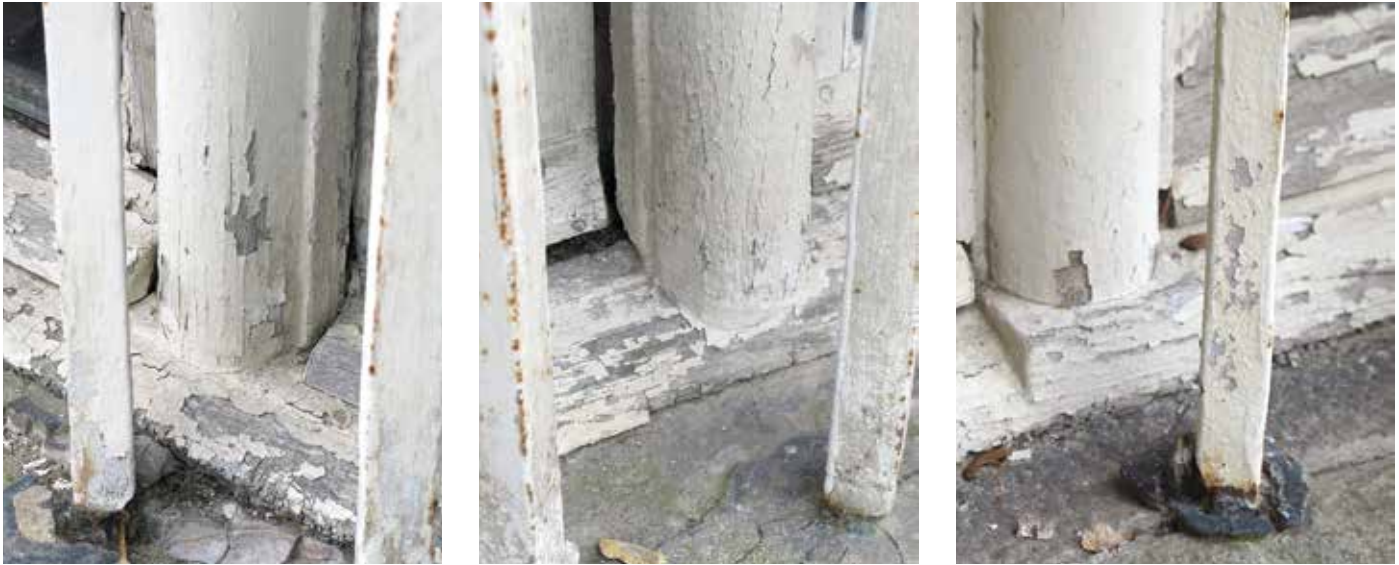
10.11

Fig. 10.11. Castle of Vaux-le-Vicomte in Maincy (department of Seine-et-Marne): three methods to attach the mullion to its sill.

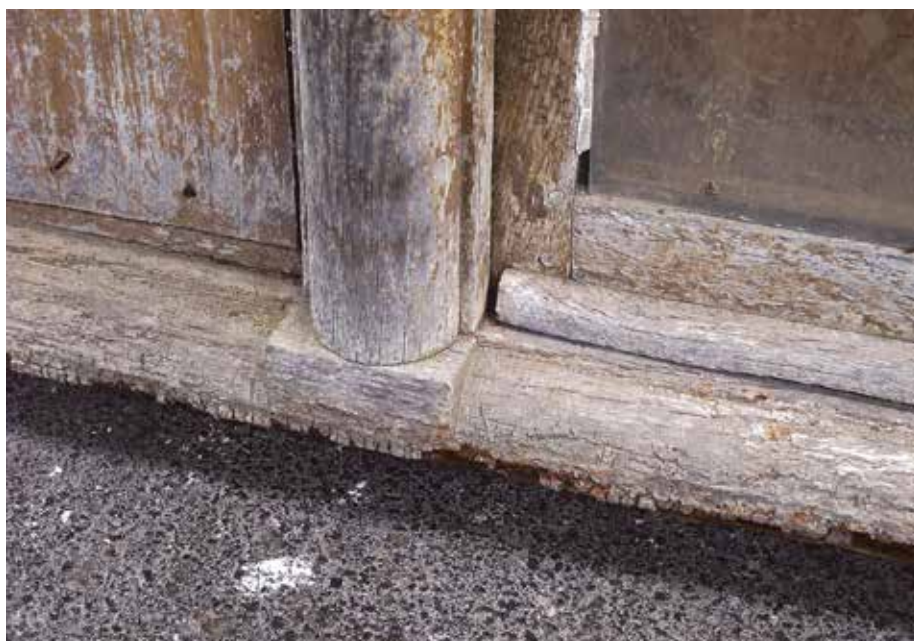
10.13

Fig. 10.13. Ancient abbey of Saint-Pierre-sur-Dives (department of Calvados): detail of the window sill and weather boards in quarter round form.

The first example dates to the end of the 17<sup>th</sup> century and comes from the ancient abbey of Saint-Pierre-sur-Dives (department of Calvados) (fig. 10.2k

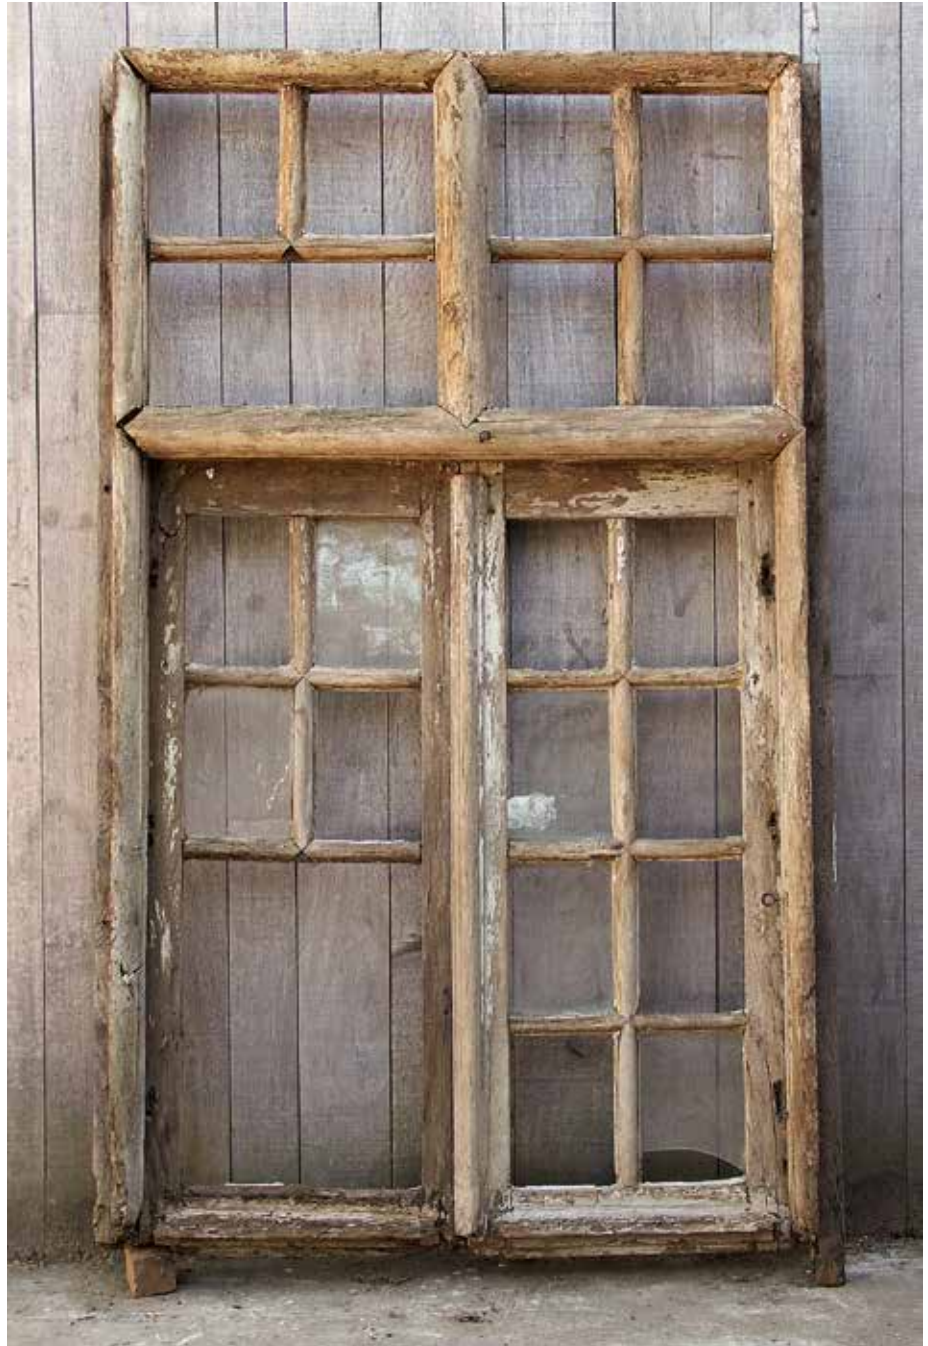
10.14

**Fig. 10.14.** House in Béchereil (department of Ille-et-Vilaine).

At a house in Bécherel (department of Ille-et-Vilaine) (fig. 10.14), probably slightly more recent, the form is the same but more pronounced, and thus more effective.<sup>21</sup>

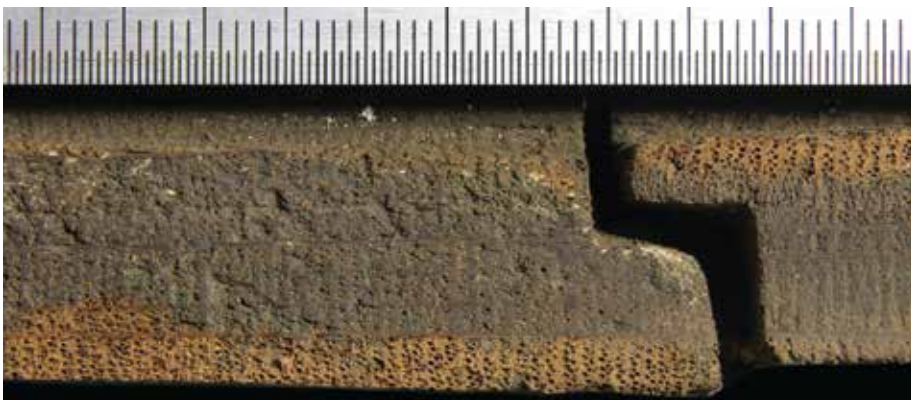
Fig. 11.7. Detail of the upper edge of an interior shutter showing the cross-lap joint assembly between the two boards (after cleaning for dendrochronological measurement). The wood comes from a very slow growing tree (narrow rings). Photo: P. Fraiture

Each compartment is covered by a folding split interior shutter, formed of two boards of unequal width allowing their lowering (plank on plank) into the window frame (fig. 11.4 and 11.5). These oak planks are assembled by cross-lap joints that ensure better prevention of light penetration and visibility and block the planks once they are aligned (fig. 11.7). A rebate was cut around each shutter to house it in the paned wing (fig. 11.8). The planks positioned next to the central mullion of the casement are 21-22.5 cm wide; those next to the lateral jambs are slightly wider since they reach 26 cm. Dendroarchaeological examination of these wooden elements shows that the planks were quarter-cut. Their flat faces were perfectly smoothed and planed, eliminating all traces of the cutting mode, which may have been by splitting or sawing. The trees from which these planks were made had a slow growth rhythm; the wood grain is rectilinear and regular (fig. 11.7 and 11.8). The wood elements forming the frame also have similar characteristics, all of which indicate a high-quality wood for use in joinery.

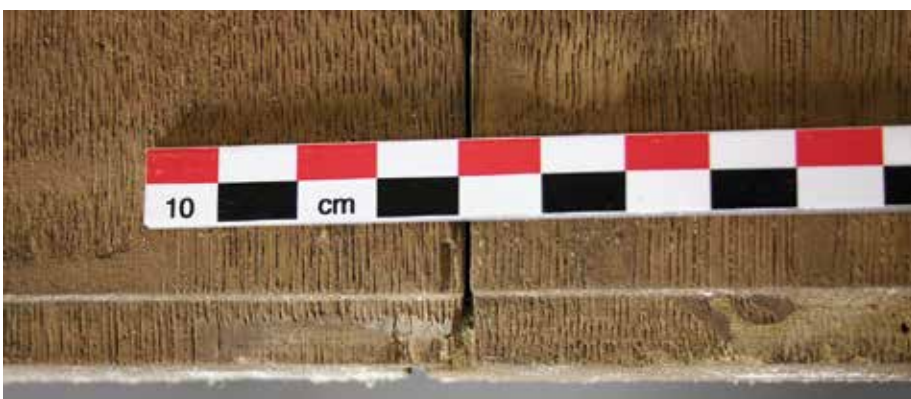
11.8

Fig. 11.8. Detail of the rebate on the exterior side of a shutter. The wood presents a straight grain. Photo: P. Fraiture

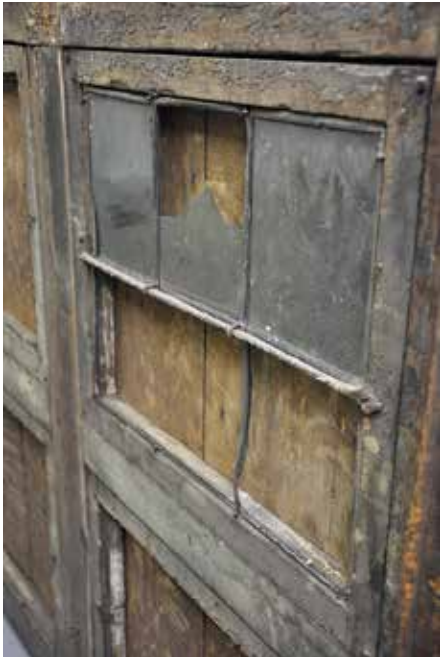
11.9

Fig. 11.9. Detail of the exterior side of the frame, lead comes and traces of greyish paint. Photo: P. Gautier

The frame shows traces of grey-green paint on the outside face (fig. 11.9). These are found on all of the joinery except for the wooden mullion corresponding to the central stone mullion of the window, against which the frame was set. The window frame was thus painted after being installed in the frame of the casement. It should be pointed out that the insertion of the frame into the masonry required some modification of the joinery to ensure correct positioning: one of the angles of the casement was shaved to fit into the rebate of the window.

One of the compartments of the frame has partially preserved the lead comes (fig. 11.9). This is part of the rebate created in each wing, on the side facing outwards. It is attached with small drops soldered to the lead comes and fixed on a saddle-bar nailed horizontally in the middle of each compartment. Small forged nails hold the edges of the glazed pane against the joinery.

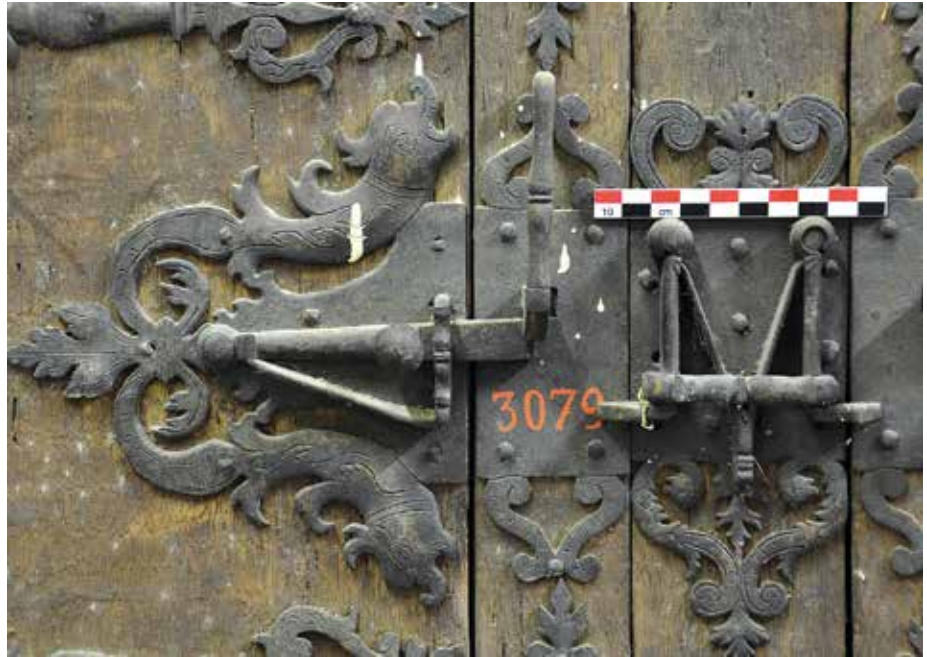
11.10

Fig. 11.10. Detail of one of the plates attaching the M-shaped double leaf spring of the paned wings and one of the spring catches of window frame inv. 3079. Photo: P. Gautier

Since all of the wooden elements were aligned, the rotation of the paned wings and shutters was done using branched hinges. This locking mechanism, when applied, has the form of a series of small wrought (hammered) iron colonettes with a base and capital, decorated with scrolls and leaves. All of the wrought iron metalwork was nailed to the joinery with small forged nails with round heads (fig. 11.10).

With respect to the style of the ironwork of frame inv. 3079, the composition extends the Gothic tradition by the abundance and animation of the décors (Genicot, 1987: 250). The motifs, in contrast, are of Renaissance style, both in the series of colonettes, capitals and scrolls and in the bestiary of sea monsters (fig. 11.10).

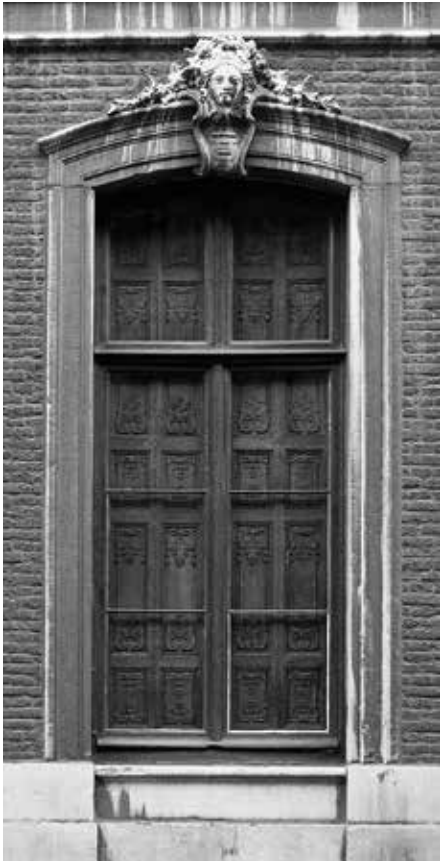
Fig. 13.7 Shutter, Hôtel Vandermaesen, 1766.

cathedral chapter and the aristocratic families – tended to favour decidedly sober façades. These were people whose elevated social status had been firmly established for generations and who presumably did not feel the need to reaffirm their superiority through the outer aspect of their houses. The *nouveaux riches*, on the other hand, including merchants and other social climbers, not only chose to build their houses where they were most on view – the busiest thoroughfares and docks –, but also made a point of endowing them with ostentatiously rich façades. Sometimes the indoor woodwork joined forces with the outside decor to enhance still further the effect of these façades as, for example, when the inside shutters were adorned with sculpted decoration which could be admired from outside when they were shut (fig. 13.7).
