Title No. 118-S99

Shear Behavior of Concrete Walls Retrofitted with Ultra-High-Performance Fiber-Reinforced Concrete Jackets

by Renaud Franssen, Luc Courard, and Boyan I. Mihaylov

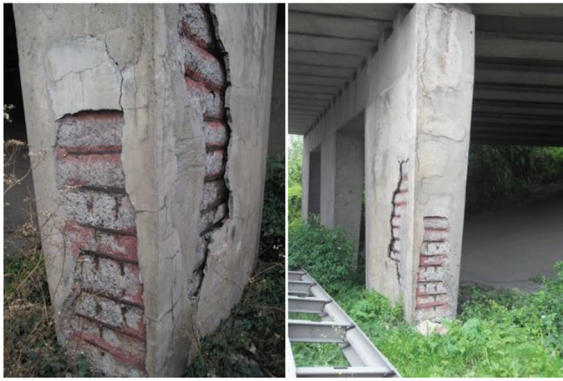
(a) Bridge piers with advanced corrosion (photos courtesy of Service Public de Wallonie)

This paper focuses on the UHPFRC rehabilitation and strengthening of walls and wall-type bridge piers, and in particular the most corroded zones of the pier immediately above the foundations; refer to Fig. 1(b). The corrosion reduces the section of the horizontal shear reinforcement which is the closest to the surface of the member. In such situations, jackets of UHPFRC cast around the bridge pier can both stop the corrosion process and strengthen the pier against brittle shear failures. The strengthening effect is mainly due to the enhanced tension behavior of UHPFRC characterized by high tensile strength (7 to 15 MPa versus approximately 2 MPa for regular concrete), effective crack control, and significant ductility.^{5,6}

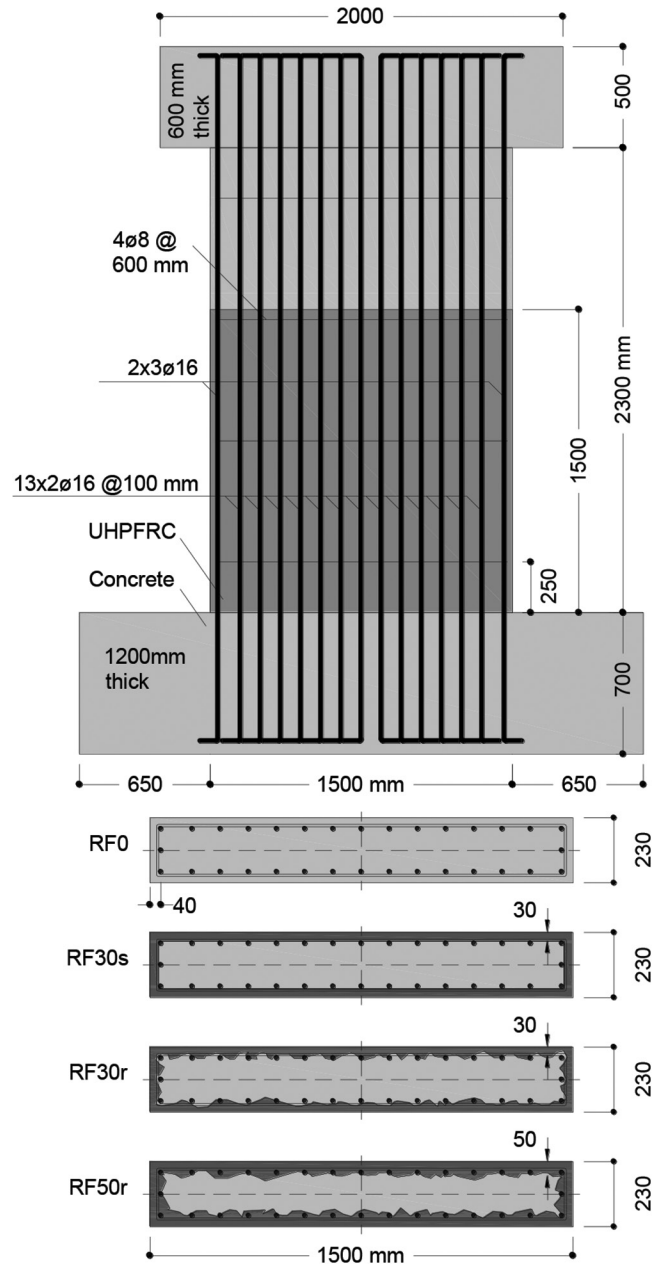
Fig. 2—Test specimens.

The experimental program consisted of testing to failure of four nominally identical concrete walls with a 230 x 1500 mm rectangular section (Fig. 2). The clear height of the walls was 2300 mm and the height subjected to shear was $a = 2550$ mm, resulting in an aspect ratio $a/h = 2550/1500 = 1.7$. One of the walls was a reference reinforced concrete member, while the other three were retrofitted with UHPFRC jackets covering the bottom 1500 mm of the member. The jackets were cast after removing a layer of surface concrete all around the section. The thickness of the jackets was the same as that of the removed concrete, and therefore the retrofitted walls had the same cross-sectional dimensions as the reference specimen. The walls were fixed in a concrete foundation block, while the load on the walls was applied via a top concrete block.

The longitudinal reinforcement of the walls consisted of $\phi 16$ bars distributed uniformly across the section (Fig. 2). The bars were anchored in the top and bottom concrete blocks without lap splicing, and their total area was 1.87% of the gross concrete area of the section. To represent existing bridge piers with corroded shear reinforcement, the specimens had only four $\phi 8$ stirrups with a stirrup ratio of 0.073%. The stirrups were anchored with 90-degree hooks to simulate poor detailing in existing structures. The top and bottom

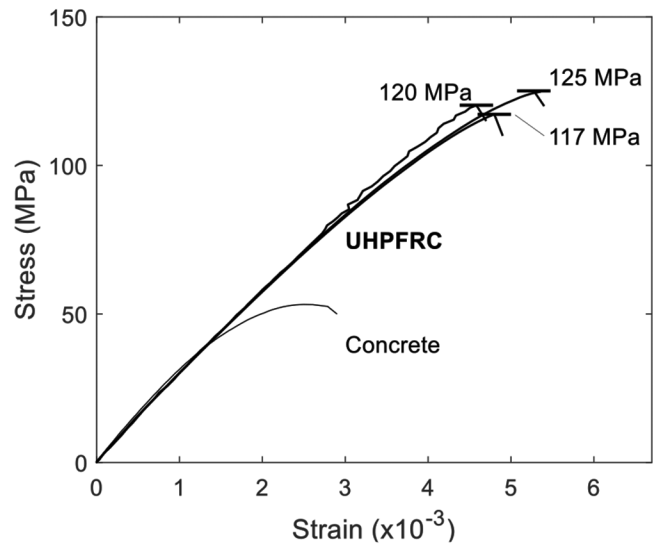
(a) Compressive behavior of concrete and UHPFRC

Fig. 3—Measured behavior of concrete and UHPFRC.

A series of tests were performed to characterize the UHPFRC. Cylinder tests on 110 x 220 mm specimens were conducted similarly to those for the concrete, resulting in an average compressive strength $f'_{c,UHPFRC}$ of 123 MPa (Table 1). In addition to strength, these tests were also used to measure the modulus of elasticity E_{UHPFRC} and pre-peak stress-strain response in compression as illustrated in Fig. 3(a). The tensile response of the UHPFRC was determined from bending tests of 100 x 100 x 400 mm prisms in accordance with the French design recommendations.^{17,18} Four-point bending tests without a notch were used to determine the modulus of rupture reported in Table 1, while three-point tests with a 10 mm notch were used to obtain the crack width versus tensile stress response in Fig. 3(b). An inverse analysis was used to calculate the curves in Fig. 3(b) from the crack width versus load response measured in the tests.^{17,18} It can be seen from Fig. 3(b) and Table 1 that the peak tensile resistance of the UHPFRC exceeded the modulus of rupture (approximately 6.5 MPa versus 5.4 MPa), and therefore the material exhibited a slight tension-hardening behavior. According to the French design recommendations, the average fiber orientation factor in the prisms is estimated at 0.52. However, direct measurements in other studies¹⁹⁻²² have shown that if the prism casting is performed from one side as in this study, this factor can reach values as high as 0.86.

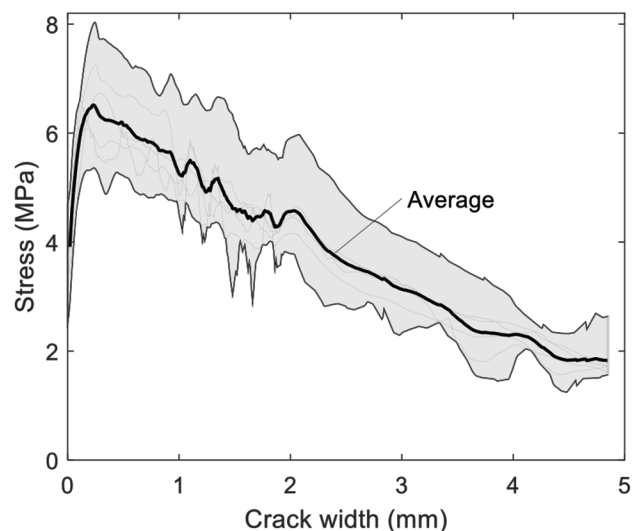
(b) Tensile behavior of UHPFRC

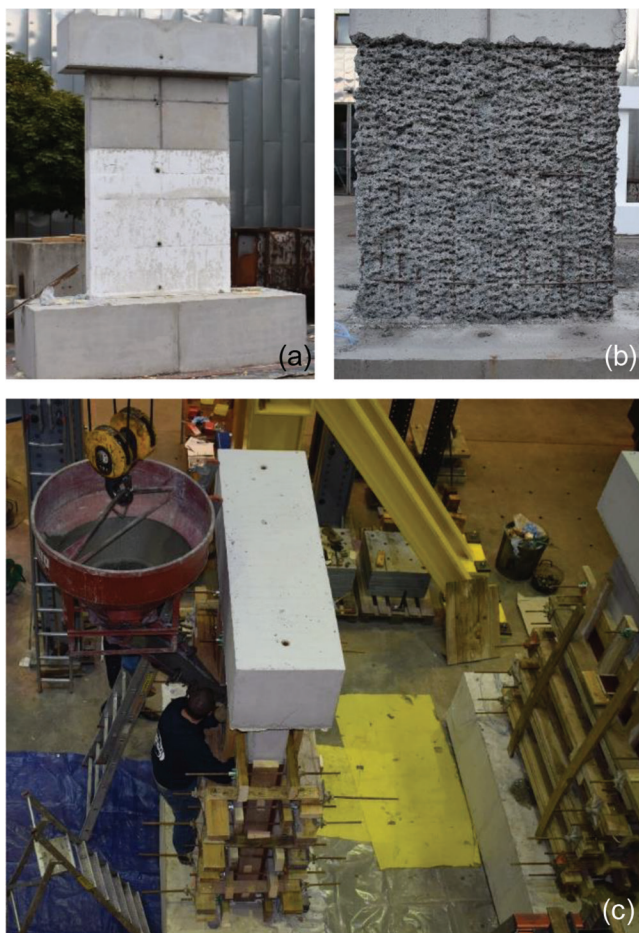
Fig. 4—Construction of test specimens.

To build the UHPFRC jackets, a formwork was installed around walls RF30s, RF30r, and RF50r, and the concrete surface was wetted lightly. The UHPFRC was cast with a bucket through two openings with shoots at the top of the formwork (Fig. 4(c)). After the removal of the formwork, a gap varying from 0 to 100 mm was observed at the top of the jackets of walls RF30r and RF50r, and a subsequent cast was needed to fill the gap. Wall RF30s did not have a gap as a consequence of problems with its formwork that bulged out during the casting. To recover the original geometry, the formwork was clamped externally using steel sections and prestressing rods. This operation put pressure on the liquid UHPFRC and resulted in the complete filling of the formwork. In practice, gaps at the top of the jacket can be avoided by using taller shoots that create additional pressure on the UHPFRC during casting.

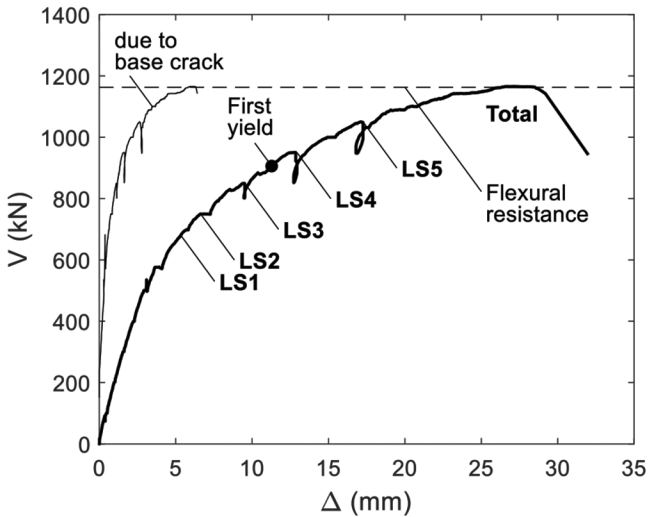
To establish a thorough understanding of the behavior of shear-critical walls with UHPFRC jackets, the results from test RF30r are discussed first in some detail. Figure 7 shows the complete shear force versus top displacement response of the specimen. The thick line shows the total displacement measured with displacement transducers DT1 and DT2 (average value), while the thin line represents the displacement resulting only from the opening of the base crack. This latter displacement is equal to the rotation in the base crack times the shear height of the wall a . The rotation in the crack was evaluated by dividing the crack opening measured with

DT10 by the distance from the displacement transducer to the neutral axis of the section. The position of the neutral axis as a function of the load was determined from a classical moment-curvature analysis of the base section, where the UHPFRC was taken into account in the compression zone only. This analysis was performed with the measured stress-strain curves of the materials and resulted in the strength prediction shown with a horizontal dashed line in Fig. 7.

Fig. 7—Load-displacement response of Specimen RF30r:

As evident from Fig. 7, Specimen RF30r behaved linearly up to a load of approximately 200 kN when the base crack (construction joint) began to open, and the stiffness began to decrease very slightly. The construction joint had a negligible tension resistance, but it was initially clamped by the axial load applied on the wall. The non-linearity became much more pronounced when the load exceeded 600 kN and horizontal flexural cracks began to appear above the base crack, refer to LS1 in Fig. 8. As the load increased further, the cracked region extended gradually upwards in the test region, and the cracks began to curve towards the compression toe of the wall due to the effect of shear (flexure-shear cracks, LS2-LS3). By load step LS3 at approximately three-quarters of the peak load V_{max} , the base crack reached a width of 0.4 mm, the steepest flexure-shear crack reached 0.3 mm, and the flexural cracks were in the range of 0.1 to 0.2 mm. It can be seen that the steepest crack was wider

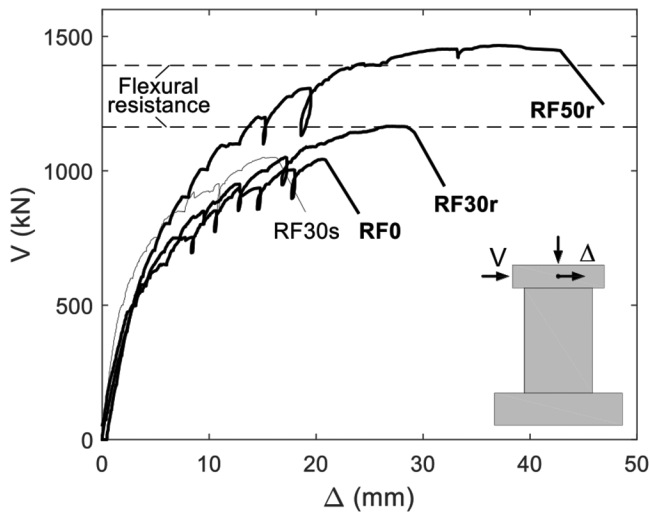
approximately 500 kN. The cracking in RF50r was delayed as this wall was subjected to a higher axial compression load. The equal initial stiffness is consistent with the fact that the UHPFRC had a modulus of elasticity of approximately 30 GPa (Table 1), thus similar to that of normal-strength concrete. However, as the shear was increased above 500 kN, Specimen RF30r exhibited a stiffer response than RF0 due to the more ductile post-cracking behavior of the UHPFRC jacket as compared to the brittle plain concrete. Eventually, the reinforced concrete specimen could not attain its flexural capacity and failed in brittle shear with only minor yielding of the vertical reinforcement near the tension edge of the wall. Therefore, the addition of a 30 mm UHPFRC jacket in RF30r was sufficient to suppress this brittle shear failure and to force a flexural failure of the base section. As a result, Specimen RF30r was 12% stronger than RF0 and had a 30% larger displacement capacity.

Because the 30 mm UHPFRC jacket was sufficient to reach the flexural capacity of the base section, the wall with a 50 mm jacket was loaded with a higher compression load. The goal was to increase the flexural capacity and to study whether the thicker jacket will be sufficient to once again suppress a premature shear failure. As evident from the dashed lines in Fig. 9, the predicted flexural capacity increased by about 20%, and so did the measured strength of RF50r relative to RF30r. The flat plateau of the top curve in the plot shows that the base section of RF50r yielded

Fig. 9—Load-displacement response of all specimens.

Finally, it is of interest to study the effect of concrete surface preparation of existing bridge piers prior to the casting of UHPFRC jackets. In Fig. 9, the load-displacement behavior of Specimen RF30s with a smooth surface (thin line) can be compared to that of RF30r with a rough surface. The two curves are almost overlapping over a large range of the applied load, even though RF30s was slightly stiffer. The stiffer response is explained with the better compacting of the UHPFRC jacket of the wall with a smooth surface. However, as evident from the plot, RF30s failed prematurely at $V_{max} = 1050$ kN, almost identical to the failure load of the reference specimen without a jacket. Therefore, the UHPFRC jacket of the wall with a smooth surface was ineffective in strengthening the wall.

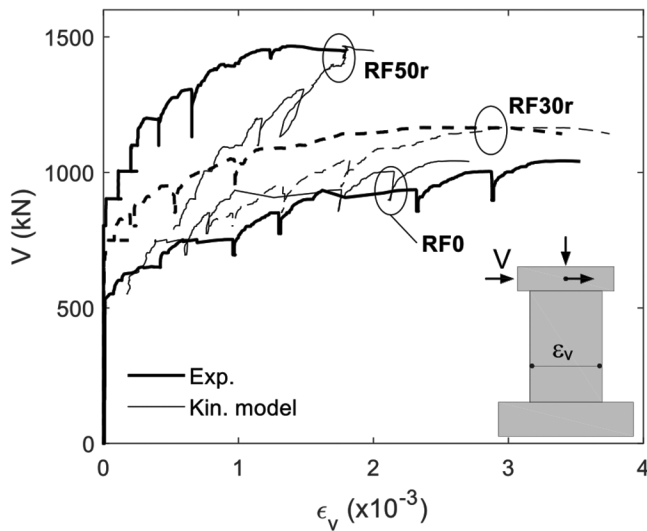
Finally, as all three walls failed along diagonal cracks, Fig. 11 compares the horizontal expansion of the web of the walls measured with DT9. This expansion can be viewed as the sum of the horizontal displacements in the inclined cracks at 750 mm above the base section, or as the average strain in the stirrups. It can be seen that, due to the high tensile strength of the UHPFRC, the flexural-shear cracks in RF30r began to develop at a higher load than those in RF0. It can also be seen that, for a given load above the cracking load, the web expansion of RF30r was significantly smaller than that of RF0. Nevertheless, as both walls eventually failed in shear along diagonal cracks, they exhibited very similar web expansions at failure. In contrast, Specimen RF50r that failed in a similar manner, developed a significantly smaller ultimate web expansion. This difference will be explained later with the help of a kinematic model of the walls.

Fig. 11—Effect of UHPFRC jacket on web expansion.

Finally, it is of interest to verify whether the kinematic model with measured DOFs can predict the expansion of the web of the walls ϵ_v plotted in Fig. 11. According to the model, ϵ_v is expressed with $\epsilon_{t,avg}$, Δ_c , and Δ_{cx} as follows²³

The results from this expression are plotted in Fig. 11 with thin lines. The values of the DOFs were calculated as discussed previously at each load level following the propagation of the major diagonal cracks. By comparing the thin and thick lines of Specimen RF0, it can be seen that the kinematic model with measured DOFs predicts well the measured web expansion along the entire range of ϵ_v values. For the specimens with jackets, the model overestimates ϵ_v at low load levels, but gradually approaches the experimental curves and provides accurate predictions prior to

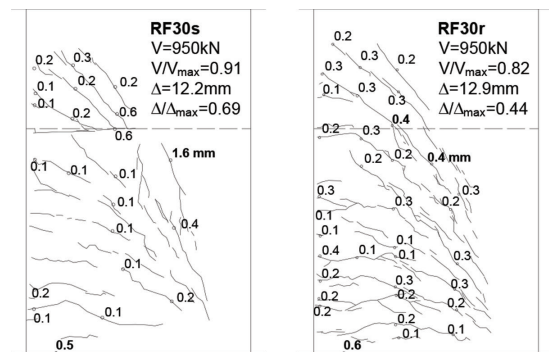
The reason for this ineffectiveness is illustrated in Fig. 12(a), which compares the crack diagrams of RF30s and RF30r at a lateral load of 950 kN. It can be seen that the cracks in the region of the jacket of RF30s were fewer than those in RF30r, and that the steepest flexural-shear cracks were significantly wider (1.6 mm versus 0.4 mm). The rest of the cracks in the wall with a smooth surface were approximately ~ 0.1 mm wide, while those in the wall with a rough surface were in the range of 0.1 to 0.4 mm. This shows that, while the deformations in RF30s localized along the diagonal crack, RF30r exhibited much more distributed deformations. As the diagonal crack in RF30s was significantly wider, that caused an early pullout of the steel fibers from the two faces of the crack, and therefore a smaller contribution of the fibers to the shear strength of the wall.

(a) Crack diagrams of RF30s and RF30r at constant lateral load

Fig. 12—Evidence of debonding of UHPFRC jacket.

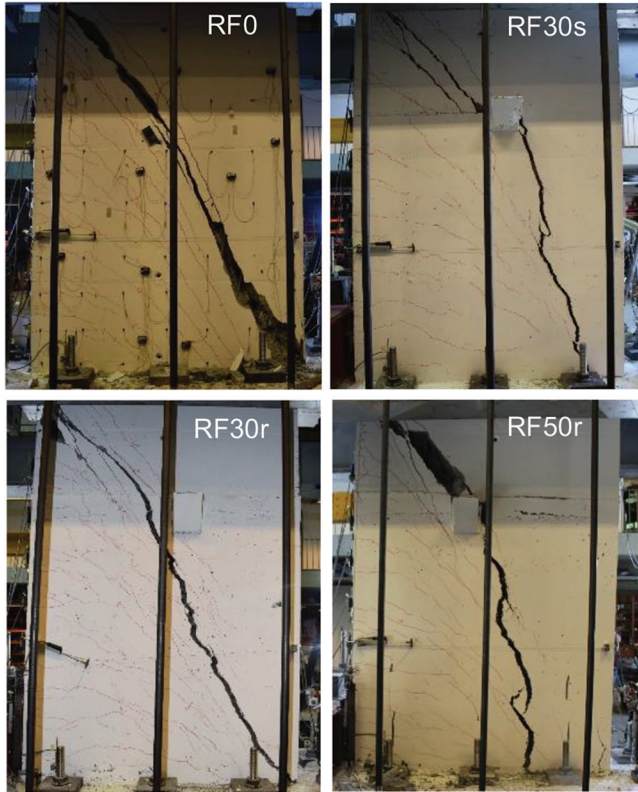
Fig. 13—Test specimens after failure.

Figure 13 shows photographs of the walls after failure and Table 3 summarizes the main test results. It can be seen from the photographs that all four specimens failed along diagonal shear cracks. It can also be seen from the table that the walls with UHPFRC jackets applied on a rough surface were significantly stronger and exhibited a larger displacement capacity Δ_{max} than Specimens RF0 and RF30s, even though their concrete was approximately 13% weaker. Wall RF50r exhibited the largest axial elongation Δ_l and top rotation θ , while RF30s had the smallest values. The sliding displacement Δ_{slip} , measured by displacement transducer DT11 in the base crack (construction joint), was negligibly small for all four walls. The widths of the critical diagonal cracks near failure w_{shear} demonstrate once again the difference in crack control between the walls: the cracks in RF30r and RF50r were two to three times narrower than those in RF0 and RF30s.

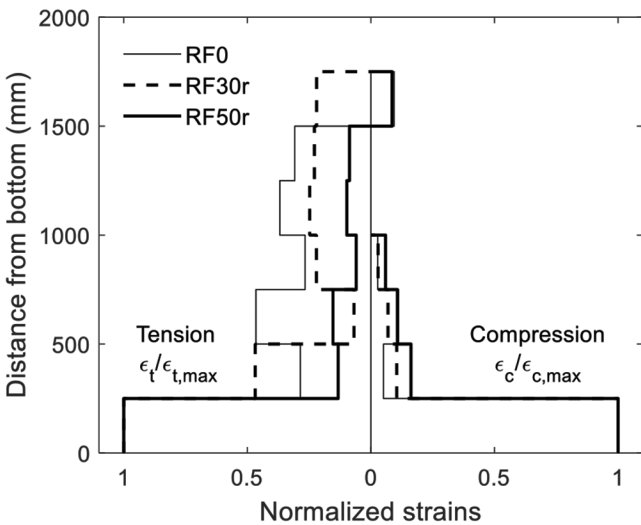
$\epsilon_{t,max} (\times 10^{-3})$	$\epsilon_{c,max} (\times 10^{-3})$
RF0	11.12	8.56
RF30r	14.40	12.08
RF50r	43.2	17.52

Fig. 15—Variation of strains on flexural-tension and flexural-compression side of test specimens at peak load.

It can be seen from Fig. 14 that the base crack w_b and its contribution to Δ_{max} increase with increasing thickness of the UHPFRC jacket. At the same time, reference Specimen RF0 without a jacket exhibited the largest average strain in the fan $\varepsilon_{t,avg}$. This shows that the jackets restrain the opening of the fan and cause localization of plastic strains in the base crack. This is made clearer in Fig. 15, which shows the variation of the strains in the fan at failure measured with displacement transducers DT12. It can be seen that the thicker the jacket, the more localized the strains in the base. The same trend is valid for the compression side of the walls where DOF Δ_{cx} is a measure of the vertical compressive strains in the critical loading zone. As evident from Fig. 14 and 15, the thicker
