# Technical study of Kongo-Central colonial steel houses belonging to the DRC patrimony

A. Mpemba Nkole Kabongo, J-P. Jaspart & J-F. Demonceau

**SDSS 2022**

**The International Colloquium on Stability  
and Ductility of Steel Structures**

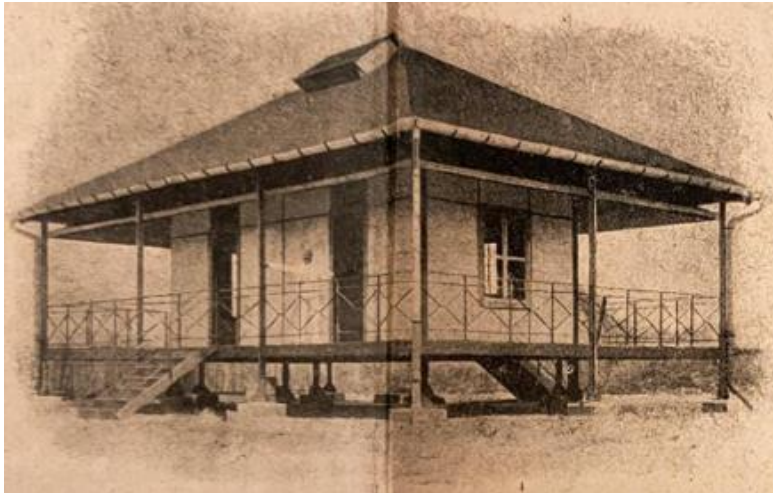
*Single-storey houses (source:  
NEPTUNE newspaper of 20 January  
1914)*

Technical study of steel frame houses with masonry or wood infill

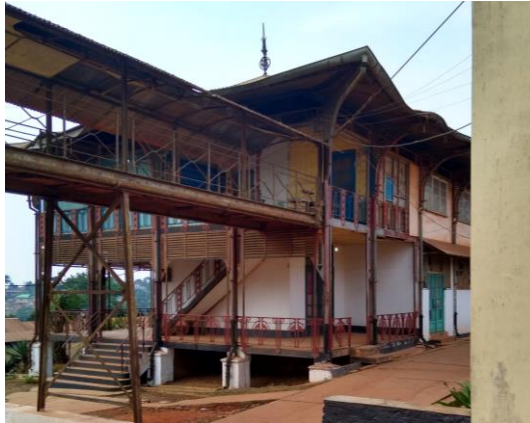
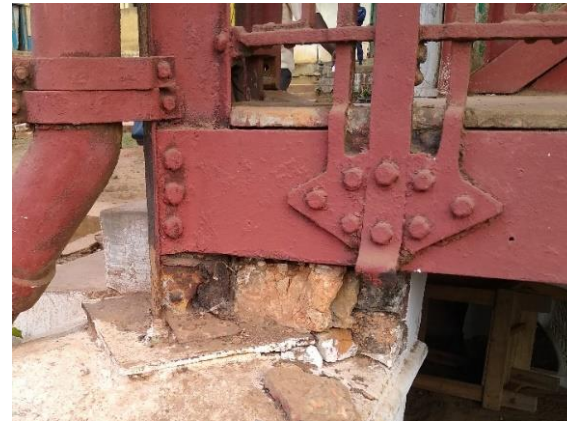
**Phase 1**

- ❑ Identification of technical characteristics of these steel houses

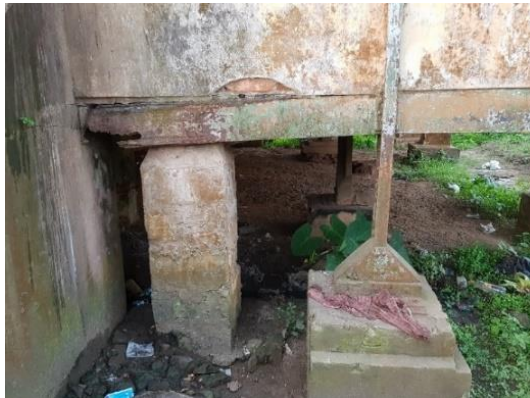
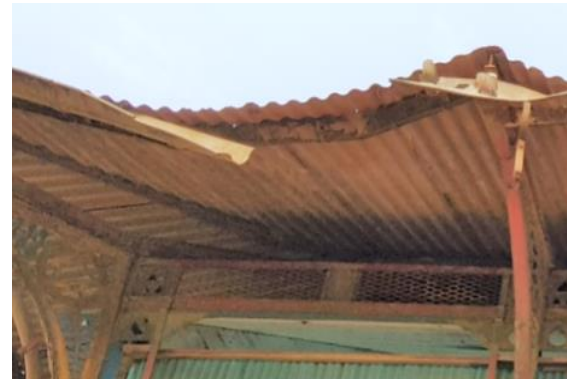
**Phase 2**

- ❑ Identification of pathologies affecting these houses

# Main causes of damage of these structural elements:

Corrosion

Lack of maintenance of these structures & deterioration of corrosion protection

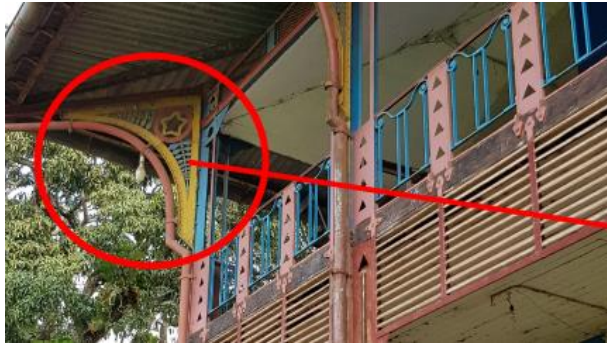
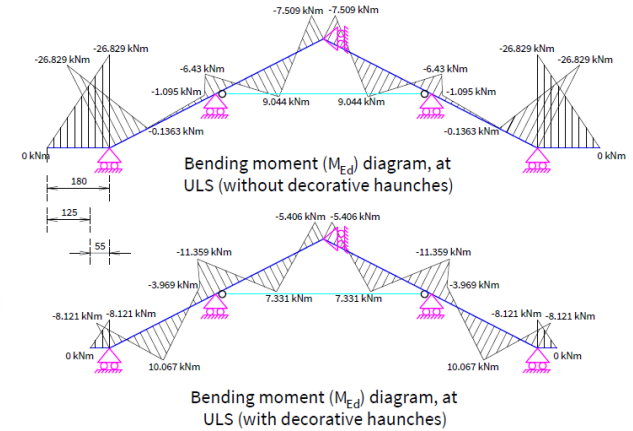
## □ Structural contribution of the decorative haunches

Decorative haunch

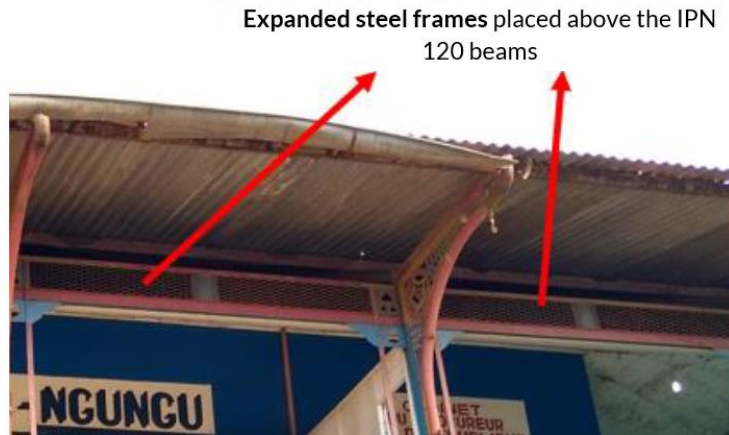
## □ Effect provided by expanded steel frames on the external frame stability

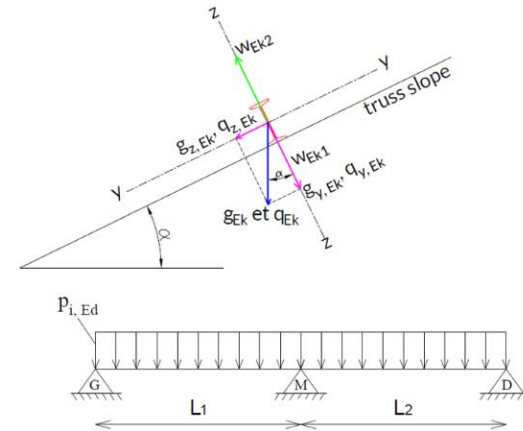
# Detailed study of an IPN 120 S235 purlin

### Legend

- : J 127 x 76 S235 Steel trusses 1
- : J 127 x 76 S235 Steel trusses 2
- : J 127 x 76 S235 Steel trusses 3
- : J 127 x 76 S235 Steel trusses 4
- : IPN 120 S235 purlin
- : Building limitation axes under the roof
- : Skylight in the roof
- : Roof bracing

Table 1: checking of the studied steel purlin

Checks	z-z axis	y-y axis
Shear strength	$V_{Ed} = 22.57 \text{ kN}$	$V_{Ed} = 0.82 \text{ kN}$
	$V_{pl, y, Rd} = 89.95 \text{ kN}$	$V_{pl, z, Rd} = 120.28 \text{ kN}$
	No M-V interaction	No M-V interaction
Cross-section resistance	Symmetrical I-section profile	
	$\left[ \frac{M_{y, Ed}}{M_{pl, y, Rd}} \right]^\alpha + \left[ \frac{M_{z, Ed}}{M_{pl, z, Rd}} \right]^\beta < 1$	
	$\left[ \frac{9.30}{14.95} \right]^2 + \left[ \frac{0.33}{2.91} \right]^1 = 0.39 + 0.12 = 0.51 < 1$	
Lateral-torsional buckling	The lateral-torsional buckling is satisfied with a loading rate of 93% (i.e., $0.93 < 1$ )	
Check of the deflection	$W_{max} = 6.9 \text{ mm}$	$W_{max} = 6.1 \text{ mm}$
	$W_{lim, max} = L/200 = 20.6 \text{ mm}$	$W_{lim, max} = L/200 = 20.6 \text{ mm}$
	$\Rightarrow W_{max} < W_{lim, max}$	$\Rightarrow W_{max} < W_{lim, max}$

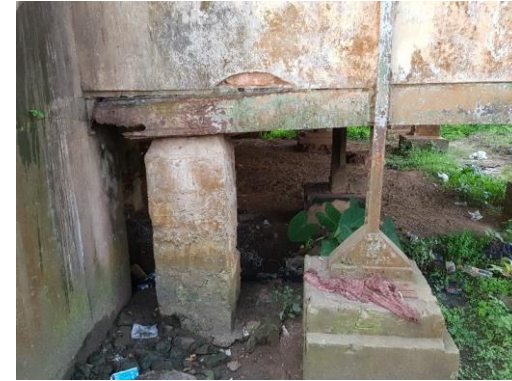
Increase of loads (not initially planned) on structural elements

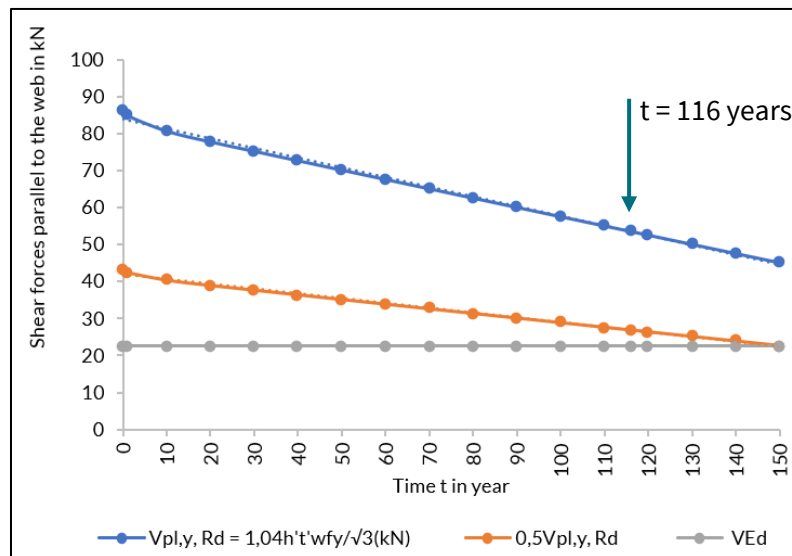
At time  $t = 0$

$$V_{pl,y,Rd} = 89.95 \text{ kN}$$

$$0.5V_{pl,y,Rd} = 44.975 \text{ kN}$$

$$V_{Ed} = 22.57 \text{ kN}$$

No M-V interaction

At time  $t = 116$  years

$$V_{pl,y,Rd} = 53.652 \text{ kN}$$

$$0.5V_{pl,y,Rd} = 26.826 \text{ kN}$$

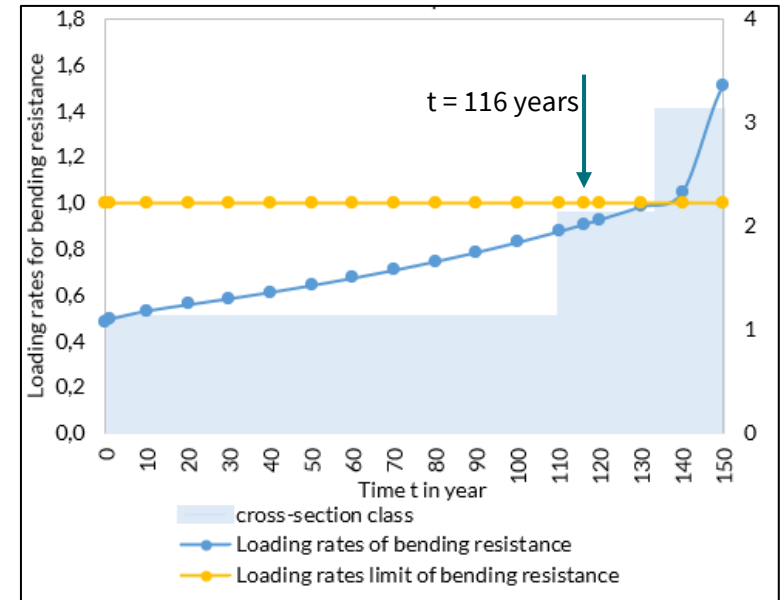
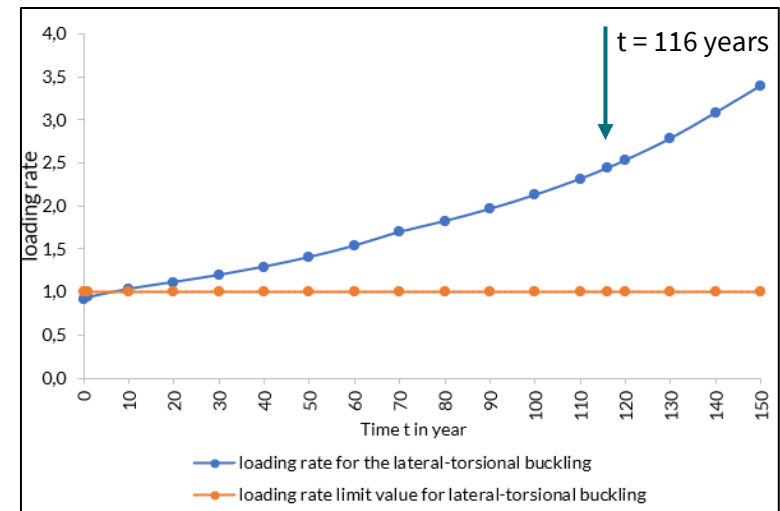
At time  $t = 0$

$$\left[ \frac{M_{y, Ed}}{M_{pl, y, Rd}} \right]^\alpha + \left[ \frac{M_{z, Ed}}{M_{pl, z, Rd}} \right]^\beta = 0.51 < 1$$

At time  $t = 116$  years

$$\left[ \frac{M_{y, Ed}}{M_{pl, y, Rd}} \right]^\alpha + \left[ \frac{M_{z, Ed}}{M_{pl, z, Rd}} \right]^\beta = 0.906 < 1$$

The lateral-torsional buckling is satisfied with a loading rate of 93% (i.e.,  $0.93 < 1$ )

theoretically, after 6 years of atmospheric exposure, the loading rate of the IPN 120 corroded purlin is  $> 1$
