# Recent earthquake-triggered landslide events in Central Asia, evidence of seismic landslides in the Lesser Caucasus and the Carpathians

H.B. Havenith

Liege University, Belgium

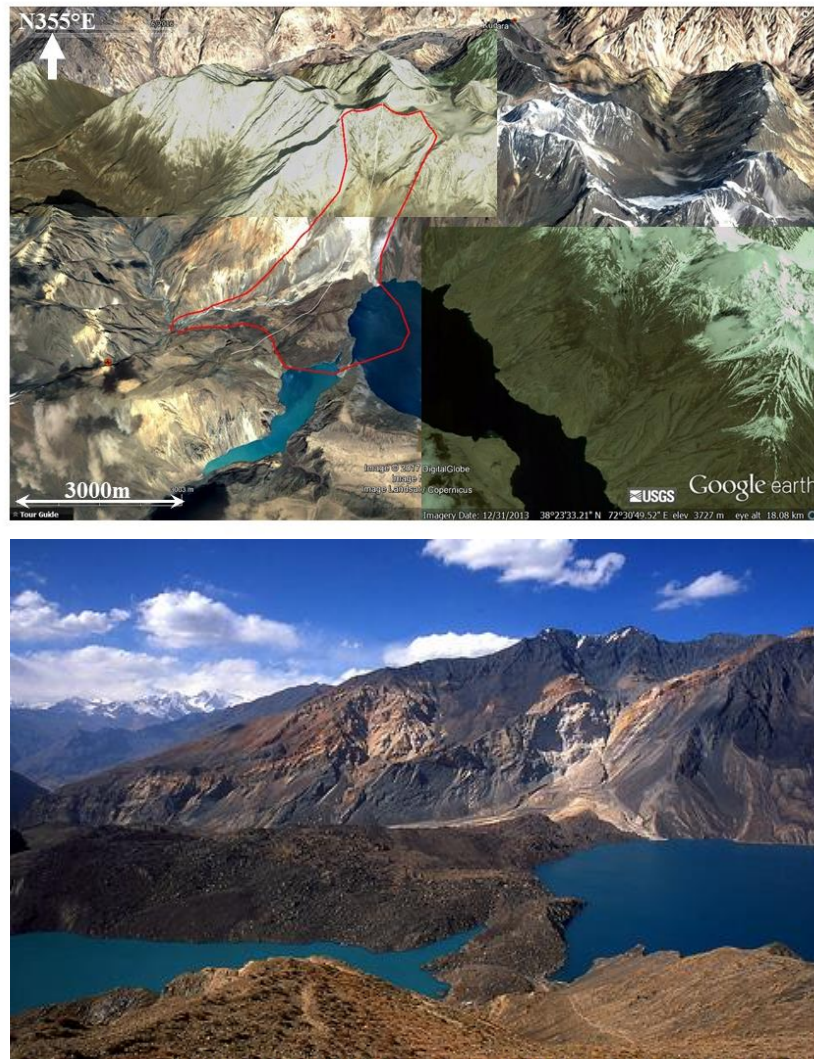
**Fig. 5.6.** Above: Usoi rockslide (coordinates:  $N38^{\circ}17'10''$ ,  $E72^{\circ}36'20''$ ) outlined in red with dammed Sarez (right) and Shadau (left) lakes (compiled Google earth imagery). Below: field view of dam and source area (behind) – (Photo from: <http://wikimapia.org/1739699/Sarez-Lake#/photo/584782>).

Behind this 600 m high natural dam (the highest dam in the world), Lake Sarez and the smaller Lake Shadau had been impounded (views shown in lower part of Fig. 5.6), the first one with a maximum depth of 500 m.

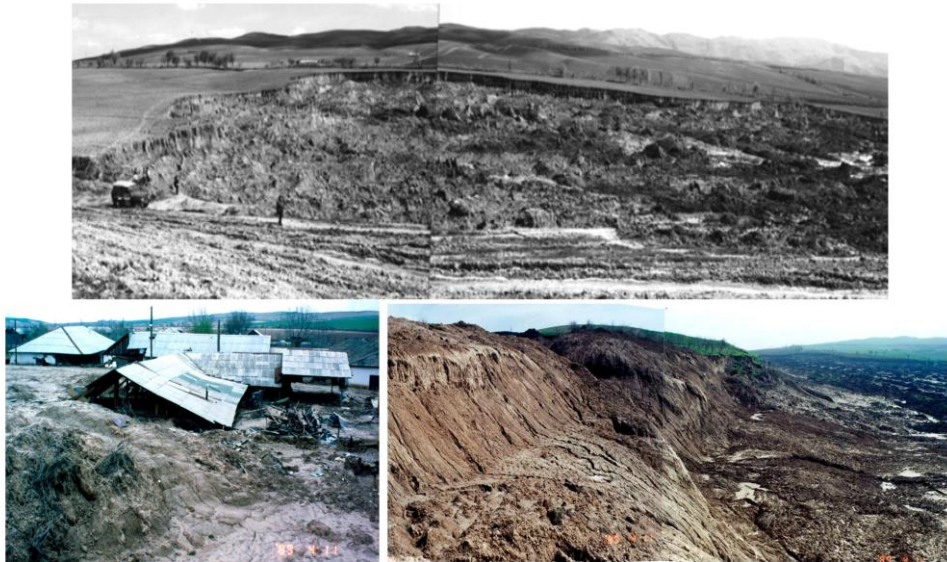
**Fig. 5.8.** Okuli-bolo loess earth-flow (coordinates: N38°29'01", E68°38'12") (Photographs by Ishihara, 2002)

The largest landslide, called ‘Okuli-bolo’ (Fig. 5.8), had an estimated volume of  $20 \times 10^6 \text{ m}^3$ . Ishihara (2002) indicated that ‘at least two slides seem to have been triggered independently from the hillsides on the north, which then merged into the main stream of the mudflow.’ The sliding surface of most landslides was located at a depth of about 15 m, within the saturated part of the 30 m thick loess deposits. Ishihara et al. (1990) also noted that the scarps of many landslides were located along a water channel installed on the shoulder of the hills. They assumed that ‘water in the channel had been infiltrating in the loess over years, leading to final failure during earthquake due to liquefaction of water-bearing loess layer’. This is supported by their observation of muddy water oozing from the earth-flow.

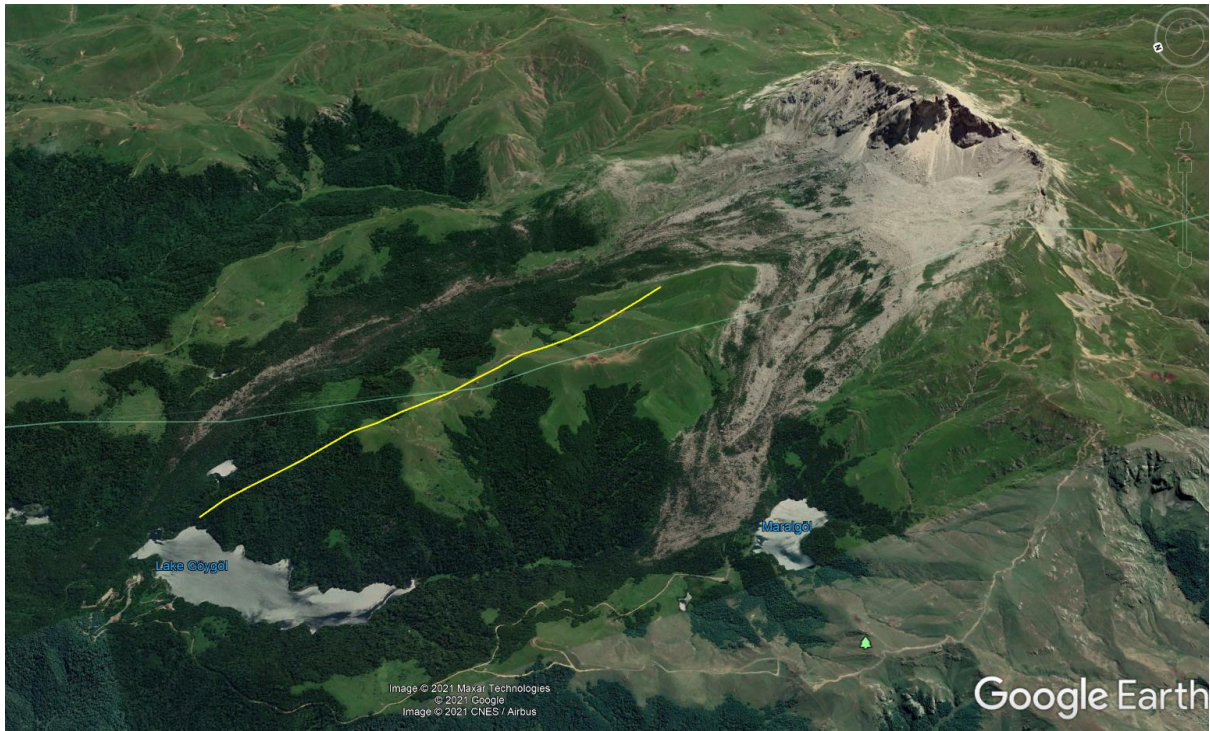
**Fig. 5.15.** Google Earth view from North-West of the Kapaz Mountain rock avalanche(s) (coordinates: N40°23'30"; E46°19'40") triggered by the 1139 Ganja earthquake in the southeastern Lesser Caucasus, which dammed several lakes, including the two larger ones of Goy-Gol (lower left corner) and the Maral-Gol (middle lower right). See also yellow line of 4 km length (for scale).

A very impressive historical event – but for which, surprisingly, little information is available in the literature – is the Kapaz Mountain rock avalanche (actually, two avalanches) triggered by the 1139 Ganja earthquake. Its location is shown by an orange arrow and circle, respectively, in Fig. 5.13); it is considered the most powerful catastrophic event in the Lesser Caucasus (Nikonov & Nikonova, 1986). The two rock avalanches dammed in total eight still existing lakes, including the two larger ones of Goy-Gol and Maral-Gol. The Google Earth view in Fig. 5.15 shows that the eastern rock avalanche part (damming Goy-Gol) is about 7 km long, while the western part (damming Maral-Gol) is almost 4 km long. The total volume of both parts would be about  $500 \times 10^6 \text{ m}^3$  (at least).

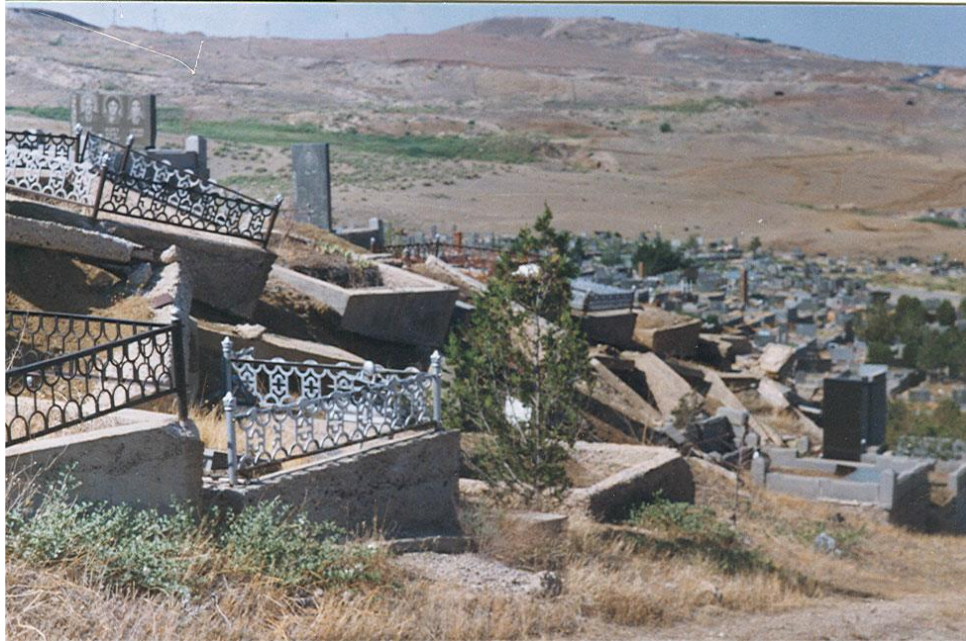
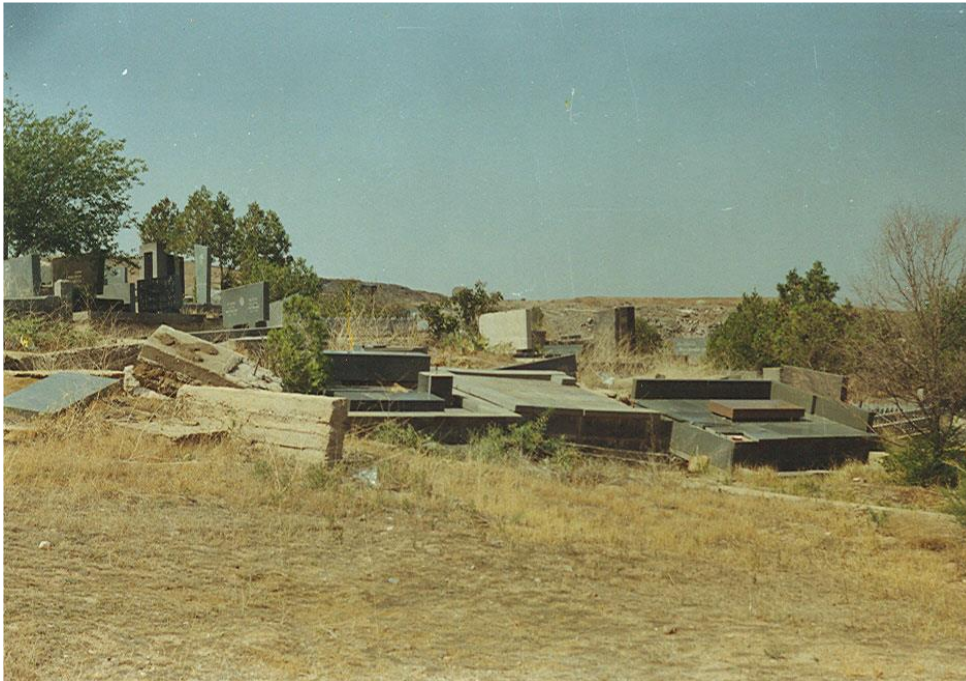
**Fig. 5.16.** Destroyed graves on the Nubarashen landslide, activated soon after the 1988 Spitak earthquake (from Boynagryan, 2009)

The most recent disastrous earthquake in the Lesser Caucasus, the 1988 Spitak earthquake with a magnitude of 6.8 had also (re)activated larger landslides. According to Boynagryan (2009), several landslides were (re)activated in the Dilijan area (see small green arrow in upper left part of Fig. 5.13, at a distance of about 50 km from the epicentre); he also indicates that the large Voghjaberg landslide (volume of more than  $100 \times 10^6 \text{ m}^3$ ) shown in the Google Earth view in the right upper part of Fig. 5.13 was reactivated during the 1988 event. Boynagryan (2009) also considered the activation of the Nubarashen landslide (in the south of the capital Yerevan, directly downstream from Garni landslide) soon after the 1988 earthquake, a delayed consequence of the seismic event (see destroyed graves on the landslides in Fig. 5.16).
