INTERNATIONAL JOURNAL OF WOOD CULTURE

Wood Used in Brussels' Old Buildings: Origin, Characterisation, and Use (12th–19th Centuries)

Abstract

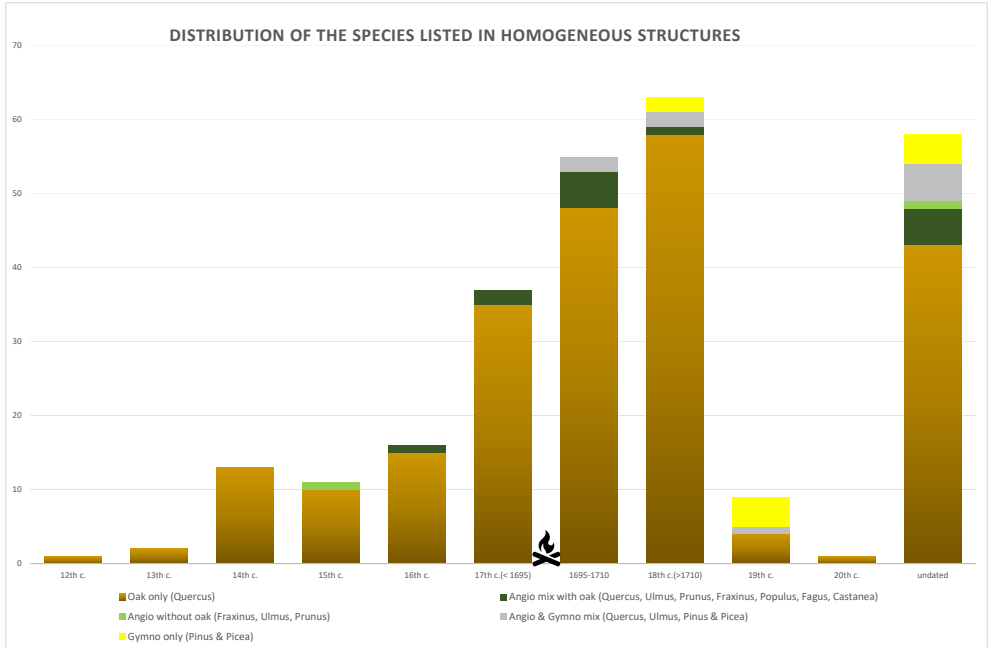
FIGURE 4 Diagram of the distribution of species in the structures studied
© ULIÈGE, KIK-IRPA, URBAN.BRUSSELS

One of the main findings of the research conducted over the last 30 years in the Brussels region is the predominance of oak (*Quercus robur* L. or *Q. petraea* Liebl.) as a species used in timber roofs from the 12th–19th centuries (Fig. 4). Nevertheless, the use of other species for timber roofs has also been observed, especially from the 17th century onwards (at present, our corpus

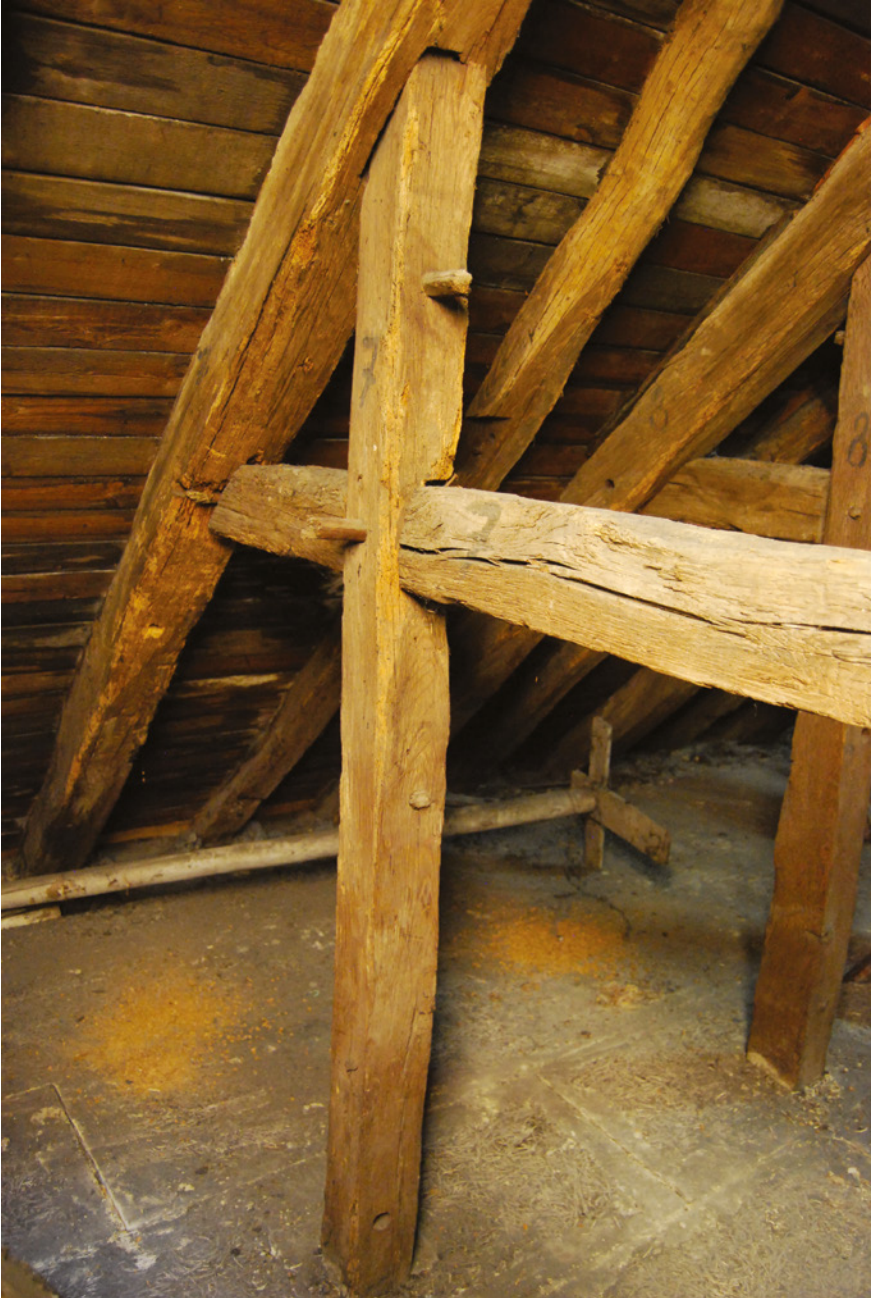
FIGURE 6 Frame covering the nave of the church of Saint-Lambert in Woluwe-Saint-lambert
© S. CREMER, WORKING PHOTO, KIK-IRPA, URBAN.BRUSSELS

The double pitch roof has small dimensions: 5.50 m wide and 3.30 m high with a 45° inclination. Tiebeams connect twelve pairs of rafters which form the principal trusses, and these are supported by two rows of posts that are crossed by a collar, without bracing. The secondary trusses, of which there are 11, are joined at the top with halved joints. They have empty mortices at mid-height, proof of the disappearance of collars assembled at mid-height at the same height as those of the principal trusses. The wood used appears to be essentially boxed heart based on the wane areas observed and the orientation of the cracks in the heart. Most of the squaring was done with an axe on all four sides. A few rare traces of a manual pit saw were observed (Hoffsummer *et al.* 2011a; Cremer 2016b) (Fig. 6).

In the case of the church of Saint-Lambert, the pieces are small sections because the roof is modest-sized: about 11×13 cm for the posts, 12×15 cm for the collar, 18×17 cm at the base and 16×15 cm at the top for the rafters of the principal trusses. The dendrochronological samples, of which there are 12, show between 12 and 51 rings, with an average of 33. Estimating the missing pith rings and adding a maximum number of sapwood rings for the four core samples with sapwood allows us to estimate that the logged trees were between

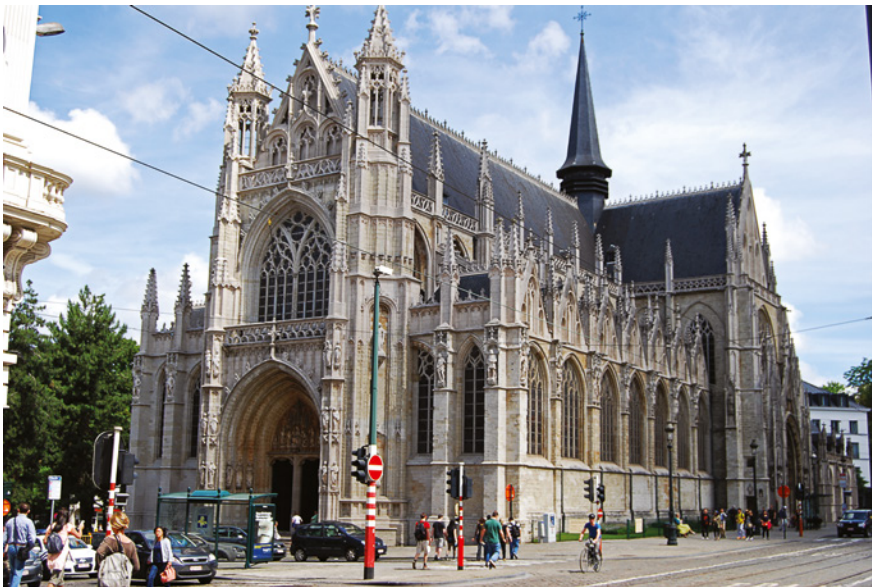
FIGURE 7 Exterior view of the church of Notre-Dame du Sablon
© A. WEITZ, WORKING PHOTO, KIK-IRPA, URBAN.BRUSSELS

At the Church of Notre-Dame du Sablon in Brussels (Fig. 7), the study of the timbers (Houbrechts & Eeckhout 2002; Weitz *et al.* 2016a; Cremer 2016a; Cremer *et al.* 2016), and the metal elements (Maggi 2015) visible in the attic has made it possible to trace the evolution of the building, which spanned the late 14th–mid-16th centuries.

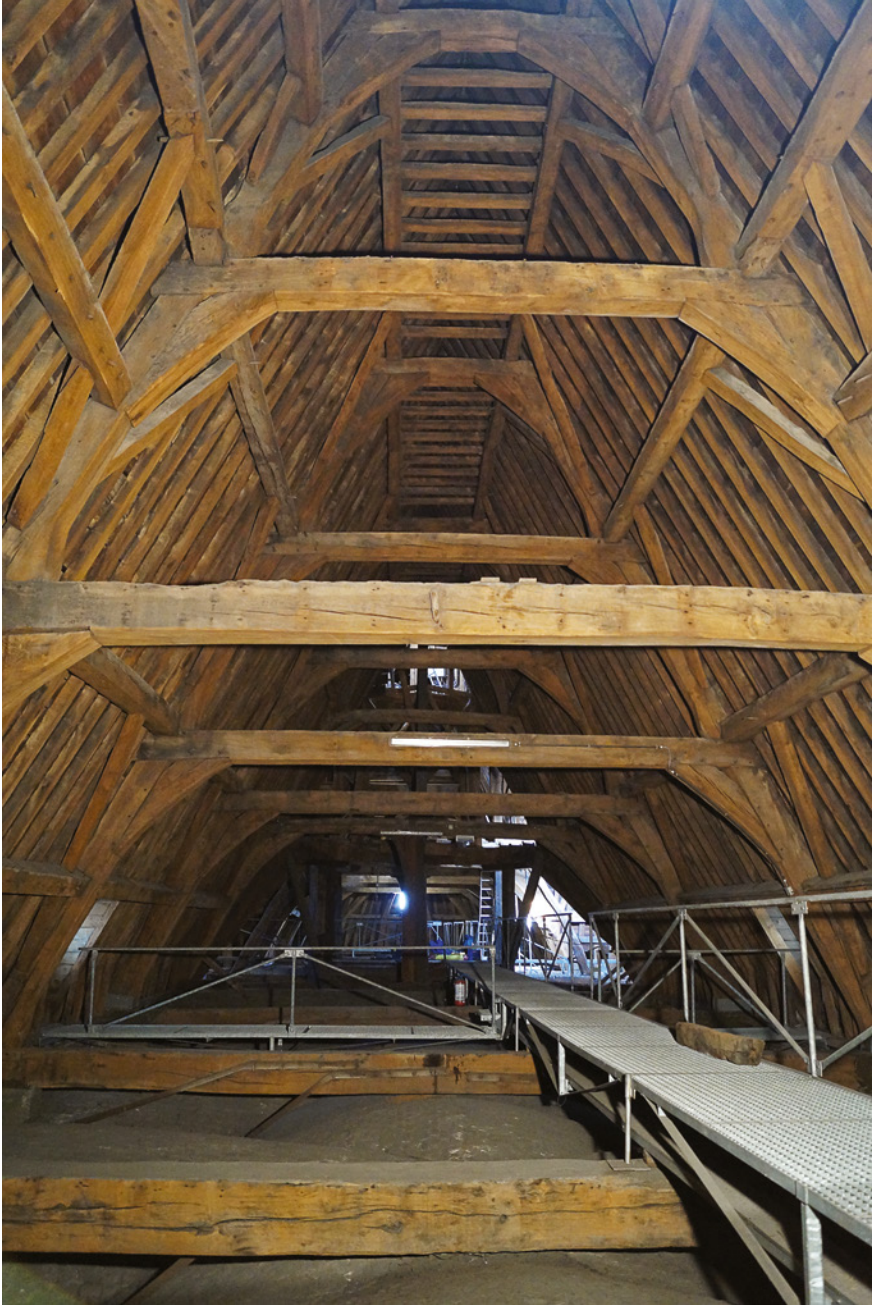
FIGURE 8 General view of the framework of the nave of the church of Notre-Dame du Sablon

The wooden structures are made entirely of oak. The double pitch roof has a 63–64° inclination and is approximately 10 m wide and 10 m high (Fig. 8). The type of structure, with three superimposed porticos, considerably reduces the number of long pieces of wood required. Only the tiebeams and rafters require long, straight bole oak from high forests. The first tiebeam, which is the most imposing piece, is a 10-m-long boxed heart oak piece measuring 41×45 cm in cross-section. The principal rafters are limited to a maximum length of 3 m (Fig. 9).

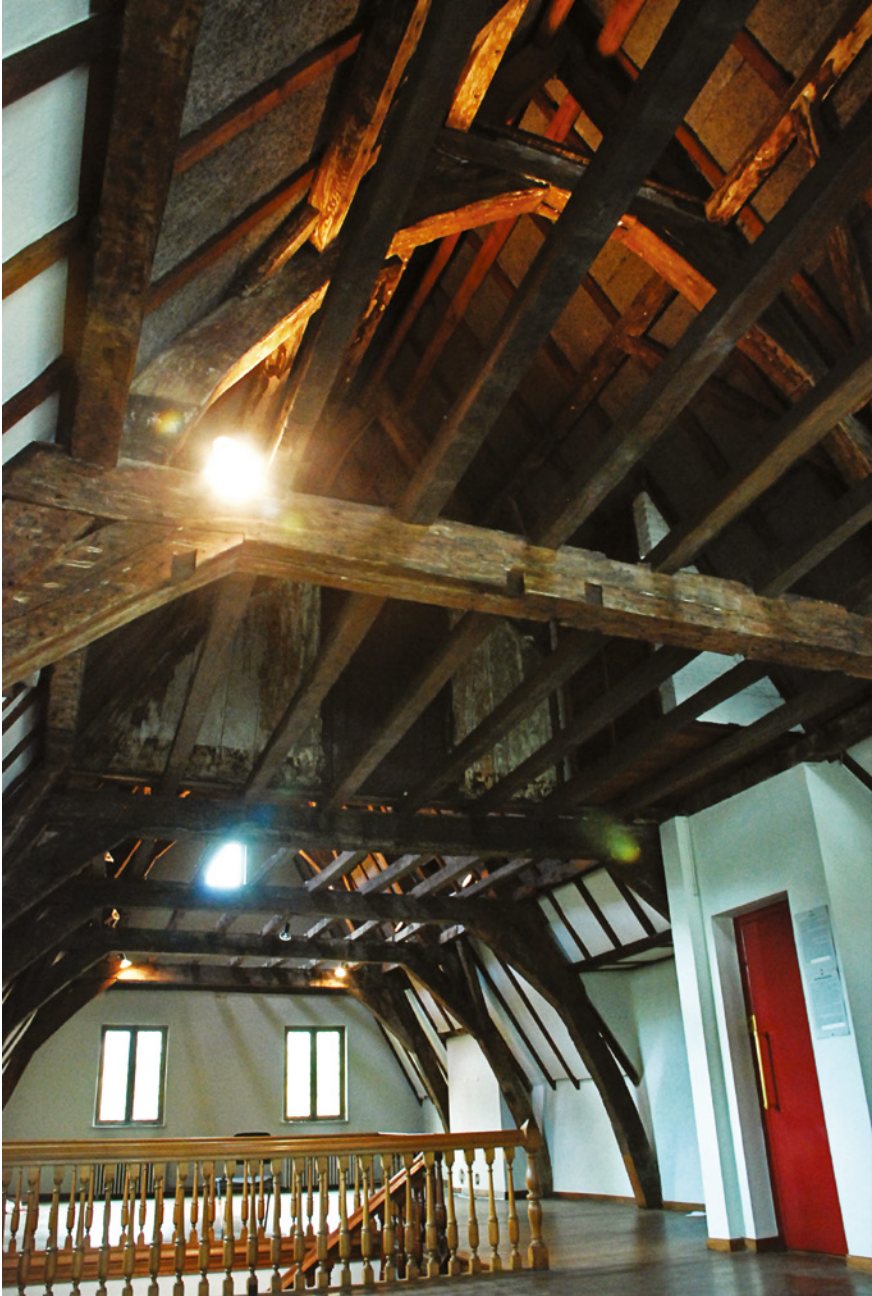
FIGURE 10 Bruegel House, general view of the attic
© P. HOFFSUMMER, ULIÈGE, URBAN.BRUSSELS

A remarkable example of bourgeois housing could be the Bruegel house located at number 132 rue Haute in Brussels (Fig. 10). In this imposing house, the structural woodwork is also entirely made of oak. The roof frame, for which the felling dates lie between 1539 and 1558d (Hoffsummer *et al.* 2011b), sits in a roof over knee walls with a gable roof facing the street with a 59° pitch. The structure is about 6.80 m wide and 6.80 m high. The typology is that of superimposed portico trusses with the feet of the principal rafters having a stronger section at their base and a slight fretwork profile. These pieces, as well as the soulaces and the second tiebeam, are 18 × 25 cm. It employs quarter, half log, or boxed heart wood. Interestingly, the squaring was done with a manual pit saw (Cremer 2018). This confirms the hypothesis that squaring appeared earlier in the Brussels region than in the Walloon region or in France (from the end of the 16th century) (Hoffsummer & Weitz 2017, p. 43). At present, only two other examples have been recorded in the corpus from before the 17th century. These are the wooden structures of the church of Notre-Dame du Sablon in Brussels (see above) and one of the chapels of the collegiate church of Saint-Pierre-et-Saint-Guidon in Anderlecht (1558d) (Cremer 2018).

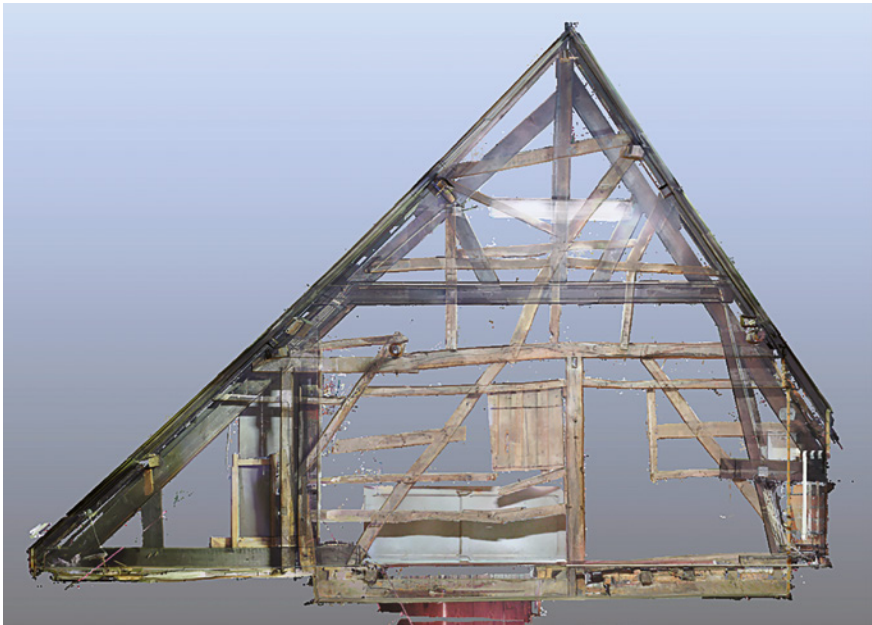
FIGURE 11 3D scan with Faro, former Beguinage of Anderlecht

The preservation of various elements of the façade (Fig. 11) and of four of the five structural trusses makes it possible to reconstruct the complete plan of the 15th-century core. With a surface area of 50 m² each, the two levels were divided into two spaces. The archaeology of the building also makes it possible to put forward a theory regarding the original state of the roof (4.56 m wide×4.90 m high, 60° pitch), where the roof frame would have been a principal rafter roof (Fig. 12). In this roof over knee walls, the trusses are composed

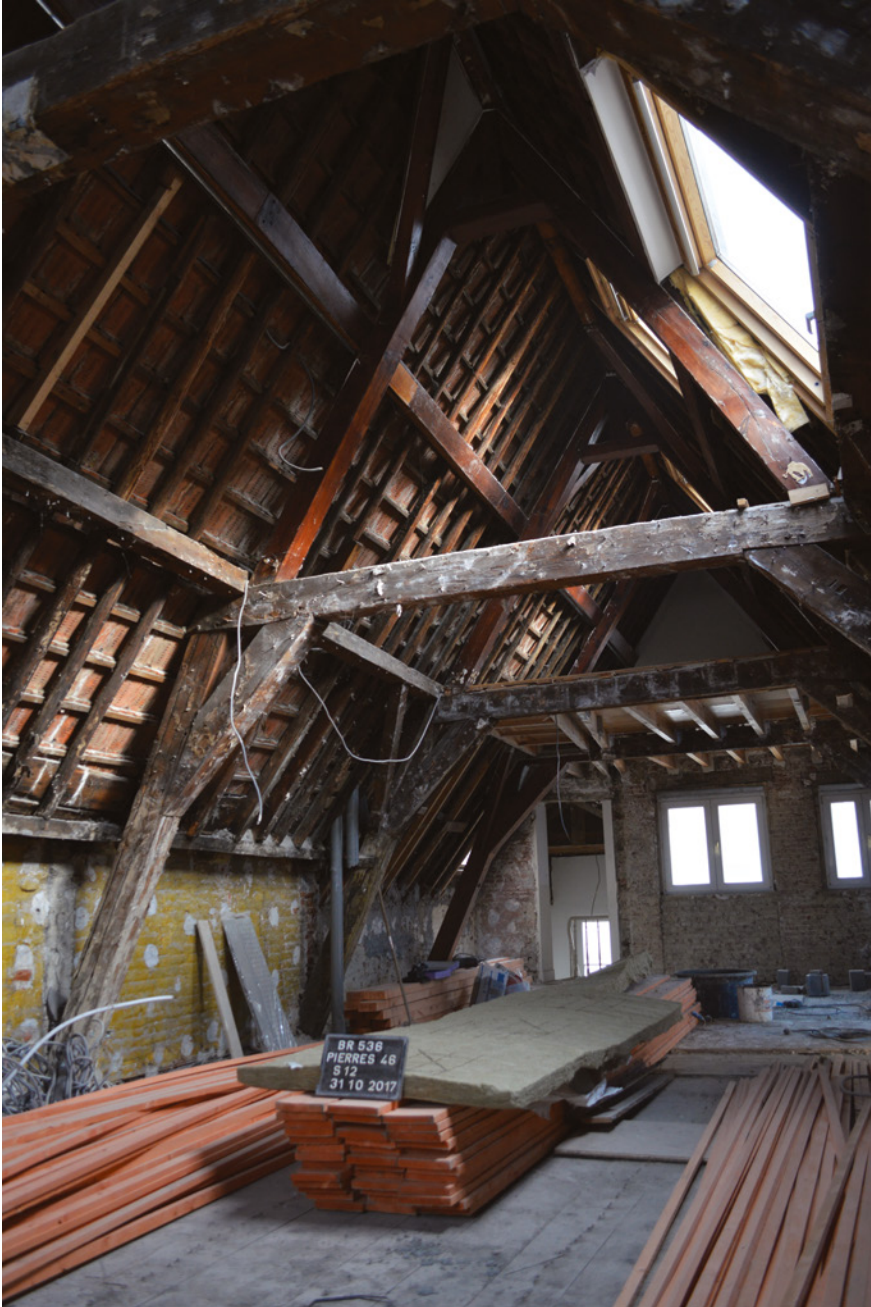
FIGURE 17 Frame in Scots pine, rue des Pierres 46, Brussels
© S. MODRIE, URBAN.BRUSSELS
