# MONITORING RECENT ACTIVITY OF THE KOYTASH LANDSLIDE (KYRGYZSTAN) USING RADAR AND OPTICAL REMOTE SENSING TECHNIQUES

Valentine Piroton, Department of Geology, University of Liege, Belgium, valentine@piroton.be  
 Romy Schlögel, United Nations Institute for Training and Research (UNITAR), Nairobi, Kenya, romy.schlogel@gmail.com  
 Hans-Balder Havenith, Department of Geology, University of Liege, Belgium, hb.havenith@uliege.be

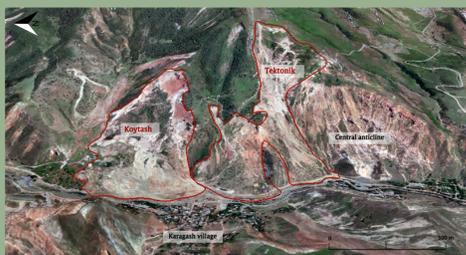
**Koytash** is a former deep-seated landslide with a rotational movement. It was reactivated the 22<sup>nd</sup> of April 2017 during the massive activation event.

**Tektonik** has a specific morphology with a well-marked scarp and its lower part divided into two lobes. Unlike Koytash, Tektonik was reactivated only in its upper part.
