DATA DESCRIPTOR

A dataset of floating debris accumulation at bridges after July 2021 flood in Germany and Belgium

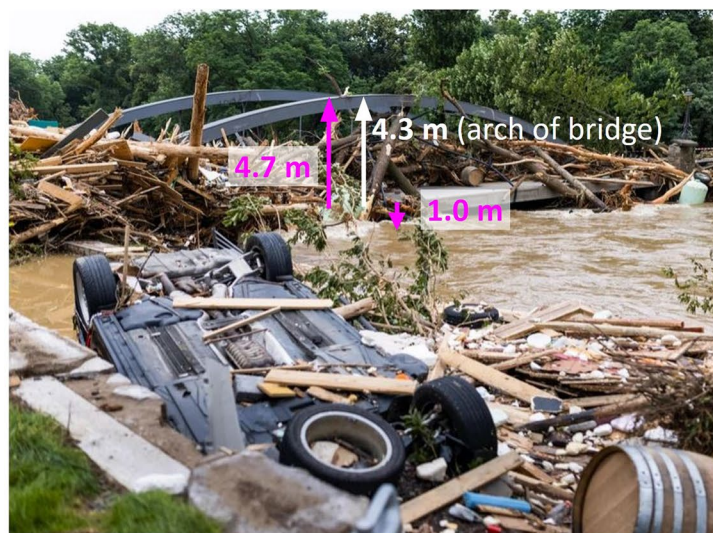
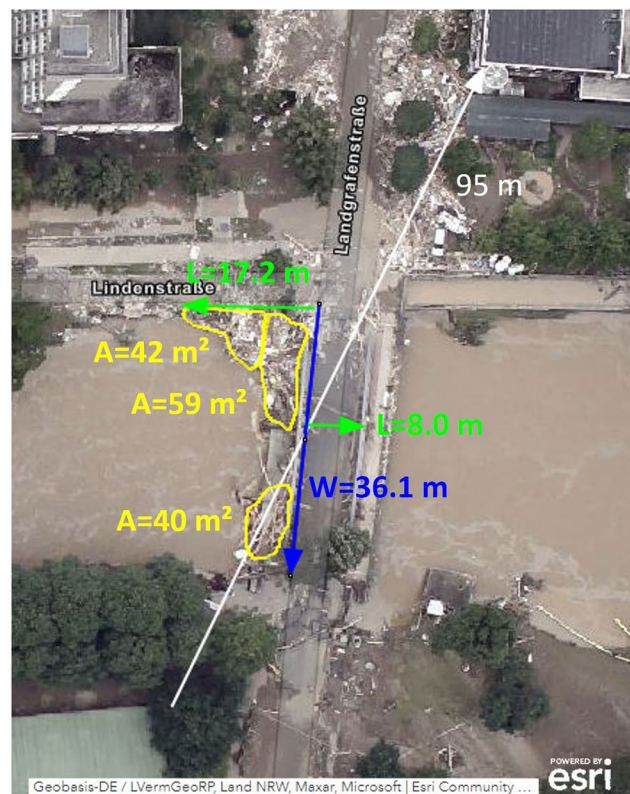
$$W_{\text{tot}} = 36.1 \text{ m}$$

$$L_{\text{tot}} = 17.2 \text{ m} + 8.0 \text{ m} = 25.2 \text{ m}$$

$$H_{\text{tot}} = 4.7 \text{ m} + 1.0 \text{ m} = 5.7 \text{ m}$$

$$V_{\text{tot}} = 42 \text{ m}^2 \times 1\text{m} + 59 \text{ m}^2 \times 3\text{m} + 40 \text{ m}^2 \times 1.5\text{m} = 279 \text{ m}^3$$

Fig. 3 Example of measurement of accumulation dimensions (W: width, L: length, H: height) and volume V, using photos from different perspectives (bridge 10016 in the database, Bad Neuenahr, Germany). Known dimensions of the bridge or surroundings are used for scale (indicated in white). Distances and areas directly measured on the photos are indicated in blue, green, magenta and yellow. The height of the three (yellow) areas is estimated rather than measured directly on the photo, given the lack of an undistorted straight-on perspective. Note the entanglement of debris with the bridge arch.

A total of 205 photos with visible debris accumulation, collected from local authorities, news agencies, inhabitants and social media, have been analyzed and processed. The software ImageJ (version 1.53) has been used to measure debris accumulations' lengths, heights and surfaces from pictures, using data from the bridge's geometry and surrounding structures for scale calibration (see Fig. 3 for an example for bridge 10016 in Germany). Information from different perspectives was combined to obtain both horizontal and vertical dimensions.
