Bridge Clogging in Belgium and Germany during the 2021 Floods

Daan Willem Poppema¹, Lisa Burghardt², Loïc Bénet³, Davide Wüthrich¹, Elena-Maria Klopries², Benjamin Dewals³, and Sebastien Erpicum³

November 01, 2024

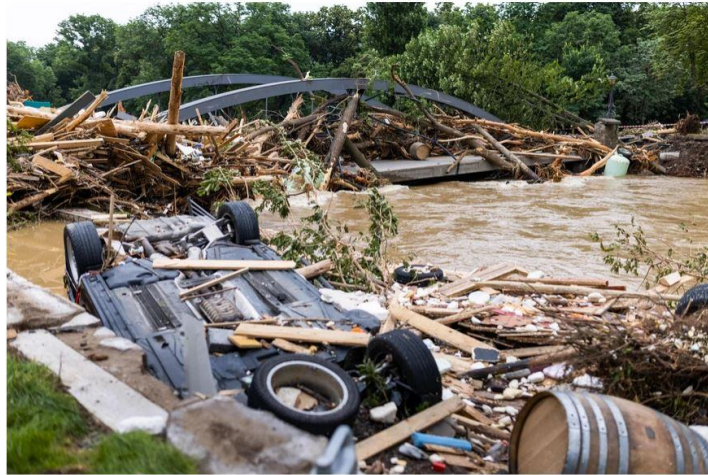
90 *Figure 1: A debris accumulation in Bad Neuenahr, Germany (bridge 16 in the database by Epicum et al. (2024)). Trees,*
91 *vehicles, tanks and other objects are present in front and on top of the bridge, with debris interlocking with the bridge*
92 *superstructure. Photo by Philipp von Ditfurth (Jannaschk, 2021).*

56 inundated areas. All this floating debris would often be blocked at bridges, creating debris
57 accumulations (see e.g. Figure 1) reducing the conveying capacity of an already overloaded water
58 infrastructure.

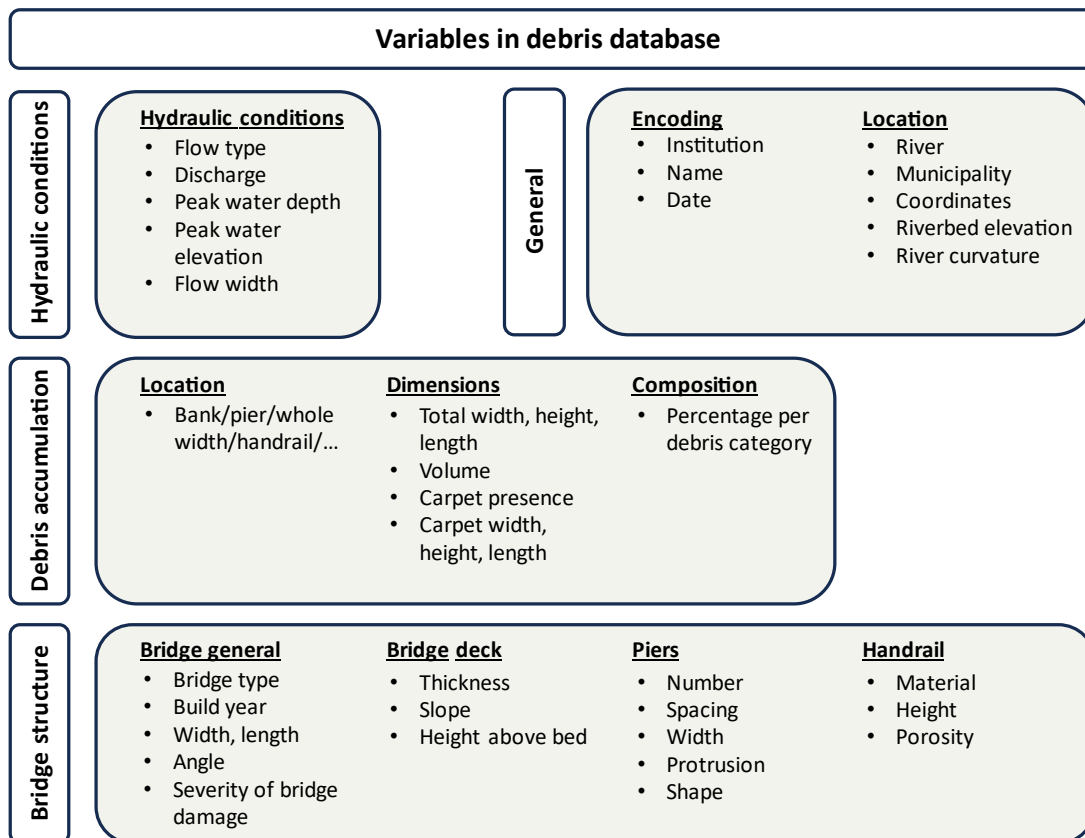
161
162 *Figure 3: Overview of the main variables documented in the debris database*

144 This paper presents an analysis derived from a database on debris accumulation at bridges in Belgium
 145 and Germany during the 2021 floods (Epicum et al. 2024). A total of 71 bridges affected by debris
 146 clogging were studied (38 in Belgium and 33 in Germany, mainly at the rivers Vesdre resp. Ahr), mostly
 147 based on aerial and handheld photos of the accumulations taken during or just after the flood. This
 148 photo analysis was needed to provide reliable information on the nature of the accumulations, since
 149 field surveys arrived late to investigate debris, when accumulations had often already been removed
 150 and dismantled. The database and analysis focus on three main aspects of debris accumulation, as
 151 summarised in Figure 3:

164 For the bridge properties, the database documents the bridge location, observed damage and the
165 design of the bridge in general, bridge deck, piers and handrail (Figure 3). Bridge properties are based
166 on the following sources:

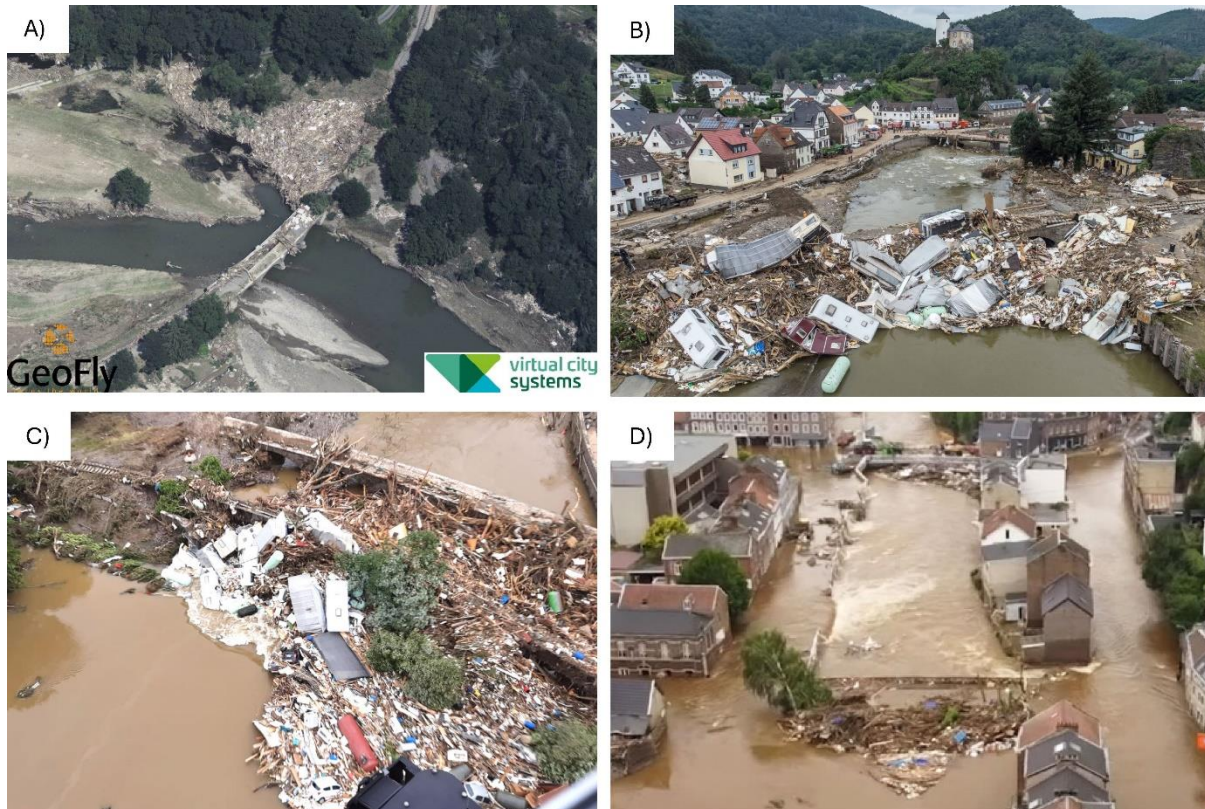
290
291 *Figure 5 Examples of clogged bridges in the database. A) Pützfeld, Germany (bridge id 63 in the database, taken after the*
292 *flood). Photo based on an aerial survey by GeoFly GmbH and provided by Virtual City Systems. B) Kreuzberg, Germany (bridge*
293 *id 62, after the flood). Source: Baumert (2024). C) Altenahr, Germany (bridge id 55 and 56, after the flood). Photo by Polizei*
294 *Thüringen (2021). D) Pepinster, Belgium (foreground: bridge id 59; background: bridge id 60. During the flood) Credit: Vedia.*
295 *The flow direction is from left to right and foreground to background.*

273 A closer examination of the largest accumulations, presented in Table 4, shows substantial variation
274 between cases. The largest accumulation, approximately 4,400 m³ consisting primarily of trees,
275 occurred at the riverbank right next to a bridge in Pützfeld, Germany (Figure 5A). The debris' location
276 against the railway track (built as a raised embankment) means the debris accumulation likely
277 generated relatively limited flow resistance and backwater rise. However, it shows the large amount
278 of debris transported during the flood, which could under different circumstances (e.g. different river
279 curvature or bridge angle) accumulate in the river channel. The second largest accumulation (Figure
280 5B, ~3,700 m³) is completely different, with a very dense accumulation in the channel in front of a
281 railway bridge. This debris was mainly of anthropogenic (i.e. man-made) origin, including caravans,

282 building rubble and tanks from heating systems. A similar accumulation (slightly less dense, with
283 several cars and slightly more trees) occurred at two parallel bridges in Altenahr, visible on Figure 5C.
284 Accumulations in Belgium were slightly smaller and generally without vehicles, but otherwise
285 comparable in composition. For instance, the two accumulations visible in Figure 5D (in Pepinster,
286 Belgium) both contained a mixture of trees and building rubble. This photo taken during the flood also
287 shows the extent of the flooding and, from the water flowing down into the river in the middle of the
288 photo, the backwater rise caused by the debris accumulation. In addition, the background shows a
289 second clogged bridge, shortly after the first one.

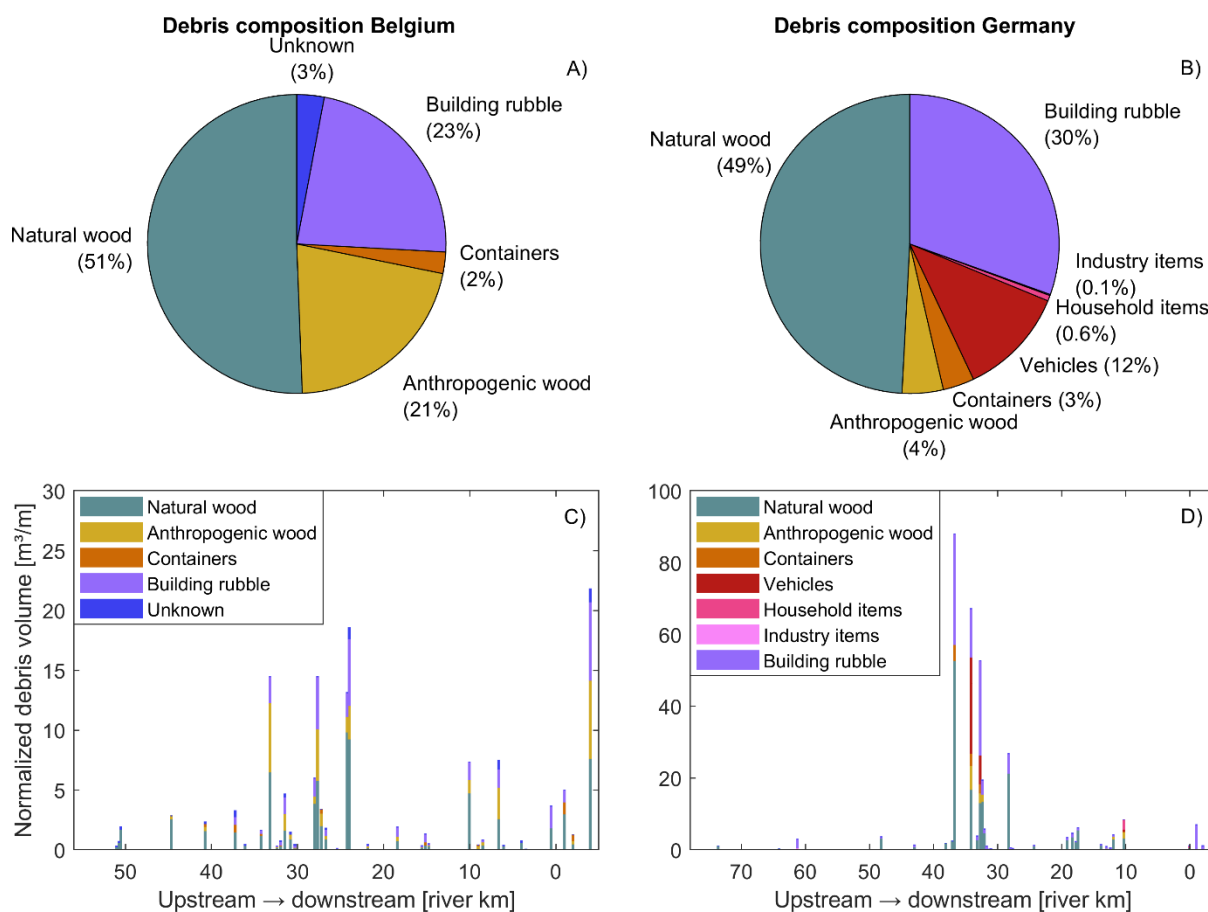
327
 328 *Figure 6: The composition of the accumulations in Belgium (subplot A and C) and Germany (B and D). The top row shows the*
 329 *volume fractions of the total debris volume per country, the bottom row the composition per accumulation.*

317 The composition of individual accumulations is shown in Figure 6C and 6D for all clogging events
 318 investigated in the present study (Figure 2). Overall, data showed different compositions at various
 319 bridges, showing a clear dependence on the geographical location as well as on the land use of the
 320 riverbanks. As an example, data shows that the overall vehicle volume in Germany is largely caused
 321 by the accumulation at river kilometre 34 that contained a large number of caravans (see the photo
 322 in Figure 5B). It shows the dependence of the debris composition on the local presence of
 323 transportable objects or materials, such as caravans at a campsite along the river. Similarly, the large
 324 accumulation volumes and high building rubble content around Ahr river kilometre 35 – i.e. the heavily

325 damaged towns of Altenahr and Kreuzberg – show that the debris volume and composition at bridges
 326 are directly linked to the local flooding severity and damage in an area.

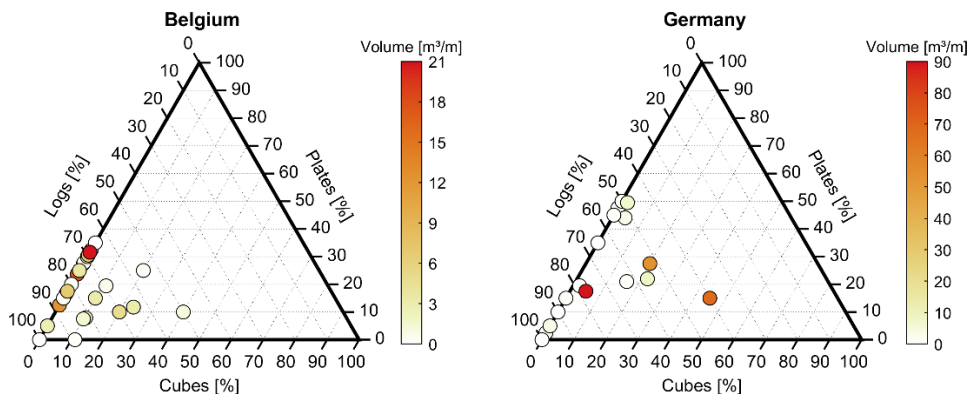
348
 349 *Figure 7: The estimated fraction of log-, plate- and cube-shaped objects in the debris accumulations. Each circle represents*
 350 *an accumulation in the database, colour-coded by volume, with its location along the three axes indicating the volume*
 351 *fraction of log-, plate- and cube-shaped objects in the debris mixture.*

330 The shape of the objects in the accumulations was analysed by examining the debris categories
 331 (Figure 6). Visual observations showed the presence of three main features: (1) elongated one-
 332 dimensional objects (here called ‘logs’); (2) flat two-dimensional objects (‘plates’) and (3) voluminous
 333 three-dimensional objects (‘cubes’ or ‘cuboids’) in each of the categories, as previously discussed in
 334 Table 3. Due to the large fraction of natural wood present, all accumulations predominantly consisted
 335 of 1D log-shaped objects, as shown in Figure 7, where the percentage of all shapes is visualised in a
 336 triangular distribution. Accumulations consisting almost entirely of trees are plotted in the lower left
 337 corner of the triangles, including the largest accumulation of Germany (also shown in Figure 5A).
 338 Accumulations with logs and plates are plotted along the left edge of the triangle, including the largest

339 accumulation of Belgium. Plate material reaches up to 35% in Belgium, 50% in Germany, often
 340 stemming from a high fraction of building rubble – where roof parts or insulation material are
 341 examples of flat objects – sometimes also from anthropogenic wood and household items. The
 342 accumulations belonging to the rightmost circles in both triangles are characterised by their high cube
 343 content (up to 45%), from tanks and containers in Belgium, mostly from vehicles in Germany. Lastly,
 344 there are a few accumulations with a substantial content of all three debris shapes, in the middle of

345 the triangles: e.g. three in Germany with 15%-25% cuboid objects, 20%-30% plate and 50%-65% logs.
 346 Overall, the large accumulations – which are most interesting from a water safety perspective – show
 347 especially in Germany quite mixed debris shapes.

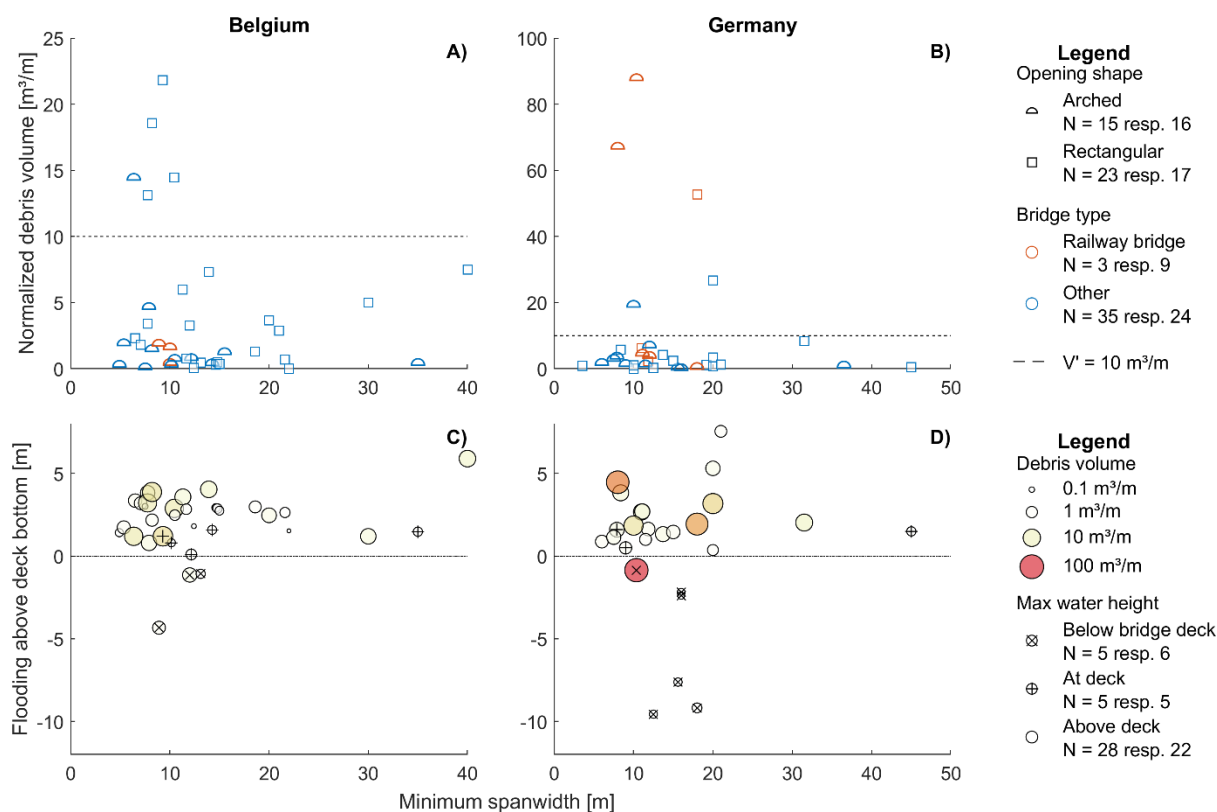
376
 377 *Figure 8: The effect of span width and (subplot A, B) bridge design or (C, D) maximum water levels on accumulation volumes*
 378 *in (A, C) Belgium and (B, D) Germany. Note: maximum water levels are indicated relative to the bottom of the bridge deck.*
 379 *Straight crosses in symbols indicate a flood height between the bottom and top of the deck. Generally, the largest debris*
 380 *volumes occurred at bridges where the span width was limited ($\leq 10 \text{ m}$) and the water level reached or exceeded the deck.*

353 Accumulation volumes were linked to bridge designs and hydraulic conditions. Bridges can block
 354 debris and affect debris accumulation at their piers and deck. While the piers can block passing debris
 355 during regular conditions, effects from the deck and railing are only possible if the water level reaches
 356 the deck (or if the emerged part of floating debris is sufficiently high to collide with the deck). During
 357 the flood, most bridges in the database had (peak) water levels above the top of the bridge deck
 358 (Figure 8), meaning both the piers and deck generally contributed to a debris blocking.

370 A limited freeboard (the distance between deck and water level) is also known to increase the
 371 *probability* of blocking (Schmocker & Hager, 2011). For the 2021 flood event, flooding was so extreme
 372 that peak water levels reached or exceeded the bridge deck for 85% of the studied bridges (circles
 373 above the dashed line in Figure 8C, 8D), frequently exceeding it by several meters. Almost all

374 substantial accumulations occurred when the water level reached or exceeded the bridge deck,
 375 supporting the importance of the bridge deck and railing for the occurrence of large accumulations.

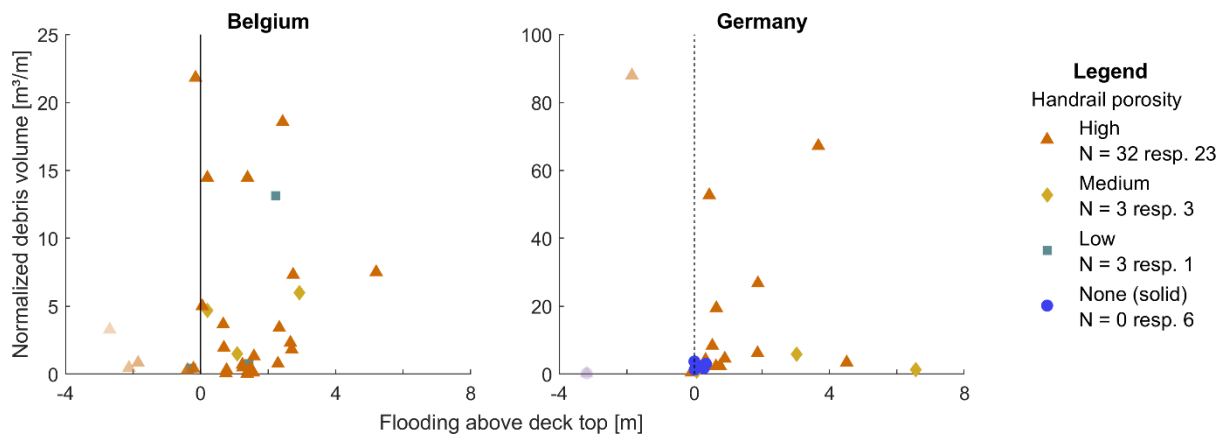
Figure 9: The effect of handrail porosity and flooding height on debris volumes in Belgium and Germany. The vertical dashed line indicates where peak water levels reached the edge between deck and handrail. Markers with lower water levels than this have increasing transparency to indicate the decreasing likelihood of debris interacting with the handrail. High porosity refers to handrail with thin elements and large spacing, medium to thin elements with low spacing, low to broad elements with low spacing and no porosity to solid walls.

381 Regarding railings, most bridges in the database have permeable metal structures, but in some cases
 382 solid stone walls are used. Figure 9 shows handrail porosities, debris volumes and water heights
 383 relative to the edge between the bridge deck and railing. For both countries, the largest accumulations
 384 occurred for highly permeable handrails, suggesting that the flow through the handrail might play a
 385 role in the accumulation process. In Belgium, no impermeable walls were present in the database, but
 386 in Germany, these impermeable railings (stone walls, indicated by blue circles) had considerably lower
 387 debris volumes. Interlocking of debris with permeable handrails likely played a role here in maintaining
 388 accumulations and preventing debris flowing over the bridge. Conversely, impervious handrails cause
 389 more flow resistance and backwater rise, leading to earlier overflow, and possibly earlier release of

390 debris. Also, handrail damage may have enabled easier transport of debris over the bridge. However,
 391 firm statistically significant conclusions are difficult to draw since only at three impermeable railings
 392 water is actually estimated to have reached the railing. For the other impermeable railings, interaction
 393 between handrail and debris would only be possible for large objects floating on the water or for
 394 inaccurate height estimations. This means that the sample size in the current database is rather limited
 395 and further examination of the effect of low, medium and high handrail porosities (squares, diamonds
 396 and triangles in Figure 9) on accumulated debris volumes shows no clear trend.
