AUTOMATIC CRACK DETECTION IN BUILT HERITAGE MASONRY USING YOLOV5

S. Boutet¹, P. Hallot²

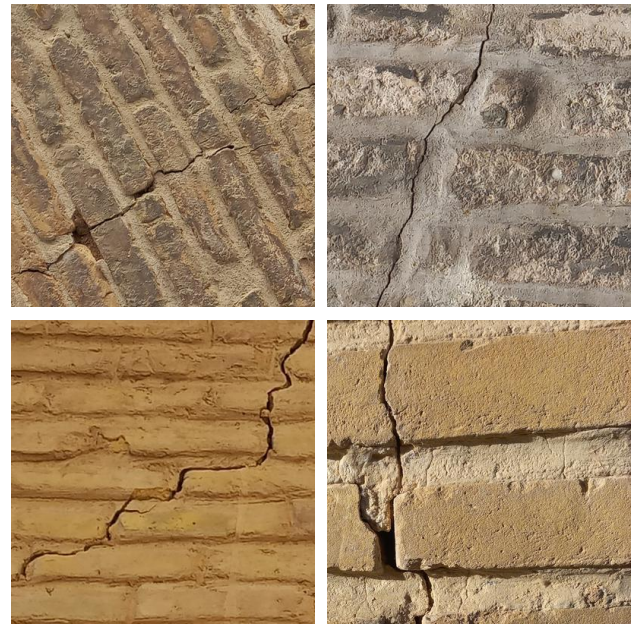
Figure 1. Example of masonry cracks used to train YOLOv5.

YOLOv5 was trained on the dataset of masonry images from the work of Karimi et al. (2024), featuring different types of cracks under varying lighting conditions and material textures (Figure 1). The model achieved a mAP50 of 96.8% and a mAP50-95 of 68.3% after training. Two main steps were evaluated during the study. First, we evaluated the robustness of YOLOv5 under practical conditions and assessed the accessibility of the technology for its potential users. To do so, we conducted a real-world case study on various buildings, manually verifying detected cracks against AI predictions.

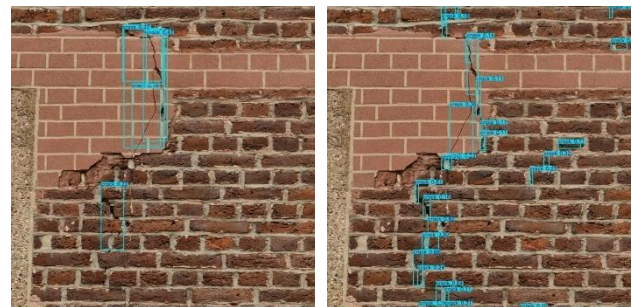
Figure 2. Impact of image resolution on predictions for the same crack

Secondly, YOLOv5's robustness was tested by varying the image resolution, the distance to the defect, the lighting conditions, both natural and artificial, as well as the incidence angle. The impact on predictions of image rotations and irrelevant objects was also explored. Figures 2 and 3 illustrate some of these tests.
