What potential does structural wood hold for reuse in urban housing in Liège? A study of timber frames from the *Ancien Régime* (14th to 18th centuries)

O Noël^{1*}, P Sosnowska² and S Trachte¹

¹ Research lab ACTE, Research unit AAP – University of Liege, Liege, Belgium

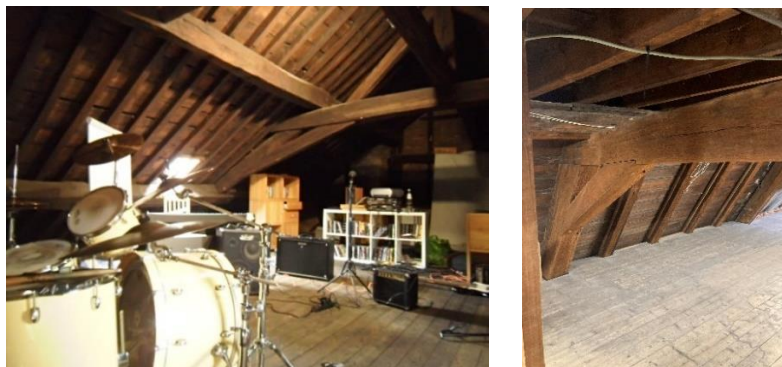
Figure 2. (a) Framework of the Donceel hotel. (b) Framework of Place Emile Dupont 9-10. Source: O. Noël

The first case study is a house in Liège, the Donceel hotel, whose oldest wood frames dates from the early 16th century. It has a remarkable wooden roof structure, but a complex one that has been successively modified from the 16th to the 20th century (**Figure 2**).

The second case study is a group of two buildings in Liège, on Place Émile Dupont, the remains of a cloistered building belonging to the Benedictine abbey of Saint-Jacques. Although the façades were rebuilt in the 19th and 20th centuries, these buildings still retain an ancient structure dating back to the 14th century, which has been modified over the centuries (**Figure 2**). These case studies reflect the building typologies and construction methods of the *Ancien Régime* and are particularly well preserved.

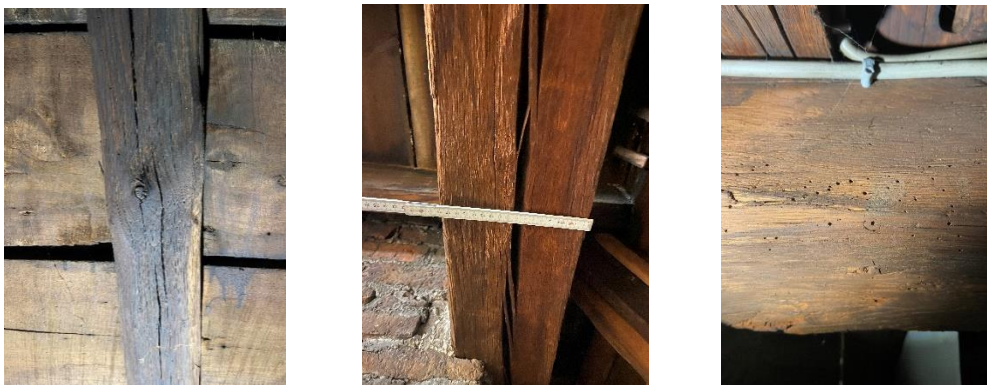
Figure 3. (a) Knots on a rafter from Place Emile Dupont. (b) Drying crack on a tie beam from Place Emile Dupont. (c) Wood-eating insect holes from Donceel hotel. Source: O. Noël

During the practical phase of the study, several factors were identified, although the process was sometimes hampered by the limited visibility and accessibility of certain elements within the case studies. Firstly, the data collected through the technical inventory and the case studies revealed significant similarities in the dimensions of the structural elements, while also highlighting some variations. These discrepancies could suggest local adaptations or evolutions in construction techniques over time. Secondly, observations from the case studies confirmed the presence of typical characteristics, such as knots (**Figure 3a**), drying cracks (**Figure 3b**), and damage caused by micro-organisms, particularly wood-eating insects (**Figure 3c**). These factors can directly impact the mechanical properties of the wood and influence its classification (**Table 4**). It is worth noting that oak, when well-preserved, is generally resistant to insect attacks; although minor superficial galleries may occasionally be found in the sapwood, the softest part of the wood, these do not compromise the overall structural integrity. Lastly, some uncertainties remain regarding certain factors, especially the precise identification of wood species. In these cases, assumptions have been made based on the typological characteristics and estimated dating of the timber, although definitive confirmation was not always possible.

Thanks to photogrammetry, applied in the case study of Place Emile Dupont, it was possible to accurately redraw and measure the singularities of a structural element. This allowed the classification method to be tested on a rafter that exhibited numerous defects and specific features, including multiple knots, cracks, and traces of xylophagous insect activity. The identification and assessment of these characteristics were carried out in accordance with standard NBN EN 1310. Based on these observations and by referring to standard NBN EN 975-1, the rafter was classified as Q-P2. According to the correspondence table between visual grading and mechanical strength classes defined by standard EN 338, timber graded Q-P2 falls into

mechanical strength class D18, meaning it retains sufficient mechanical properties to be reused in its original structural function. The assumption is that other rafters could be classified in the same way. However, for the rafters in the Donceel hotel case study, a different classification may be necessary due to their very specific condition, such as reused timber used with deformation and twisting and the presence of many knots. Purlins, stirrups and beams, which are subject to higher loads, must achieve at least strength class D 24.
