Testing timber columns for resistance until fire burnout: Role of thermal wave, smoldering, and active suppression

This paper presents a numerical and experimental study on stability until burnout of glued-laminated timber columns in compartment fires. In a previously reported experimental study, six 3.7 m long, 280 × 280 mm² timber columns designed for 60 min of standard fire resistance failed to survive various compartment fires, with four of the six columns failing due to thermal wave penetration into the cross section during the decay phase of the fire. Here, six additional compartment fire tests are conducted, supported by numerical simulations, to investigate the design of timber columns for burnout resistance. A finite element model is used to design the size of the columns to mitigate the effect of the thermal wave. Five tests on columns up to 400 × 400 mm² show that increasing the section size at constant loading enhances fire endurance, but the columns later failed due to local smoldering. While failure in the smaller columns was driven by the thermal wave and occurred within two hours of ignition, failure in the larger columns was caused by smoldering and occurred more

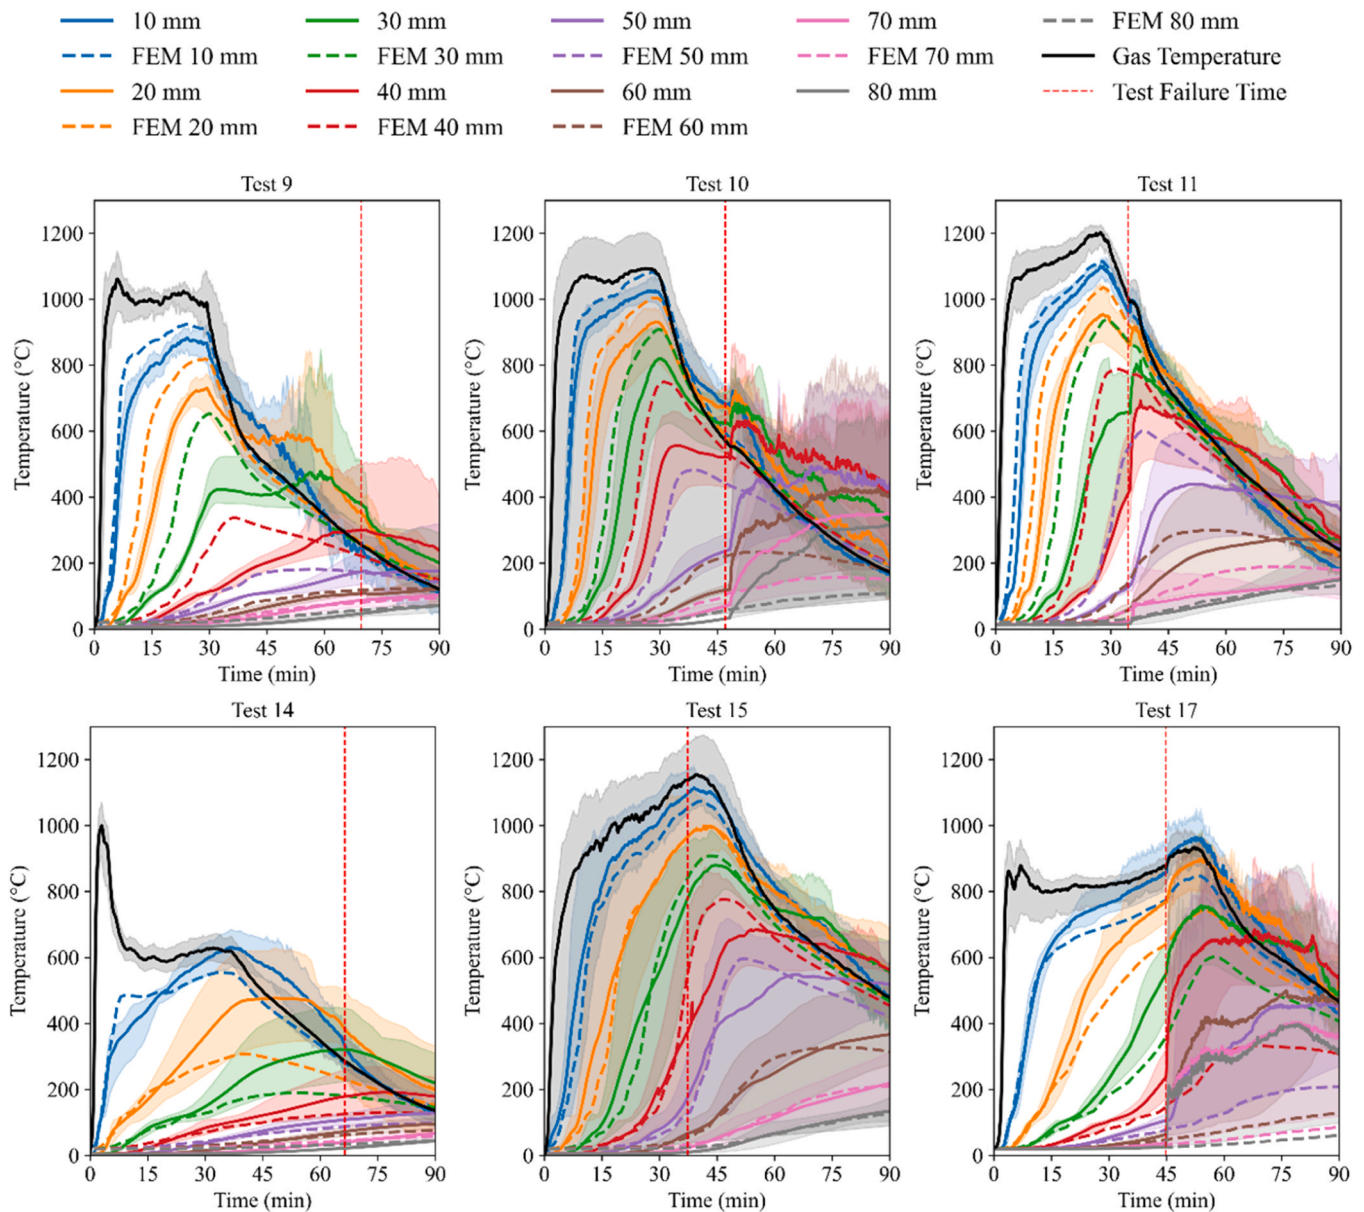
Fig. 3. Comparison of measured and computed temperatures in the cross-section of the timber columns, with thermal properties from Eurocode 5 and nominal parameters.

material, as shown by the extent of the shaded zones around each average curve). This highlights the need for further research on this aspect. Still, the model provides useful predictions of temperatures at any point in the section throughout the heating and cooling phases of the fire, using a given set of temperature-dependent thermal properties and parameters, for the purpose of informing the next experiments. The results from the thermal analysis are next used in the structural analysis.

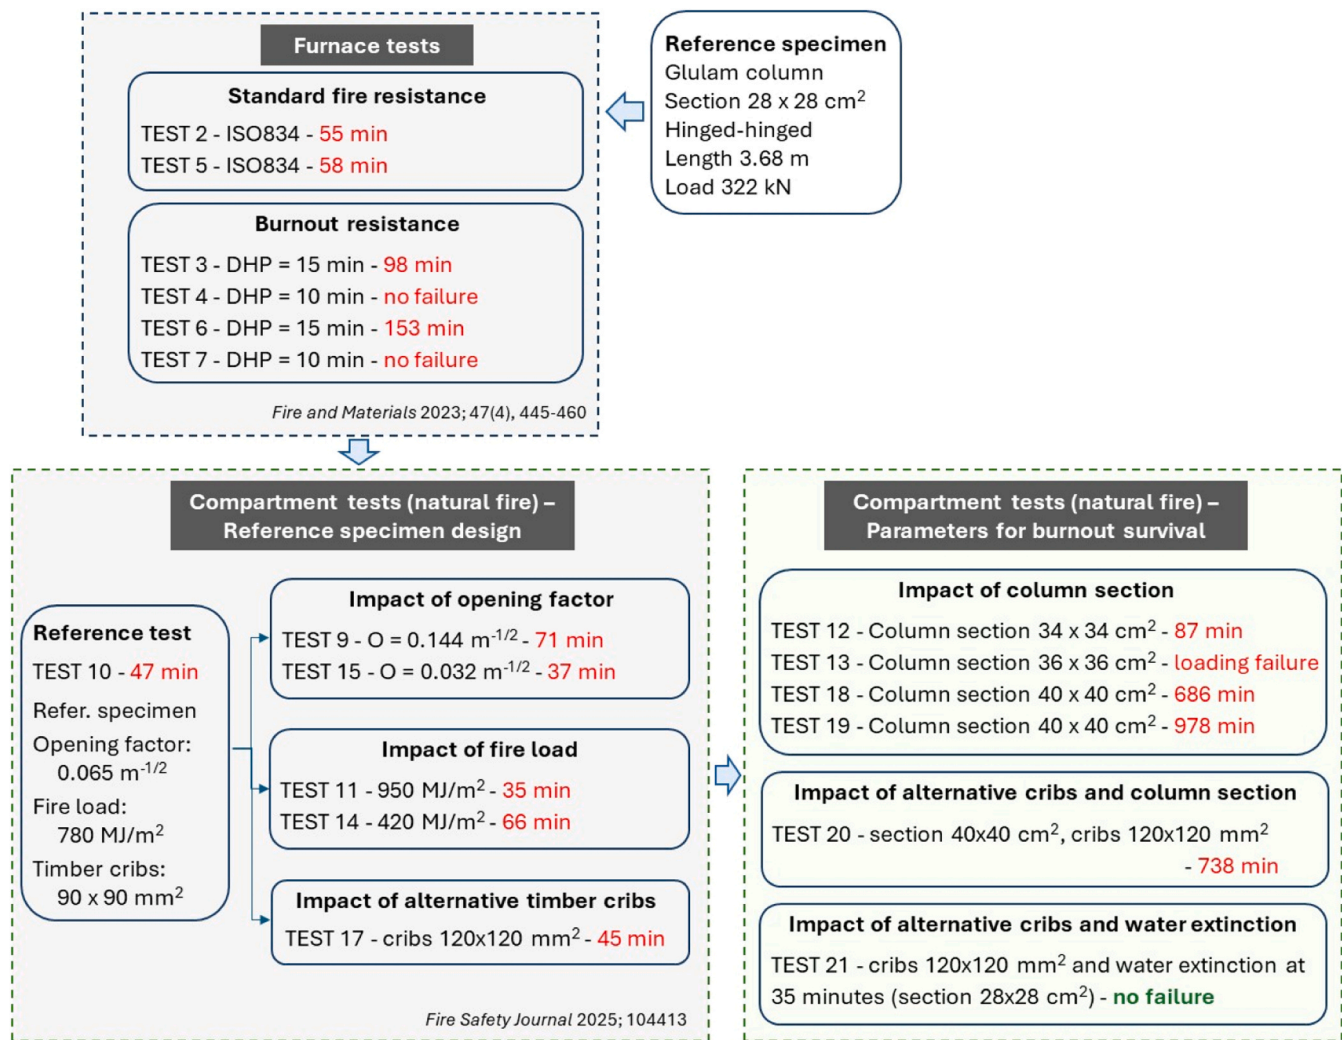
Fig. 6. Complete test program on glulam columns in fire (including data previously reported in [22,24]). The new tests, shown on the right, focus on columns with increased section or active suppression to investigate survival to burnout of natural fires.

The test program is summarized in Fig. 6. Test 10, described in a previous publication [24], serves as reference test for the program. Test 10 was conducted on a glulam column with a section of 280 × 280 mm², used a fire load $q = 780 \text{ MJ/m}^2$, opening factor $O = 0.065 \text{ m}^{1/2}$, and wood cribs made of 10 layers of 5 sticks of 90 × 90 × 1000 mm³ with 138 mm of clear distance between adjacent sticks. Test 12 is conducted on a column with section 340 × 340 mm². Test 13 uses a section of 360 × 360 mm². Tests 18, 19, and 20 use a section of 400 × 400 mm². Other than the section size, the test conditions used in Tests 12, 13, 18, and 19 are identical to those of the reference Test 10 [24]. Test 20 uses the same parameters except it uses an alternative wood sticks arrangement to maintain the fire load of 780 MJ/m² but modify the burning rate, i.e., wood cribs made of 5 layers of 5 sticks of 120 × 120 × 1000 mm³ spaced by 100 mm and an amount of heptane reduced to 3 liters. Test 19 is a replicate of Test 18 but on a specimen that did not contain any thermocouple inside the section. This was to eliminate the possible influence of the groove, thermocouple wires, and defect in the gluing plane of the two halves of the column required for installation of thermocouples. Finally, Test 21 focuses on the effect of water extinction. It uses a 280 × 280 mm² section, which is the same as in the previous

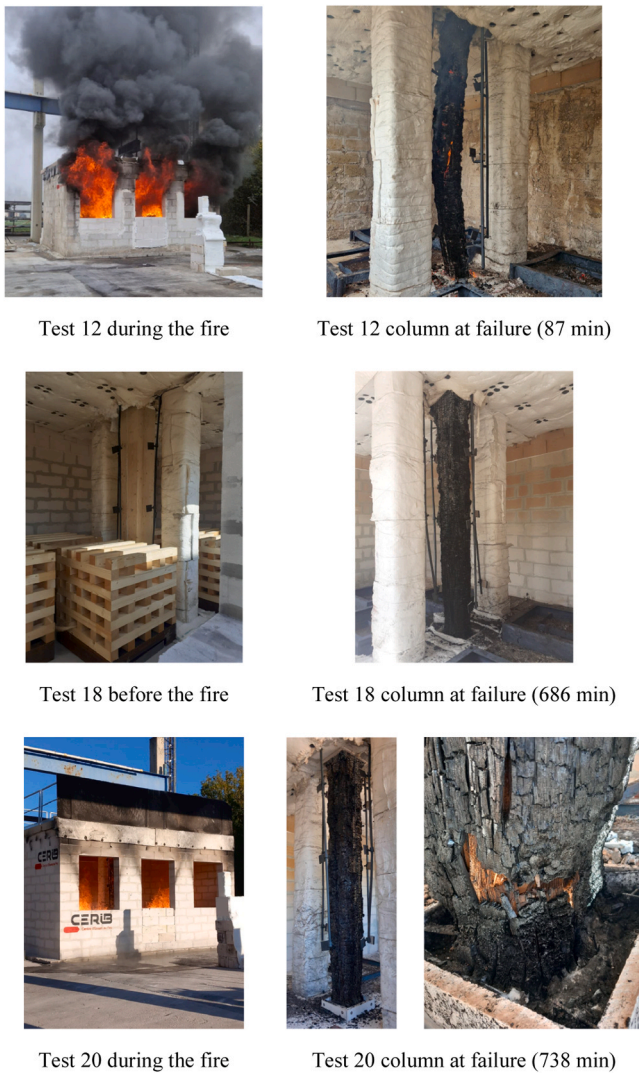
Fig. 8. Pictures of three of the compartment fire tests on glulam columns.

Test 13, localized continuous burning, due to the presence of an air gap at the top of the column, provoked an instability of the loading system at 98 min, so the test was inconclusive. In Tests 18, 19, and 20, conducted on the columns with 400 × 400 mm² section, failure occurred late in the decay phase, 11–16 h after ignition. Therefore, in the absence of fire suppression, the timber columns failed to survive the fire to full burnout. Pictures of the experiments are provided in Fig. 8.

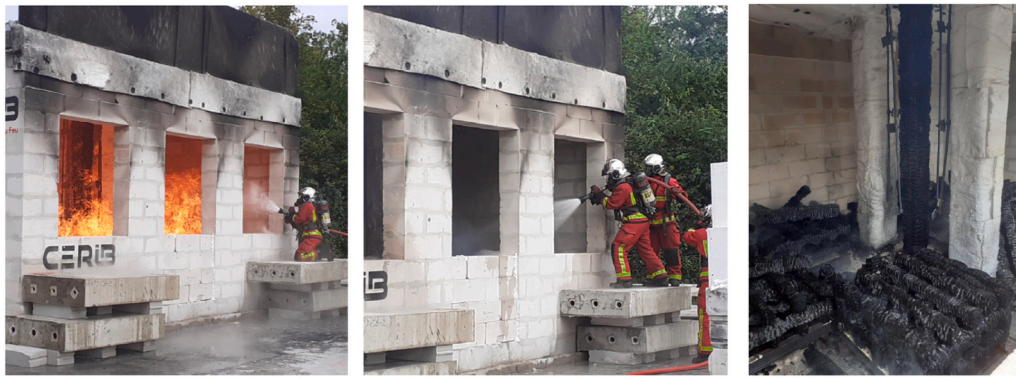
Fig. 15. Extinction at 35 min in Test 21.

Test 21 served to investigate the effect of firefighter intervention (water extinction), see Fig. 15. The tested column had a cross-section of $280 \times 280 \text{ mm}^2$, and the firefighter intervention started 35 min after ignition. At this time, firefighters sprayed water in the compartment from the outside with a water hose to extinguish the wood cribs and reduce the temperatures in the compartment, then sprayed the column and finally entered in the compartment to scratch the charred layers away from the column. The amount of water used in the intervention was roughly 1 m^3 . The column maintained its stability until the full cooling with no failure.
