# Structural behavior of timber columns in wood crib compartment fire tests

## ABSTRACT

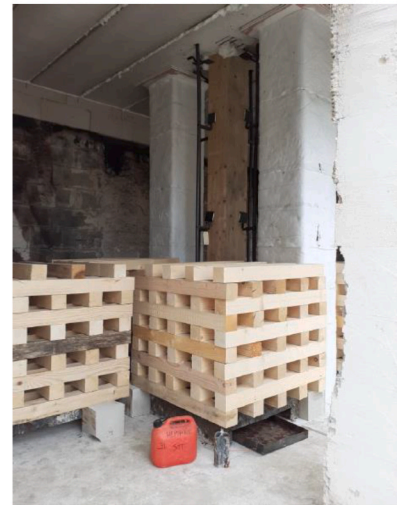
(b) Wood crib (780 MJ/m<sup>2</sup>)

The wood cribs used for the fire load were made of 10 layers of 5 sticks of  $90 \times 90 \times 1000 \text{ mm}^3$  with 138 mm of clear distance between adjacent sticks. The amount of wood was adjusted in each test, taking into account wood density and moisture content, to generate the desired fire load density, with a value of  $780 \text{ MJ/m}^2$  in the reference case, see Fig. 2(b) and Table 2. In addition, in Test 17, sticks with different thickness and arrangement were used to generate another fire development (the aim was to reduce the initial fire power and to obtain temperatures nearer from the temperatures of the ISO curve). The wood cribs were changed to 5 layers of 5 sticks of  $120 \times 120 \times 1000 \text{ mm}^3$  spaced by 100 mm. This maintained the fire load constant but modified the burning rate of the fire [24,25]. In each test, the wood cribs were ignited simultaneously by heptane, with the aim to reach the fully developed phase of the fire (i.e., post-flashover) as quickly as possible. The quantity of heptane used in the initial phase of the fire was 18 L in all tests except for Test 17 for which it was 3 L. Fig. 2(c) and (d) show the fire development in Test 9 and 10, respectively. The two experiments

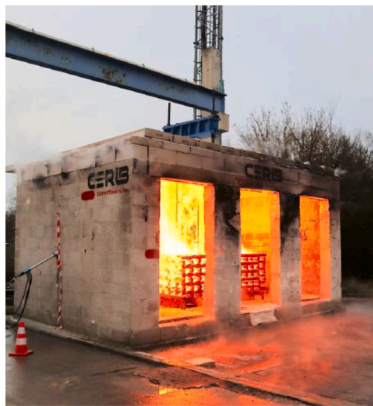
(c) Test 9,  $O = 0.140 \text{ m}^{1/2}$

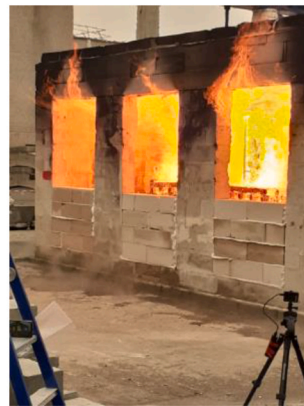
(d) Test 10,  $O = 0.065 \text{ m}^{1/2}$

differ by the size of the openings.

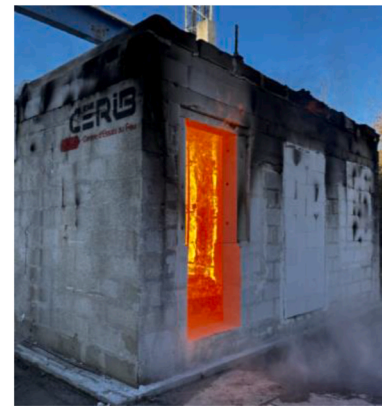
(e) Test 15,  $O = 0.032 \text{ m}^{1/2}$

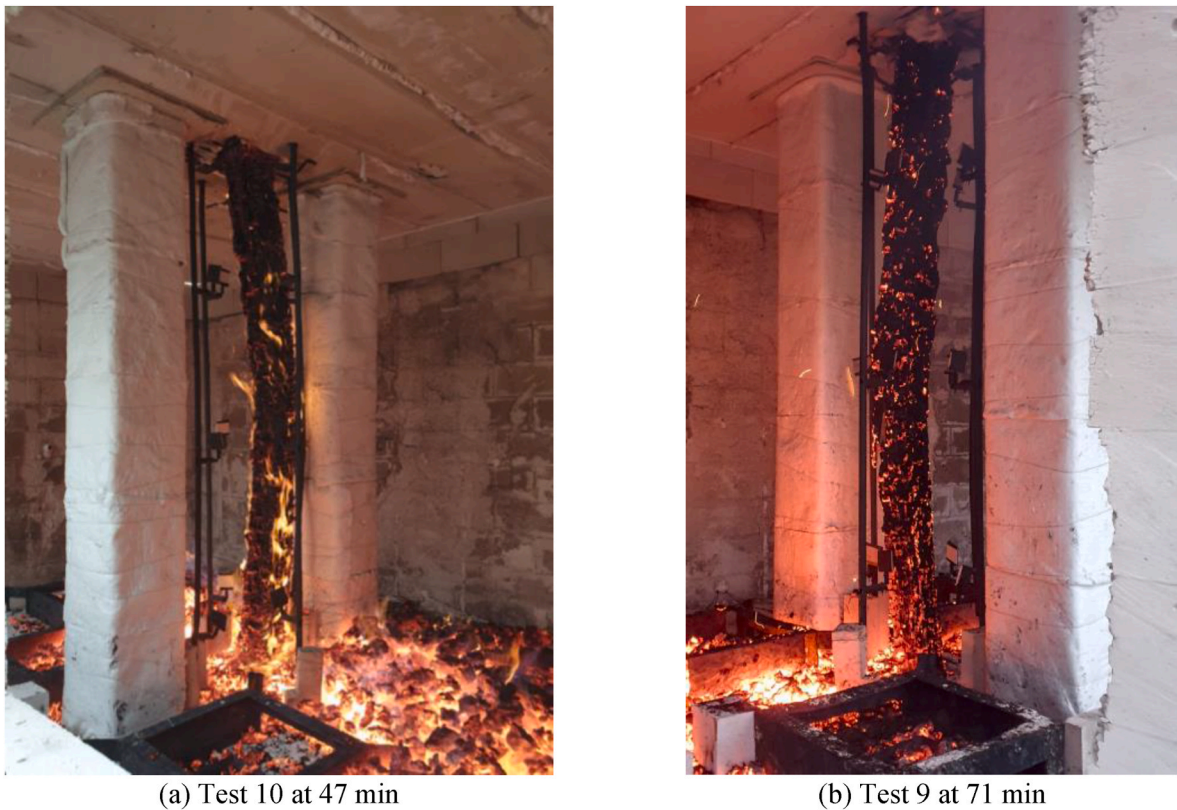
Fig. 5. Timber columns at the time of failure.

The column is shown at the time of failure in Fig. 5(a). The wood crib had been consumed. Flaming combustion reappeared along the column

In Test 9, the column failed after 71 min when the temperatures in the compartment had cooled down to the range 200–300 °C. The column at failure is shown in Fig. 5(b).
