Disaster mitigation strategies for adobe houses: A case study of District Awaran, Balochistan, Pakistan

Mamoon U R Mengal, Waqas A Mahar

Department of Architecture, Balochistan University of Information Technology,
Engineering & Management Sciences (BUIITEMS) Quetta.
e-mail: mamoonmengal@gmail.com, architectwaqas@hotmail.com.

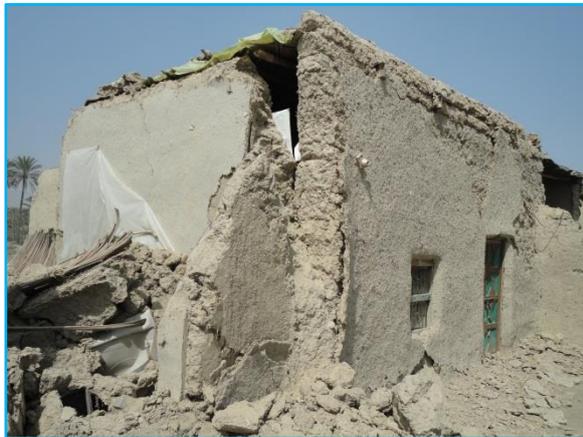
Figure 9(a). Mud-stack walls

For mud stack walls, wheat husk and animal dung are usually mixed with the mud in order to strengthen the mud, figure 9(a). The foundations are normally laid 1-2 ft. in the ground (30.4-61 cm) with the same mud-stacks but slightly wider than the actual wall. No stiffeners are used anywhere in the wall in horizontal as well as vertical directions. Wooden lintels are sometimes provided on the top of windows and doors in isolation, which have little affect towards strengthening the wall. Whereas the bricks are made from a mixture mainly consist of mud but, small stones with organic materials like weeds and reeds are also used to strengthen the brick. The brick size was, 4"x6"x12" (10.1x15.2x30.4 cm) constant throughout the district. A steel mould is used for this purpose which is open from top and bottom. Moulded bricks are left on the open ground to get dry. The foundations are normally laid 1-2 ft. (30.4-61 cm) in the ground constructed of the same bricks as used in the walls. Foundations with stone boulders were also seen at some locations. No stiffeners are used in brick walls which is similar to the mud stack walls, figure 9(b). Moreover, wooden lintels are also placed on top of the doors and windows, which does not strengthen the walls.

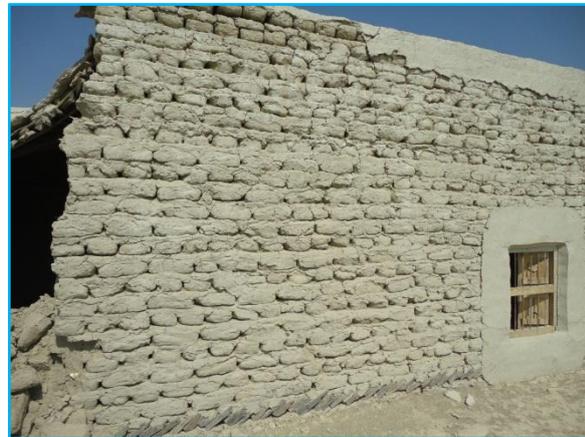
Figure 9(b). Mud-brick walls

Walls were constructed of mud stack in the northern parts of Awaran which changes to the south where stone boulders are being used for the construction of walls. The use of mud-brick is generally more common in the whole region. For mud walls, the wall thickness is constant as well, which was 18" (45.7 cm) for all the houses.

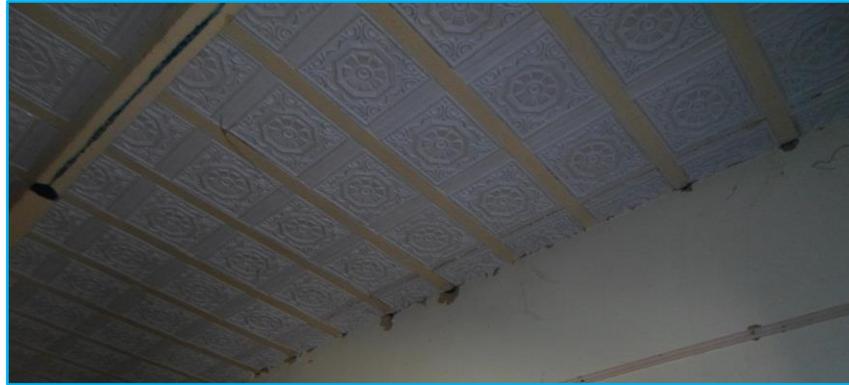
Figure 10(a). T-Iron and girder roofs with terracotta tiles

Figure 10(a) shows the roof constructed of t-iron and girders which is also called tiled roof because of the use of terracotta roof tiles. In this type of roof t-shaped steel sections are placed over the I-shaped steel girders and terracotta tiles are placed on the T-shaped iron bars. The terracotta tile used for this purpose was of the size 12”x12” (30.4x30.4 cm) with a thickness of 1.5” (3.8 cm). A plastic sheet is usually placed on the top to insulate the roof against rainwater then the screed of mud mortar is spread

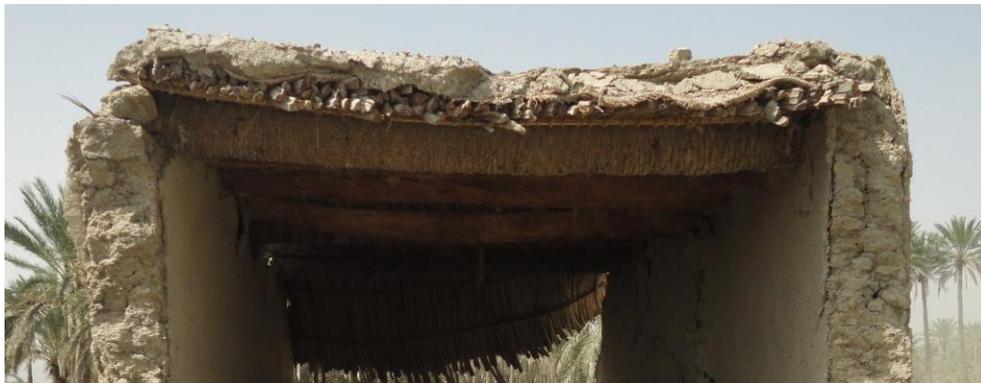
Figure 10(b). Roof made of Date-Palm joists and Date-Palm branches serving as purlins

Date palm roofs as shown in the figure 10(b) are very common in most of the houses, since the date palm is locally available in the region. According to local tale, the date palm is termite proof if cut in the winter season. The roof consists the joists made from date palm tree trunk. The use of steel girder and telephone line poles was also seen in some houses. The joists or girders are placed directly on top of the walls without using lintel band or ring beam. A net made of date palm branches is commonly used on the top of joists or girders. A mat is placed on the date palm branches then a plastic sheet for insulation against water. At the top, finally a layer of mud mortar is laid for the insulation against heat.
