SDSS 2022  
The International Colloquium on Stability  
and Ductility of Steel Structures  
14-16 September, University of Aveiro, Portugal

# Technical Study of Kongo-Central Colonial Steel Houses Belonging to the DRC Patrimony

Aris Mpemba Nkole Kabongo<sup>1</sup>, Jean-Pierre Jaspart, Jean-François Demonceau

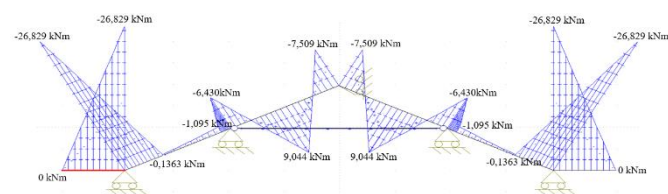
Through the performed analyses, it is demonstrated that, when the presence of the decorative haunches (see Figure 4) is not accounted for, the cantilever parts of the truss members, with large spans compared to the geometry of the members (see the static scheme in Figure 5), generate excessive internal forces at the level of the end supports of these members, as illustrated through the moment diagram in Figure 5 below obtained through a first order linear analysis.

Figure 5 : bending moment ( $M_{Ed}$ ) diagram, at ULS, in one of the beams of the courthouse roof when the presence of the decorative haunches is not considered

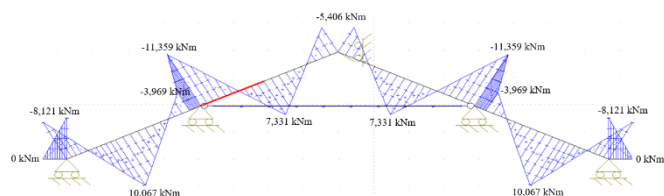
Considering the presence of these decorative haunches, it is found that reasonable internal forces (see Figure 6) satisfying the strength and stability criteria of EN1993-1-1 [11] are obtained which demonstrates that the structural role of these decorative haunches is crucial for the resistance and stability of these roof beams.

Figure 6: bending moment (MEd) diagram, at ULS, in the same beam and under the same load combination as in Figure 5 when considering the presence of decorative haunches

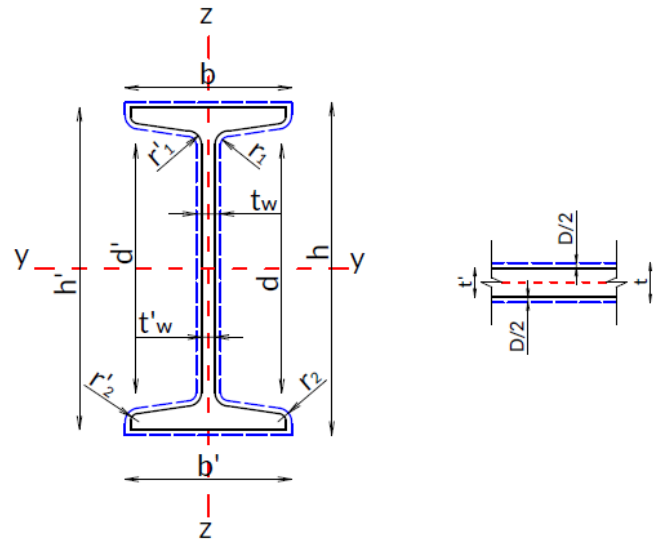
Figure 13: illustration of the evolution of the I-profile cross-section under corrosion (in blue: initial cross-section; in black: corroded cross-section)
