2-3D dynamic numerical modelling of seismically induced rock slope failures

Hans-Balder Havenith, Anne-Sophie Mreyen, Emilie Lemaire

Liege University, Belgium - HB.Havenith@uliege.be

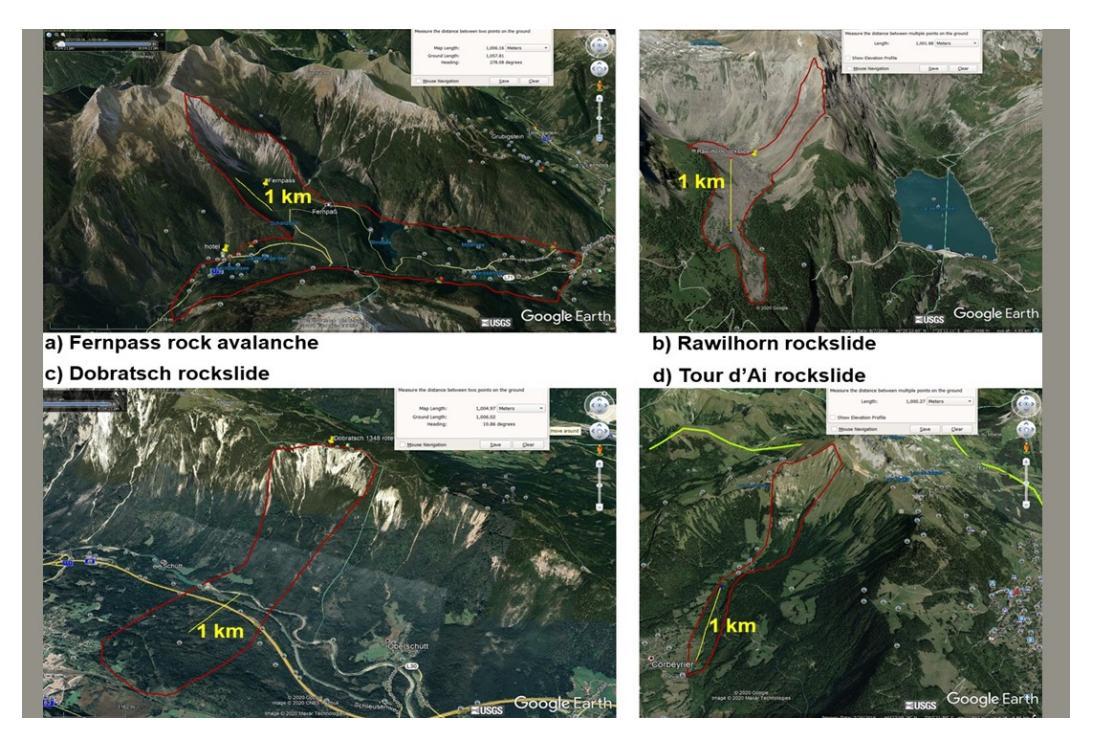
Figure 2 : Rockslides in the Alps with possible/proved seismic origin.

Rockslides were studied in the Alps and Carpathian Mountains (Figures 2 and 3). There is a long record of landslide disasters in historical and recent times in the European Alps, but there are only a few documented cases of larger rockslides triggered by earthquakes (see e.g. cases in Switzerland described by Fritsche et al., 2012, some shown in Figure 2). For instance, in 1348, six landslides (with volumes of 1, 3.5, 8, 15, 20, and 100 mio m³) were triggered in the Dobratsch Mountain (Lenhardt, 2007; Figure 1) by an earthquake in the Friuli region (northern Italy; Prager et al., 2008).

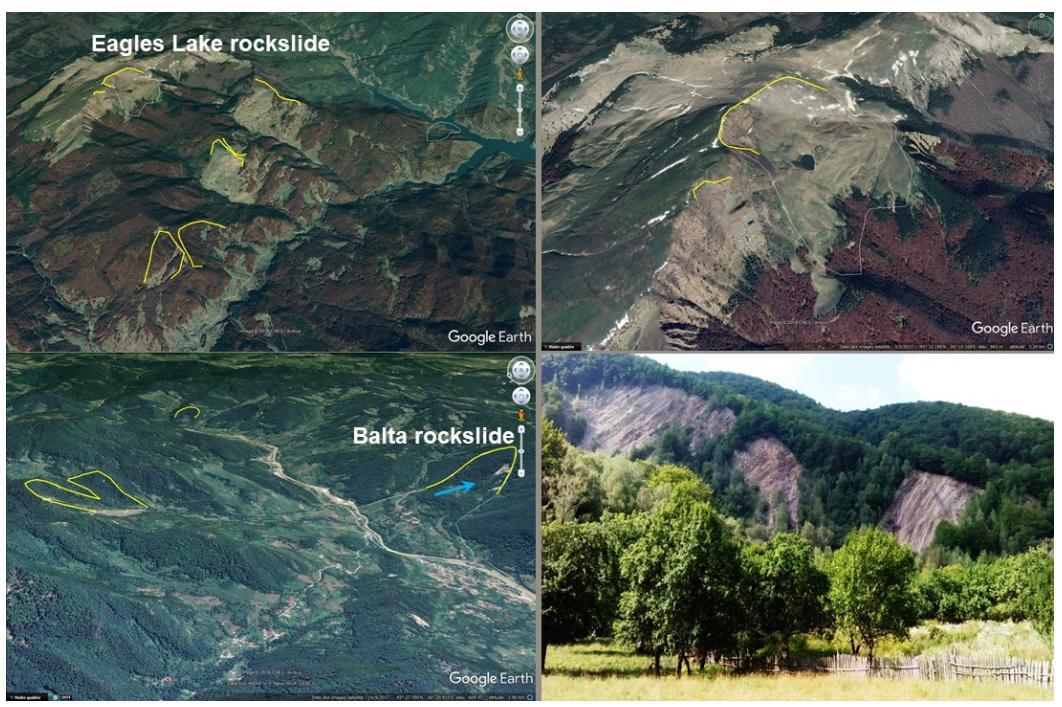
Figure 3 : Rockslides in the Carpathian Mountains with likely seismic origin.

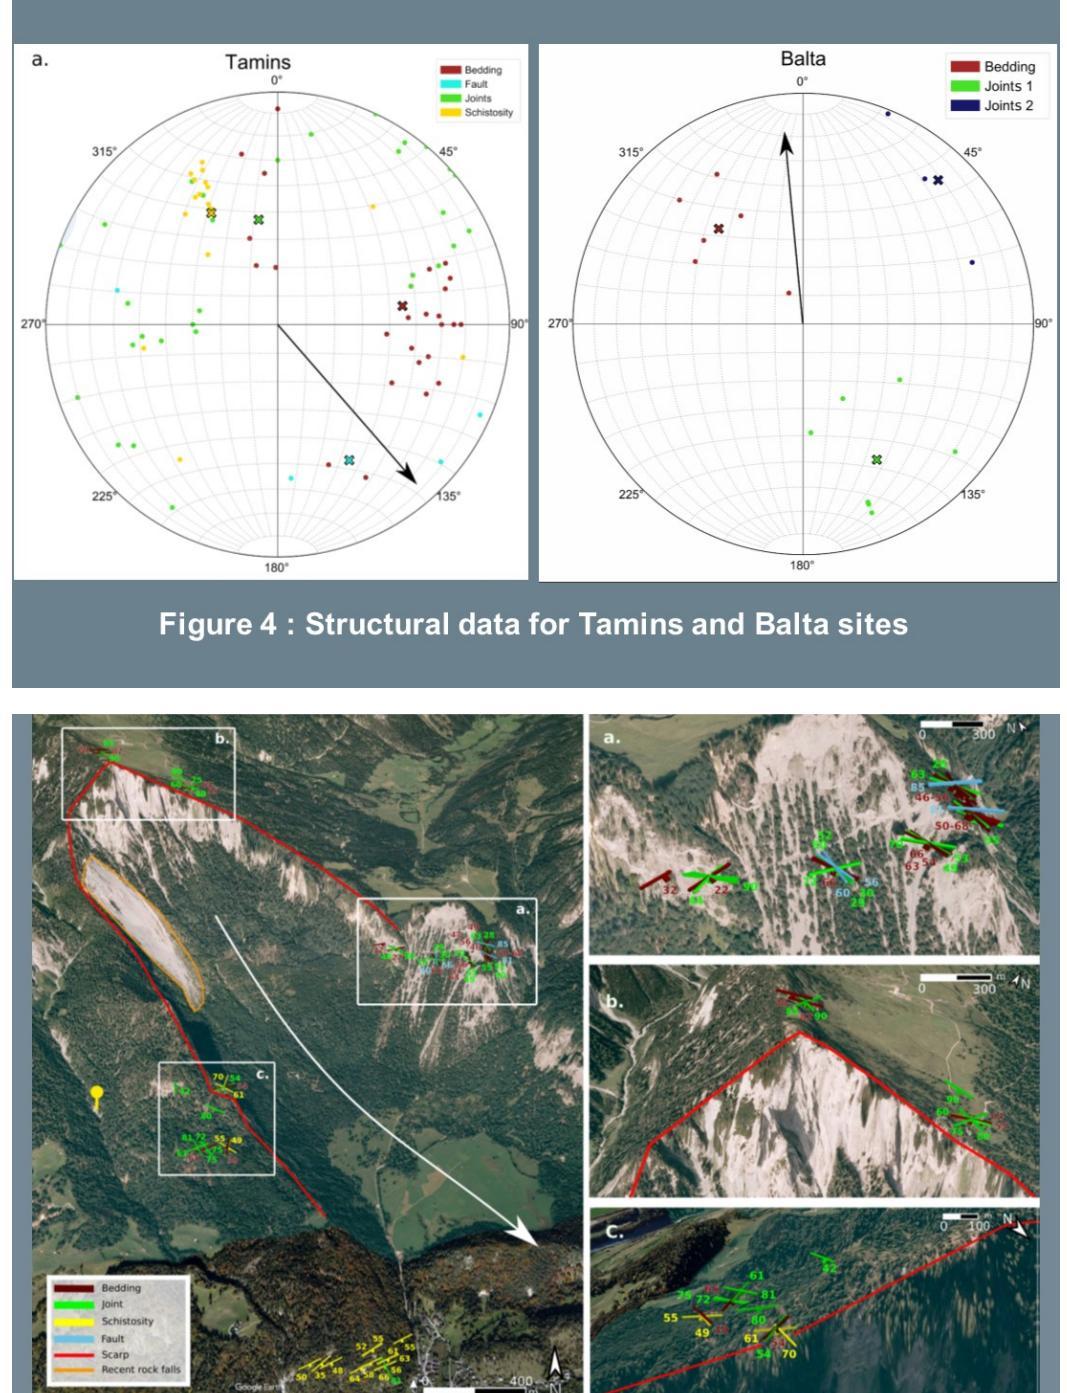
Figure 5 : Representation of the structural data within a 3D surface model (with imagery) of Tamins

Below structural models of the Tamins and Balta rockslide sites are shown. Figure 4 presents the structural data collected in the field. The following figures present plots of the main structural planes within surface models of the Tamins and Balta (partly also for Eagles Lake) sites.

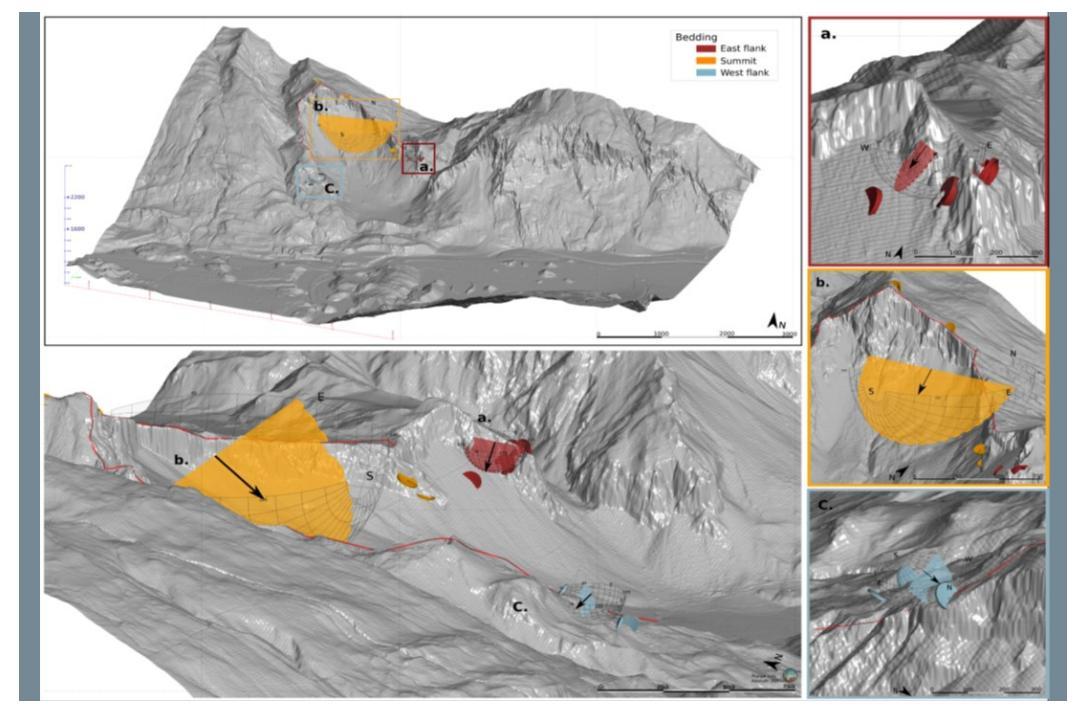
Figure 6 : Representation of the structural data within a 3D surface model (hillshade) of Tamins

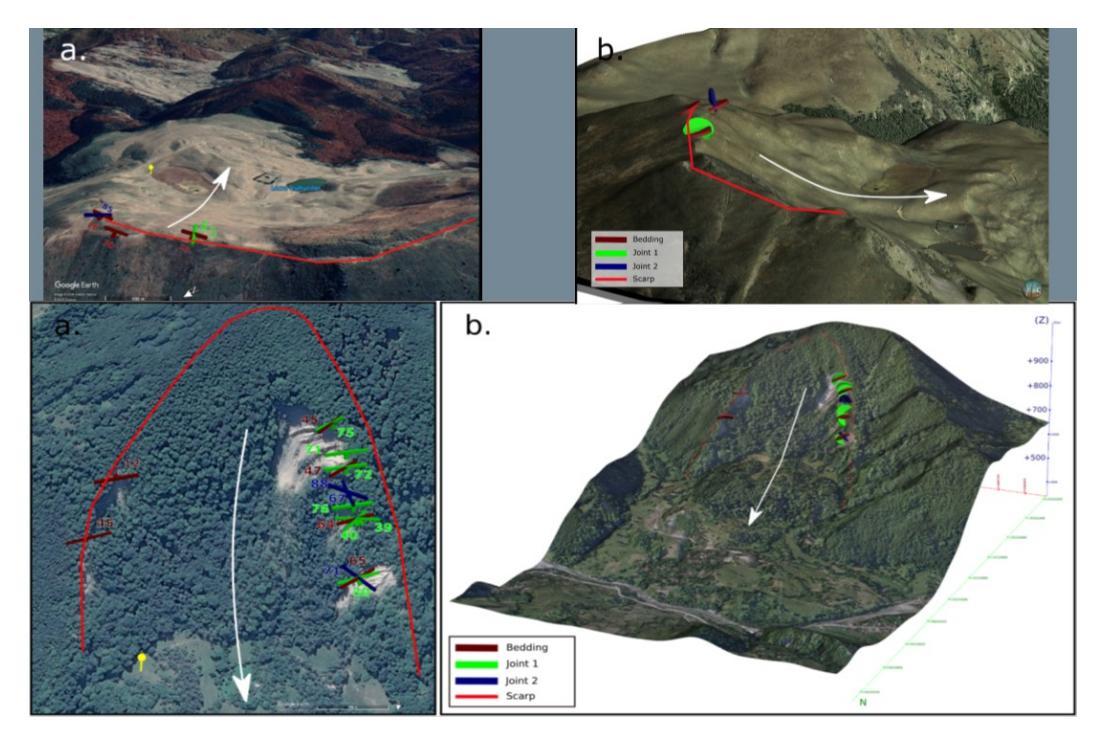
Figure 7 : Representation of the structural data within a 3D surface model (with imagery) of Eagles Lake (above) and Balta below

The Balta rockslide in Romania is the prime example of an ancient, massive slope failure whose origin is unknown but for which a seismic origin is very likely since that site is composed of an initially stable bedding structure, dipping into the slope with 35° to 50° , locally including very thick (>5 m) sandstone beds. Similar observations were made for the Eagle's Lake rockslide.

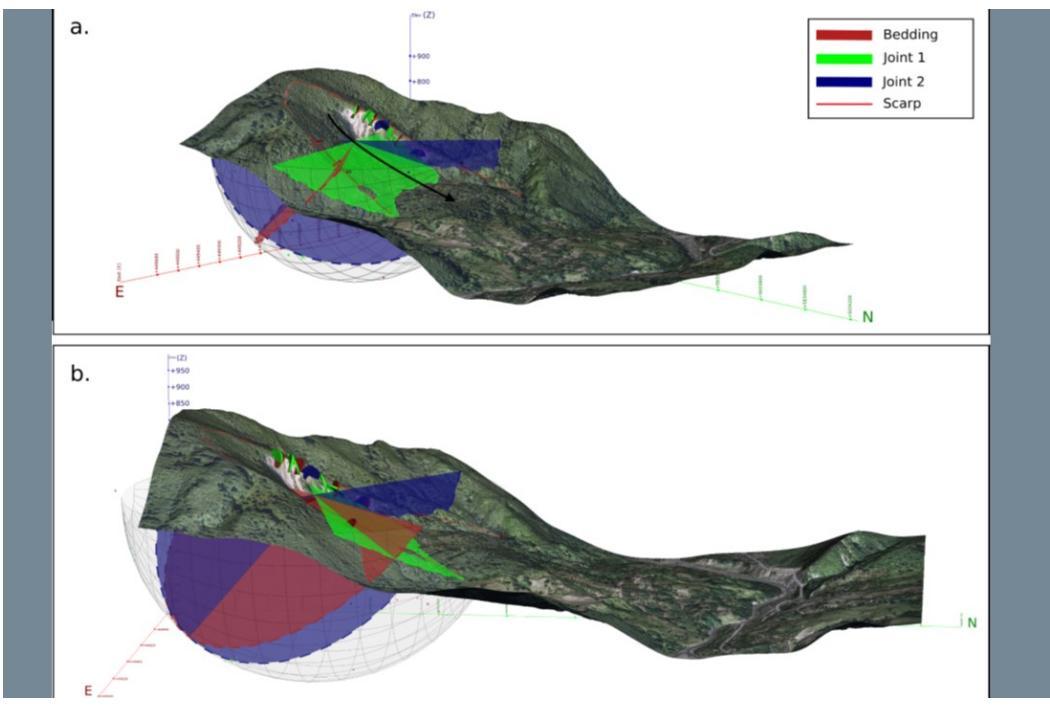
Figure 8 : Structural geomodel of Balta site

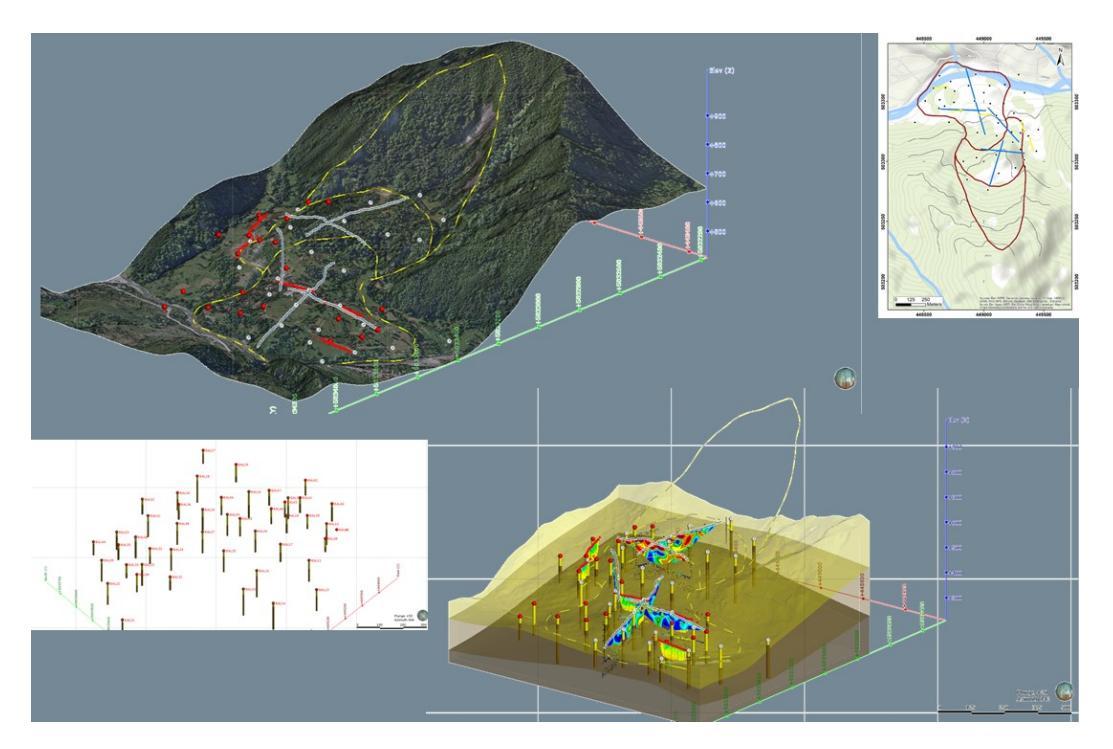
Figure 9: 3D geomodel of Balta including geophysical subsurface information

The last figures (9 and 10) shown below present a geomodel of Balta with geophysical subsurface information that was used to create a full 3D model of the rockslide site and to reconstruct the original site before failure for back-analysis.

For the Balta rockslide also a full 3D geomodel (based on geophysical data), and 2D and 3D numerical models were created. They confirm the relatively high static stability of the back-analysed (reconstructed) slope site - but massive failure could be simulated after introduction of an earthquake input (Friuli 1976 accelerogram, with PGA max of 0.2g) at the model basis and vertical upward propagation of the seismic shaking.

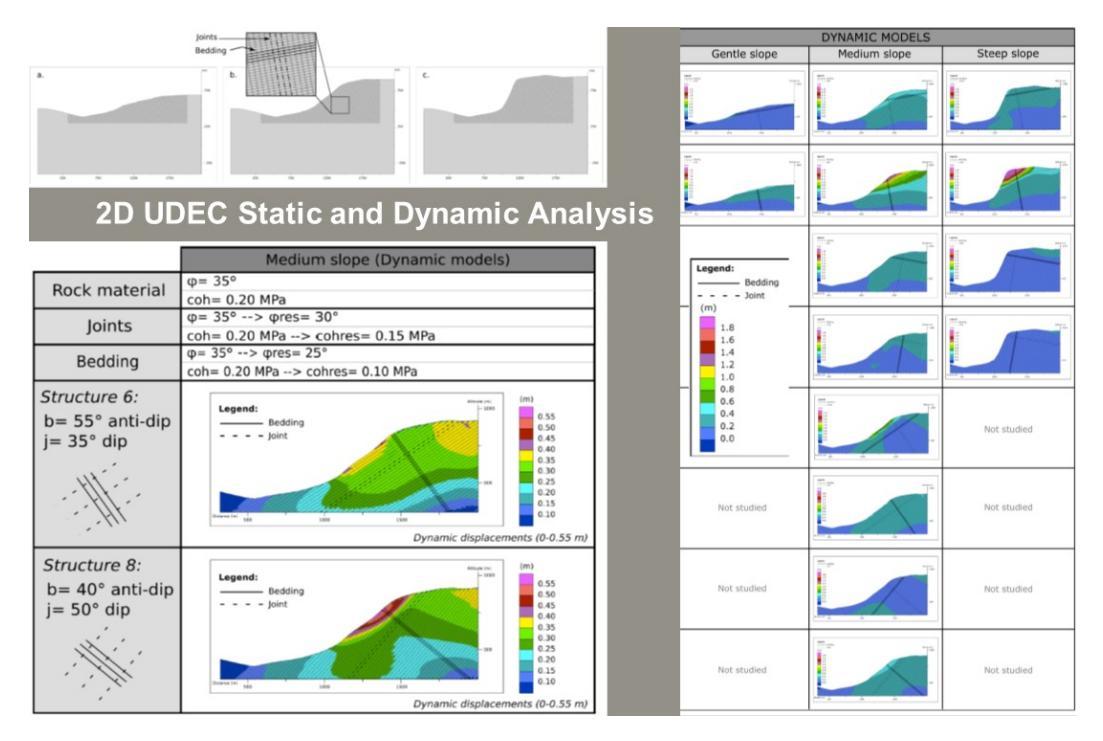
Figure 11 : 2D parametric numerical dynamic analysis based on the central reconstructed Balta slope section (published in Lemaire et al., 2020).

Below results of 2D and 3D numerical dynamic analyses completed with UDEC and 3DEC (Itasca software) are presented (Figures 11 and 12). As seismic inputs Ricker wavelets and earthquake accelerograms were used.

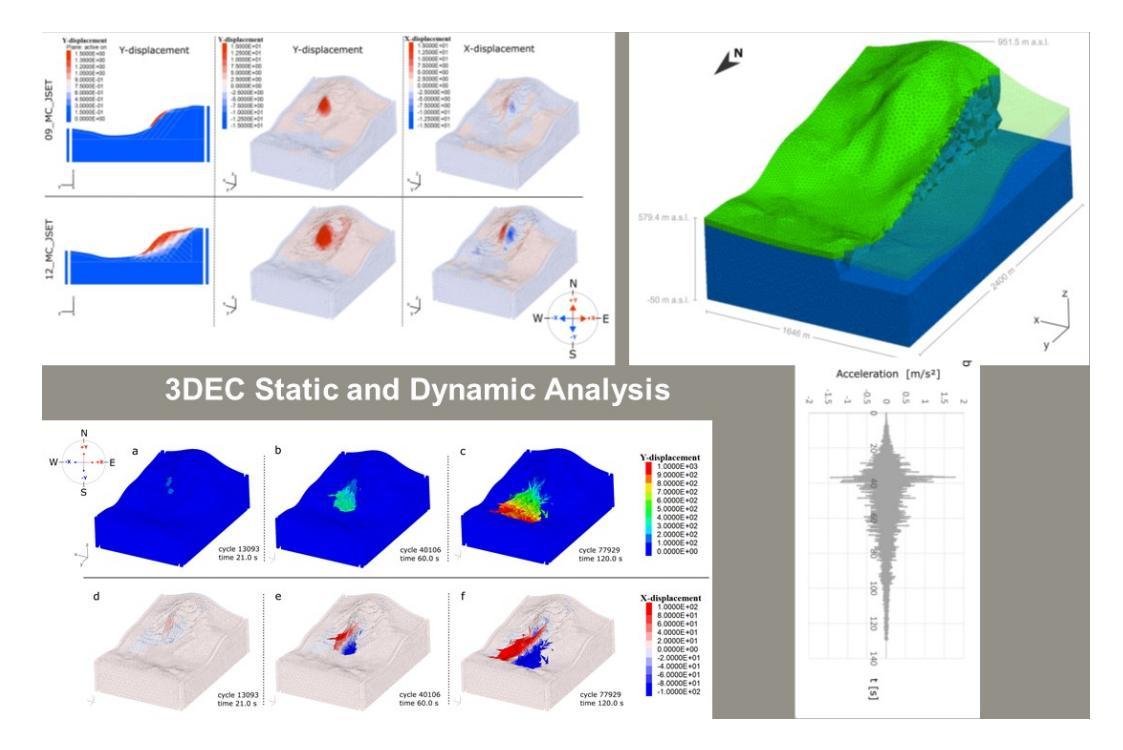
Figure 12 : 3D numerical dynamic analysis of the seismically induced response and failure of the reconstructed Balta slope site.
