# Formation, breaching and flood consequences of a landslide dam near Bujumbura, Burundi

**Abstract.** This paper investigates the possible formation of a landslide dam on the Kanyosha River near Bujumbura, the capital of Burundi, as well as the interplay between the breaching of this landslide dam and the flooding along the river. We present an end-to-end analysis, ranging from the origin of the landslide up to the computation of flood waves induced by the dam breaching. The study includes three main steps. First, the mass movement site was investigated with various geophysical methods that allowed us to build a general 3-D model and detailed 2-D sections of the landslide. Second, this model was used for dynamic landslide process modelling with the Universal Distinct Element Code. The results showed that a 15 m high landslide dam may form on the river. Finally, a 2-D hydraulic model was set up to find out the consequences of the breaching of the landslide dam on flooding along the river, especially in an urban area located downstream. Based on 2-D maps of maximum water depth, flow velocity and wave propagation time, the results highlight that neglecting the influence of such land

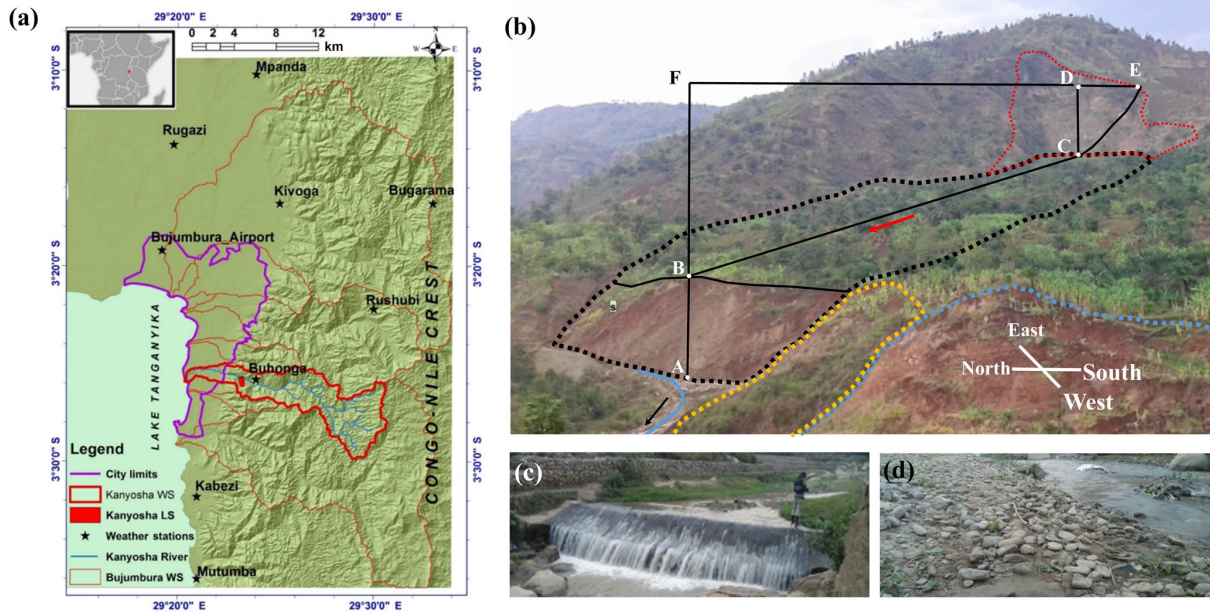
**Figure 1.** (a) Bujumbura region with indication of watersheds of the main rivers, the limits of the city and Lake Tanganyika. The watershed of the Kanyosha River is highlighted in the central part, with the river network inside. The weather stations in and around Bujumbura, the Kanyosha landslide (in the text called “Banana Tree Landslide”, also referred to as BTL, in red contours) and the Congo–Nile crest are also shown. “LS” and “WS” stand for “landslide” and “watershed”, respectively. (b) View of BTL (black dotted contour) and the main scarp (red dotted contour) as well as its lateral local instabilities (orange and light blue dotted contours). The landslide sliding direction and the river flow direction are indicated by the red and the black arrows, respectively. AB indicates the height (26 m) of the landslide frontal part near the river; BC outlines the BTL length in the sliding direction ( $\sim 750$  m); CD shows the height of the main scarp ( $\sim 75$  m) along profile points B–C–E. The blue line indicates the river channel axis. (c) Waterfall over a former flood control structure (located 270 m downstream of cross section 3 shown in Fig. 3). (d) View of the riverbed during the dry season with presence of cobbles and fine boulders that are deposited after floods during the wet season.

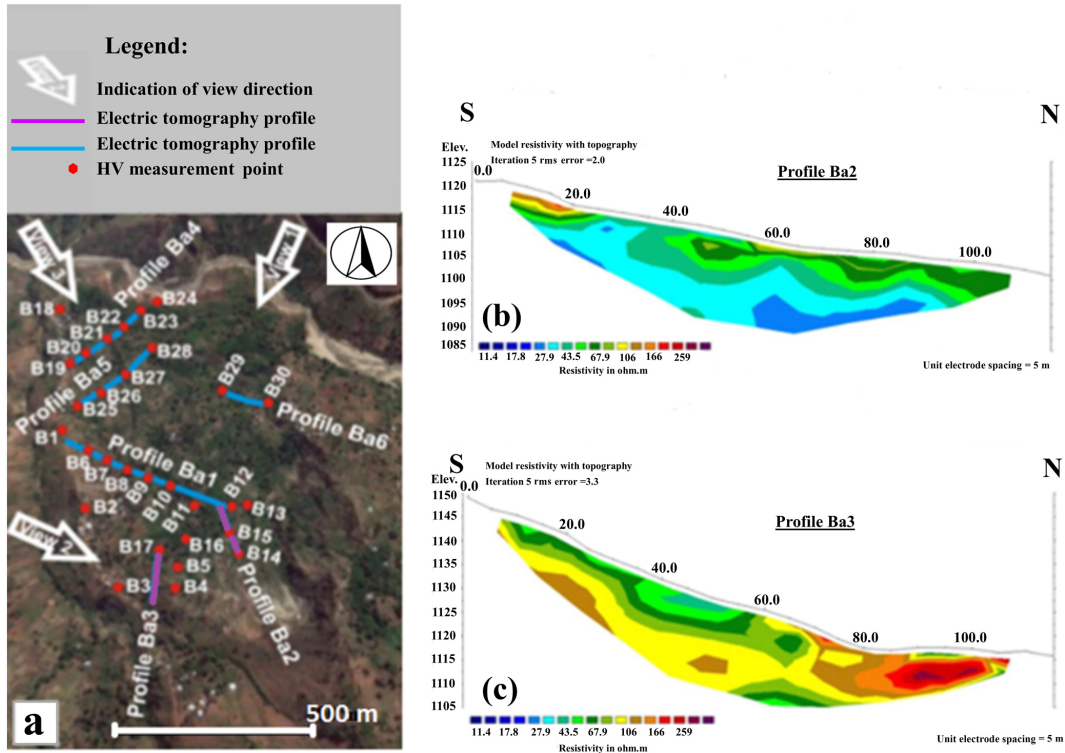
**Figure 5.** The Banana Tree Landslide field measurements: overview of ERT and HV measurement locations (a), ERT profiles Ba2 (b) and Ba3 (c). In panel (a), Ba2 and Ba3 profiles are highlighted in purple.

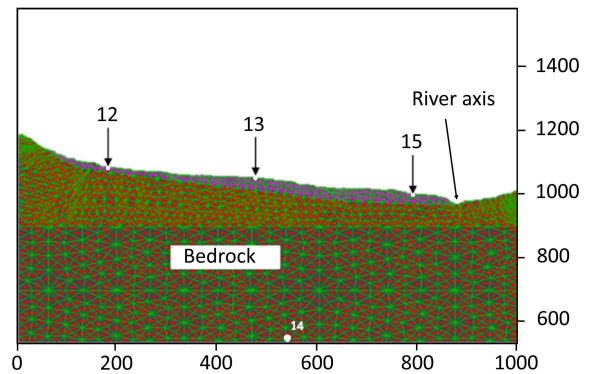
**Figure 7.** Materialization of blocks, joints and materials for the actual model. History (measurement) points 12, 13 and 15 (white dots) located, respectively, on the upper, middle and lower blocks correspond to the surface area where parameters were monitored (e.g. the  $x$  acceleration). Point 14 is located at the base of the model, within the bedrock. The axis of the Kanyosha River is located to the right of history point 15.

points 12, 13 and 15 in Fig. 7, which are located on the upper, middle and lower blocks, respectively). Cracks (joints) included between the blocks (that represent also main geomorphic and geophysical units observed in the field) allow for the simulation of a more flexible movement of the mass. The same material (material 1 in Table 1) was attributed to all landslide blocks. It corresponds to the average type of the material found within the landslide. The original material of BTL is a gneiss which, by weathering, is partially trans-

formed into a clay on the surface. The depth of the weathered layer is about 20 m. The study area experiences alternations between dry and rainy seasons. The long dry season (from June to September) is followed by the small rainy season (from October to December), then by the small dry season (during the months of January and February). The cycle ends with the strong rainy season from March to May, just before the return of the dry season. Since the photos in Fig. 2 were taken in October, the ground was relatively wet but not as wet as is usually the case in December and during the strong rainy season. Especially for the lower parts of the landslide, the humidity is never very low due to the recharge of the water table by the ponds of water located on the landslide. On the other hand, the groundwater recharge follows the dynamics of the seasons. In the context mentioned above, the action of the rainy season in the body of the landslide is quickly remarkable, due to the higher amounts of infiltrating water. Material 2 was attributed to the stable bedrock (Table 1 and Fig. 7).

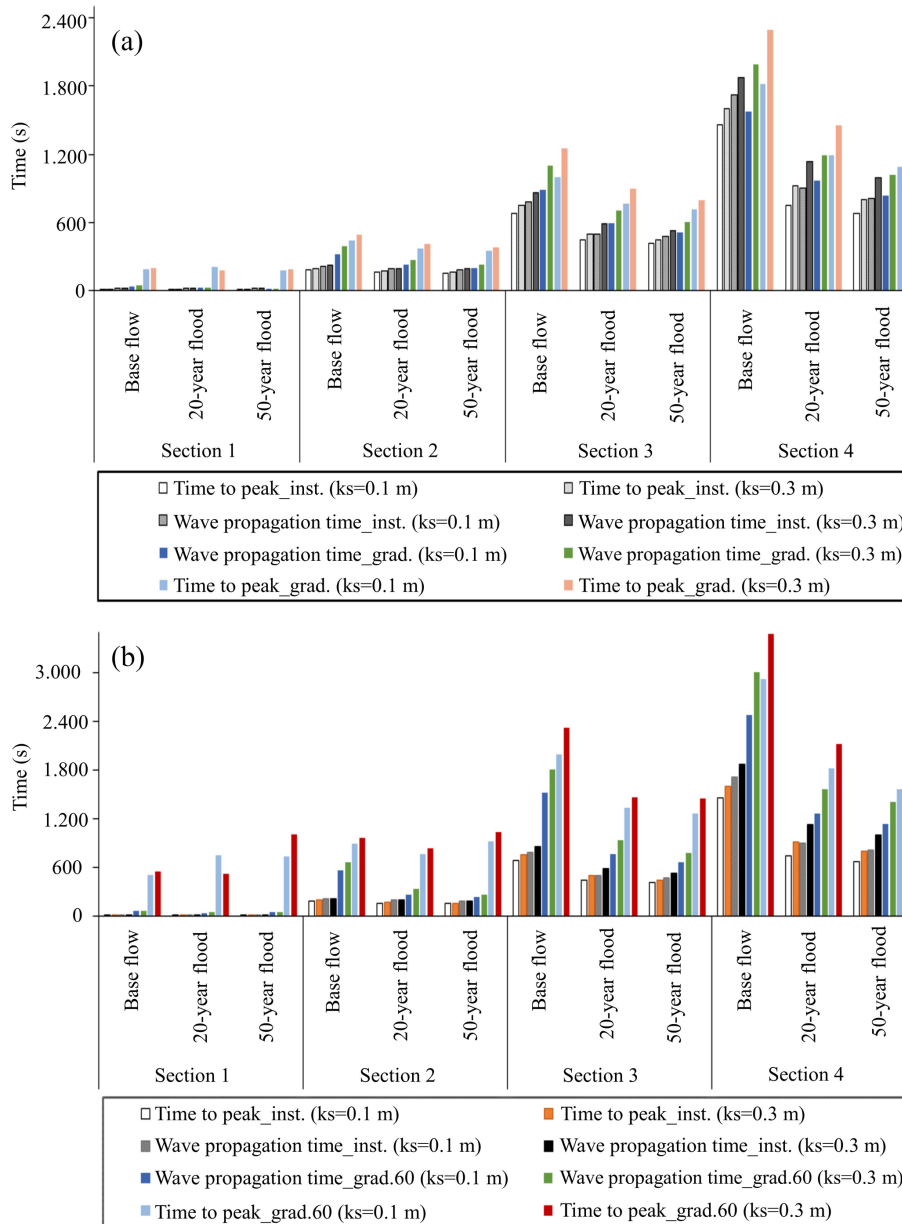
**Figure 14.** (a) Computed wave propagation time and time to peak in sections 1 to 4, for various pre-failure flow conditions (base flow, 20- and 50-year flood) and for two different roughness heights ( $k_s = 0.1$  m and  $k_s = 0.3$  m). The gradual failure time is 10 min. (b) Computed wave propagation time and time to peak in sections 1 to 4, for various pre-failure flow conditions (base flow, 20- and 50-year flood) and for two different roughness heights ( $k_s = 0.1$  m and  $k_s = 0.3$  m). The gradual failure time is 60 min.

Figure 14 displays the wave propagation time in sections 1 to 4, i.e. the time elapsed between the dam failure and the moment the flood wave reaches the corresponding section of the river. The time to peak, i.e. the time between the dam breaching and the arrival of the peak discharge in the corresponding river sections, is also displayed. Results are shown for two roughness heights,  $k_s = 0.1 \text{ m}$  and  $k_s = 0.3 \text{ m}$ .

Figure 14 shows also the diffusion of the flood wave as it propagates in the valley. While the difference between the wave arrival time and the time to peak is low in sections 1 and 2 (generally below 0.5 min), it reaches 1 to 2 min in section 3 and 2.5 to 4.5 min in section 4. This shows that the flood wave is considerably steeper in the upper part of the valley (sections 1 and 2). Also, the wave remains steeper when dam breaching occurs during a river flood than when it occurs during base flow.

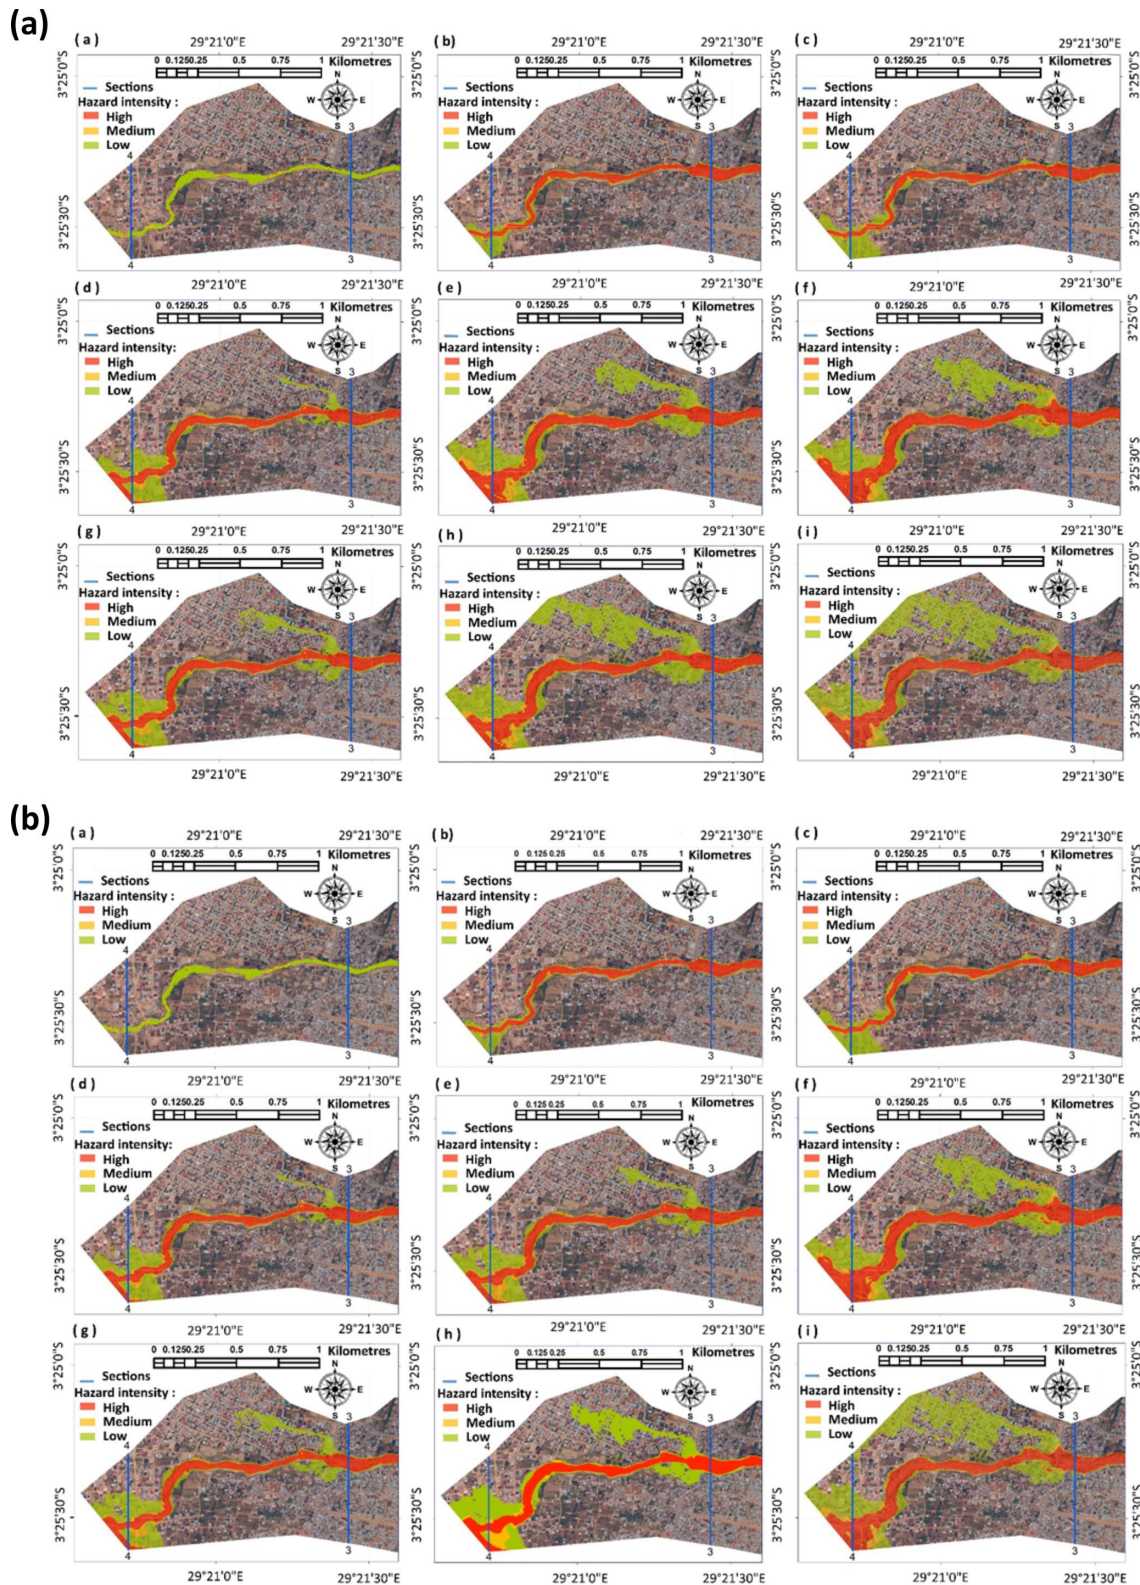
**Figure 15.** Flood intensity maps for various initial steady discharges and roughness: the first column (subfigures a, d, g) corresponds to the pre-failure scenarios, while the second (subfigures b, e, h) and third (subfigures c, f, i) columns relate to the gradual (a 10 min and b 60 min as breaching time) and instantaneous breaching. The first line (subfigures a, b, c) is based on the base flow and a roughness height of 0.1 m. The scenarios of the second line (subfigures d, e, f) are simulated using a 50-year flood and a roughness of 0.1 m. The third line (subfigures g, h, i) is similar to the second one but considers a roughness height of 0.3 m.
