Interruptions, Lunch Talks, and Support Circles: An Ethnography of Collective Repair in Steam Locomotive Restoration

Christophe Lejeune

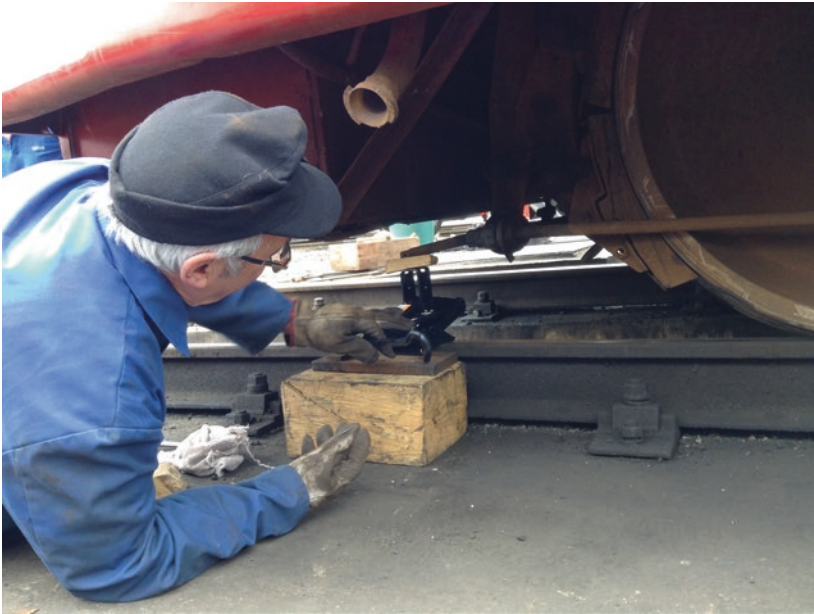
Fig. 8.1 Operating the car jack (© Photo: C. Lejeune)

The end of this threaded rod was slightly bent, probably because it came into contact with the rail when the railcar was derailed. The first repair would therefore involve the straightening of this metal rod. The method used was very instructive. One of the two members picked up an old tube that was lying around inside the locomotive shed. It was actually a steam locomotive tube, through which hot gases from the firebox would pass, before reaching the smoke box (the functioning of a steam locomotive will be described in detail below). This tube was used as a tool, in an attempt to straighten the brake linkage. Sliding the end of the brake linkage into one end of the tube meant that the volunteer had enough leverage to straighten the linkage with his bare hands.

However, this first attempt failed. In fact, as the linkage was relatively close to the bottom of the railcar body, the tube touched the bottom of the body and there was not enough space to straighten the threaded rod.

The volunteers stared at each other. “We need a car jack,” they said in unison. Ian asked me to get a few pieces of wood from a junk pile next to the roundhouse. Meanwhile, he went to look for a jack in his own car, which would normally be used to change a tire. As Fig. 8.1 shows, he positioned the jack on the rail thanks to a few pieces of wood and placed a small one between the top of the jack and the end of the threaded rod. Doing so, he grumbled, “I told them a dozen times that the shed should be provided with an industrial pneumatic jack.” He then turned the crank on the jack, in order to lift its end, which gradually straightened the threaded rod. While Ian was about to release the pressure on the crank, the two members then noticed the threaded rod was returning to its

initial bent position. They instantly diagnosed a “spring effect.” Without a word, Ian made an additional turn of jack handle to counter this tendency. The threaded rod had now returned to its rectilinear position in alignment with the entire linkage.

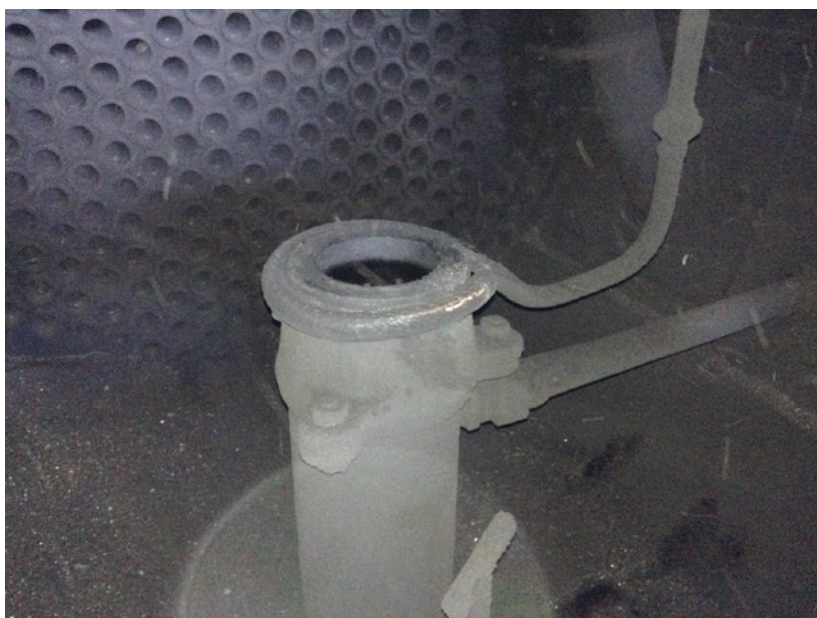
Fig. 8.3 Inspecting the blower (© Photo: C. Lejeune)

The smoke box is fitted with a blower. The latter consists of a pipe pierced with very small holes, through which the pressurized steam escapes. It causes the gases contained in the smoke box to be blown towards the top of the smoke box and directed towards the chimney. This device therefore makes it possible to regulate the draught.

Restoring or reassembling is not always possible. This repair differs from the two previous ones in that no incident or breakdown caused the problem. A diagnosis step was therefore needed. The blower did not suffer from deficient maintenance. It did not need to be restored. It had to be replaced. The need to replace may depend on the material. Pieces made

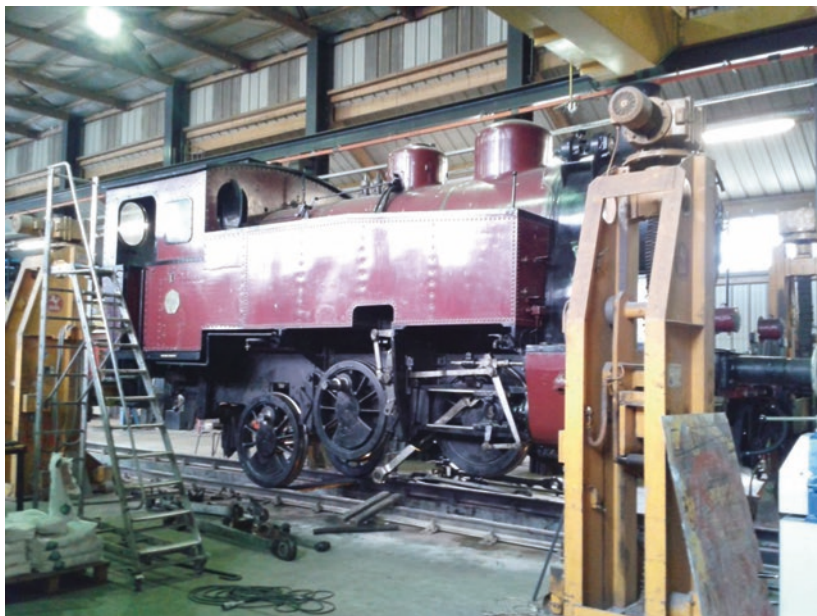
Fig. 8.4 Lifting the locomotive (© Photo: Serge Poncé)

As using this thick lubricant did not appear to produce the desired effect, the team decided that more serious steps needed to be taken with the locomotive. A couple of weeks before I started my fieldwork, the locomotive was therefore returned to the workshop. It was positioned over a pit and lifted (i.e., its wheels were no longer touching the rails) so that it was possible to work directly on the axle boxes. While explaining, Leo showed me some pictures on his smartphone. Another member, Serge, shot these pictures in the shop and published it on his blog (see Figs. 8.4 and 8.5).

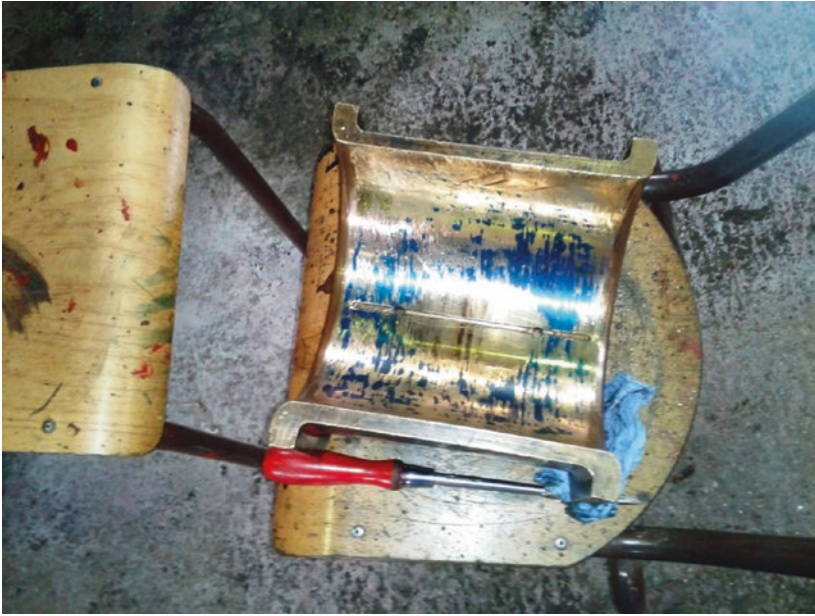
Ray commented on Fig. 8.5. Inside the boxes, the axle comes into contact with the rest of the chassis through a bearing. This bearing is a concave piece of bronze, whose bore is coated with an antimony

Fig. 8.5 Engineer's blue (© Photo: Serge Poncé)

alloy. In order to detect places affected by excessive friction between the axle and the bearing, the rear axle was smeared with some Engineer's blue paste. As expected, there were many blue marks. The first solution envisaged smoothing the concave part, which comes into contact with the axle. This antimony part was therefore machined, in an attempt to reduce the friction that was causing the axle box to overheat. Readers interested in (smaller) bearings are invited to read Tom Dant's chapter in this volume.

This third step, after using thick oil and polishing the bearing, produced the desired effect: the axle boxes became less overheated. The final solution was actually based on a different diagnosis from the two previous steps. Using a thick oil and polishing the bearing were based on a diagnosis that focused essentially on the question of friction or rubbing. On the other hand, insulating the ash pan was based on a diagnosis that pointed to the thermal bridge created between the firebox and axles. This does not mean that the only cause of the axles overheating was that identified by the final diagnosis. In fact, it is likely that the two effects—friction and thermal bridge—had combined to result in the hot box.
