CLINICAL ARTICLE

Orthodontic-assisted one step- no prep technique: A straightforward and minimally-invasive approach for localized tooth wear treatment using polymer-infiltrated ceramic network CAD-CAM prostheses

Amélie Karine Jacques Mainjot DDS, MS, PhD^{1,2}; Carole Charavet DDS, MS, PhD³

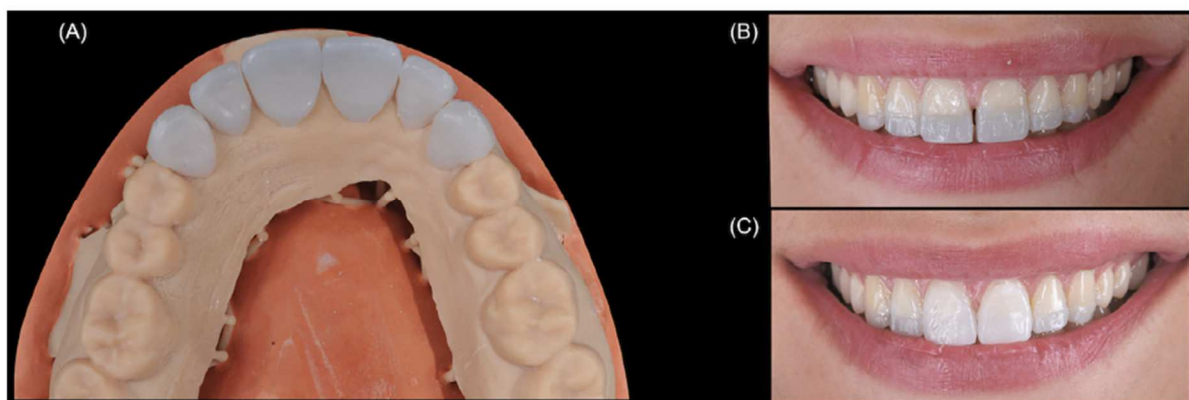
FIGURE 3 Case #1. A, A CAD-CAM anterior mock-up in wax on a printed model of the maxilla (Omniscam camera); B, Try-in using Vaseline of the first mock-up. It consists of palatal veneers, which do not close the diastema. C, Try-in of the second mock-up. Here, the diastema was closed, extending palatal veneers to the buccal surface of central incisors, providing the restoration an “envelope” design. On this basis, the patient decided to close the diastema

The digital smile analysis and wax-up (cases #3 and #4) were shown to the patient for approval. For case #1, two different CAD/CAM mock-ups were performed in wax and tried in to validate the esthetic result, particularly with respect to the diastema (Figure 3). Indeed, in one of the mock-ups, the diastema was closed by the extension of palatal veneers (partial-coverage restoration aiming to restore palatal and incisal tooth surfaces) to the buccal surface of the central incisors, providing the restoration an original design that the authors called “envelope” design (no-prep partial-coverage restoration, restoring palatal and buccal surfaces of an anterior tooth, without recovering proximal surfaces). On this basis, the patient decided to close the diastema.

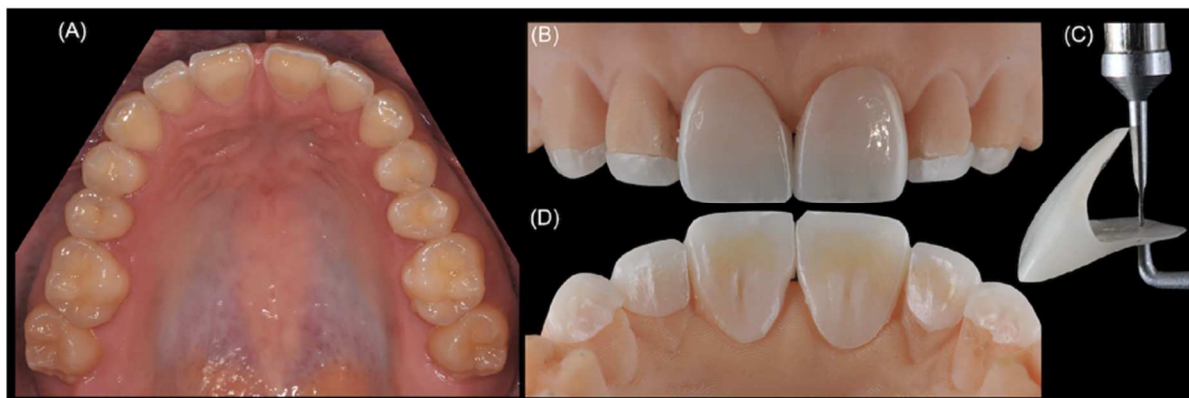
FIGURE 4 Case #1. A, Occlusal view of the maxillary anterior teeth before restoration placement: no tooth tissue preparation was performed (no prep, only sclerotic dentin is depolished with a diamond bur). B and C, PICN (Vita Enamic) palatal veneers (on laterals and canines) and “envelope” restorations (on centrals) on printed model after staining with Optiglaze. D. PICN “envelope” restoration for the central incisor. Dental technician: Jean-Michel Paulus, Liège

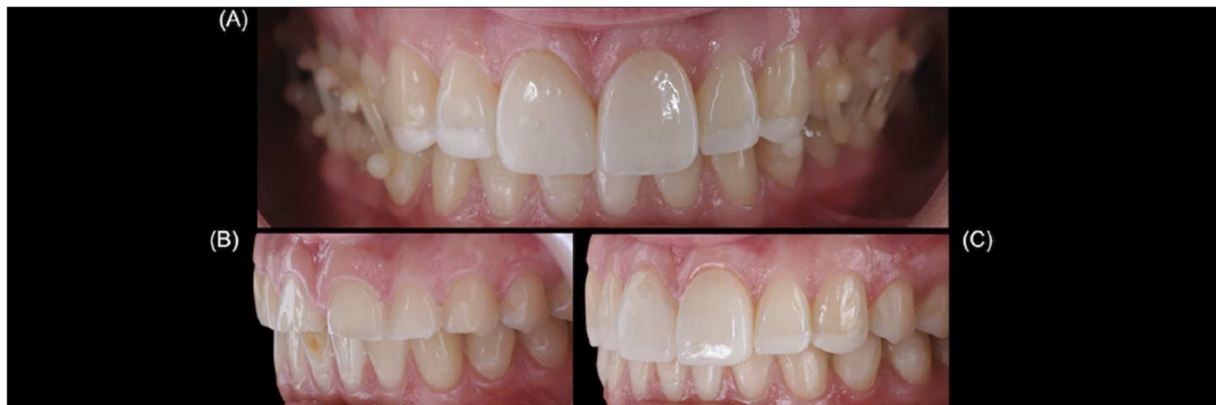
FIGURE 6 Case #1. A, Frontal view after restorations bonding and with lateral orthodontic system. Note that restorations shade was lighter since a bleaching procedure will be later performed (which is not possible when dentin is still exposed). B and C, Lateral views before and after restorations bonding and orthodontic treatment, respectively

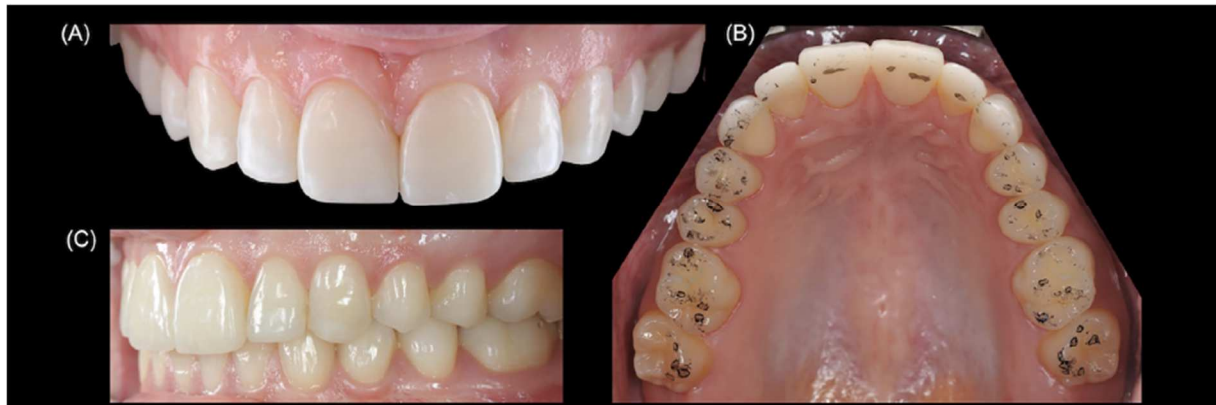
FIGURE 8 Case #1. A, Frontal view after bleaching and masking of the junction between buccal surfaces and palatal veneers with direct composite. B, Occlusal view at the end of treatment, showing proper occlusal contacts everywhere. C, Lateral view at the end of treatment

Therefore, the overall orthodontic treatment time was 64 days (34 and 30 days for active and retention phases, respectively) with a final equilibrated occlusion obtained (Figure 8C).

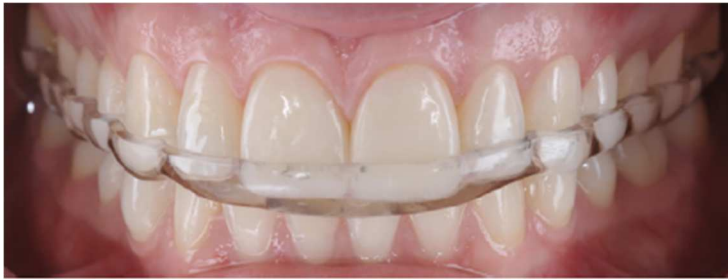
FIGURE 11 Case #1. Acrylic occlusal splint

A bleaching procedure was performed (which was not possible when dentin was still exposed). To mask the labial finish line of palatal veneers of maxillary anterior teeth, direct composite was added on a slight chamfer made across the finish line and where needed to optimize tooth shape (Figures 7, 8, and 15). In case #4, the palatal veneers were designed and bonded after the orthodontic treatment and alignment of the maxillary anterior teeth (Figure 23). Finally, an acrylic occlusal splint (for the maxillary anterior teeth) was made for all patients (Figure 11).

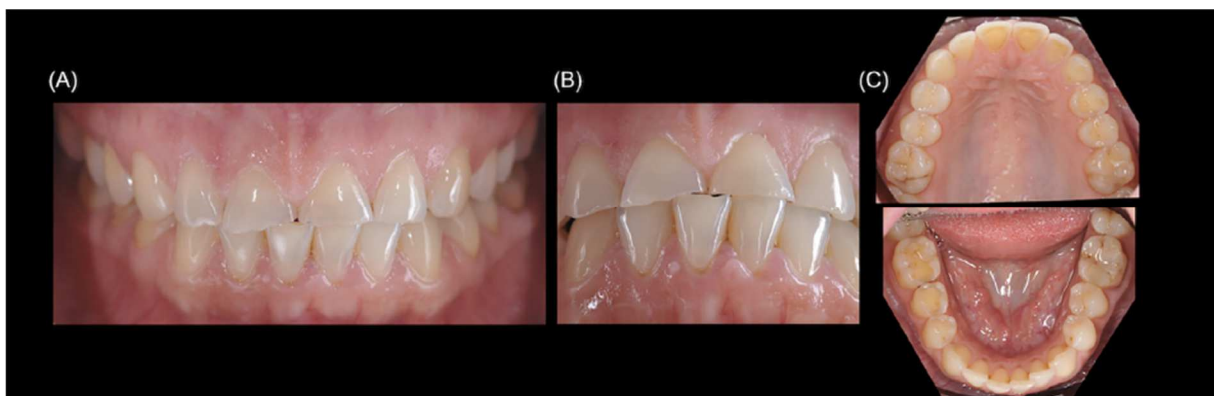
FIGURE 12 Case #2, a 32-year-old female patient. A and B, Frontal views before treatment showing severely worn maxillary anterior teeth and end-to-end occlusion with absence of interocclusal space to place restorations. C. Occlusal views showing localized severe tooth wear on the maxillary anterior teeth but also moderate tooth wear (dentin exposed) on teeth #29 and #30. Slight tooth wear is also present on mandibular incisors but it was decided to not treat it

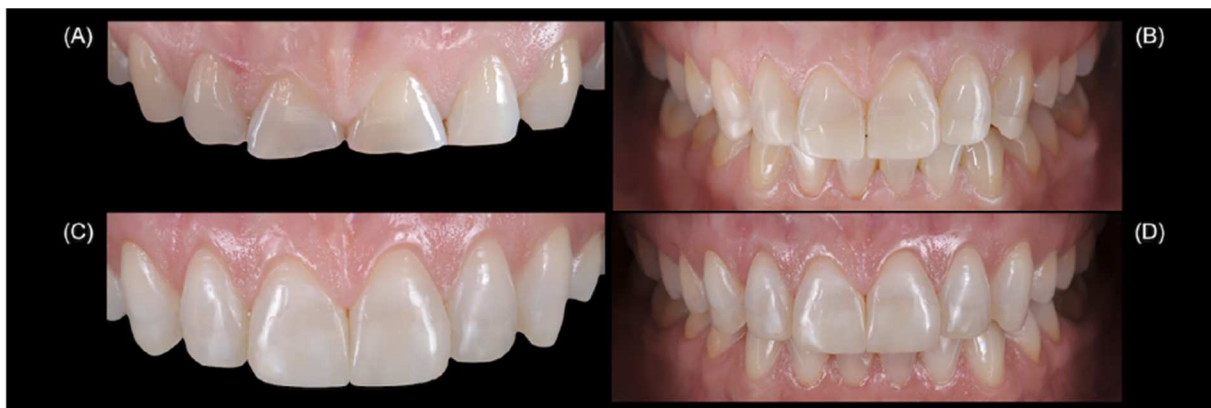
FIGURE 15 Case #2. A, Frontal view before treatment. B, Frontal view after palatal veneers bonding and direct restoration of teeth #29 and #30. C and D, Frontal views at the end of treatment, after bleaching, masking of the junction between buccal surfaces and palatal veneers, and reshaping of teeth #8 and #9 with direct composite (Inspiro). Orthodontics: Prof. Carole Charavet. Prosthodontics: Prof. Amélie Mainjot

composites.²⁵ It is noteworthy to mention that minor chippings were observed on posterior restorations: they were related to borders of very thin occlusal veneers, which were submitted to occlusal contacts, while no major fracture of restorations was observed, despite the high occlusal stress.²⁶ The development of new generations of PICNs, with higher mechanical properties should reduce these types of complications.^{26,27} The results confirm those of the 2-year study about the one step-no prep approach for treatment of generalized tooth wear, in which PICN palatal veneers behaved very well and some minor chippings were observed with very thin table tops.²⁸ Moreover, in case #2, the mesial part of the direct composite, which was added to reshape tooth #8, was fractured and had to be repaired (Figure 25D). This direct composite failure could have been avoided with a better design of the palatal veneer (a small diastema was present, Figure 15B).

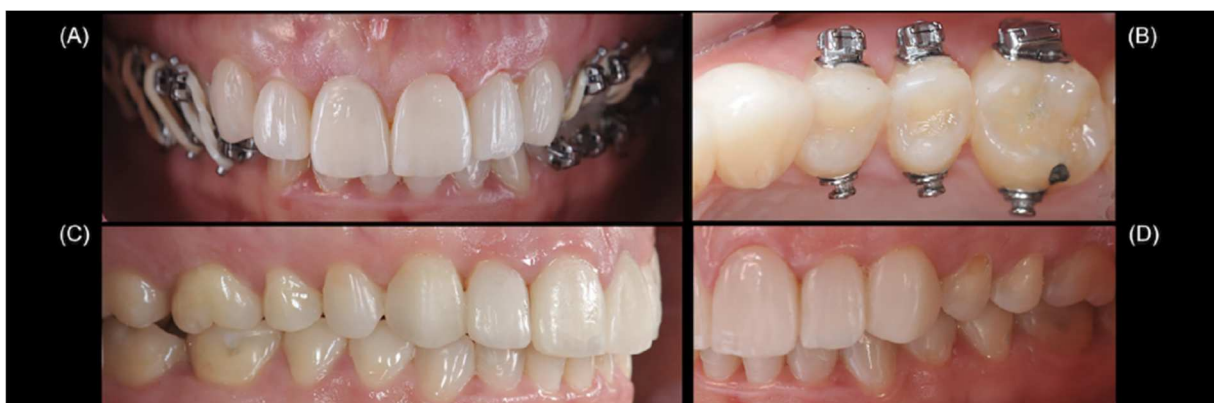
FIGURE 18 - Case #3. A and B, Damon Q metal self-ligating brackets (Ormco, California) were used from the first premolars to the second molars with additional lingual metal buttons on mandibular premolars and molars. Intermaxillary crossbite elastics (IntraOral Elastics, Medium Pull, 1,3 N, Ø 3,2 mm/1/8 in, Dentaureum, Ispringen, Germany) were placed between each tooth on the right quadrant (eg, first premolar to first premolar) and between maxillary brackets with their corresponding lingual buttons on the left. C, Lateral view after treatment and restoration of the tip of the buccal cusps of tooth #14 with direct composite. D, Lateral view just after orthodontic treatment

Patient #3 (Figure 18): After performing the bonding procedure according to the manufacturer's instructions (Transbond Self Etching Primer, 3 M, Maplewood, Minnesota), Damon Q metal self-ligating brackets (Ormco, California) were fixed from the first premolars to the second molars, and lingual metal buttons were placed on the maxillary premolars and molars (Figure 18B). Intermaxillary elastics (IntraOral Elastics, Medium Pull, 1,3 N, 3,2 mm/1/8 in, Dentaurem, Ispringen, Germany) were prescribed between each tooth on the right quadrant (eg, first premolar to first premolar) and between maxillary brackets with their corresponding lingual buttons on the left (crossbite elastics) 24 hours/day, except while eating or drinking and brushing the teeth (Figure 18A). Lingual buttons were used in this clinical situation because the posterior teeth needed to be displaced horizontally due to an existing lateral overjet, in addition to the need for a vertical extrusion. After the completion of the final posterior occlusion, intermaxillary elastics were prescribed 16 hours/day during the retention phase. The overall orthodontic treatment was achieved in 168 days (120 and 48 days for active and retention phases, respectively).

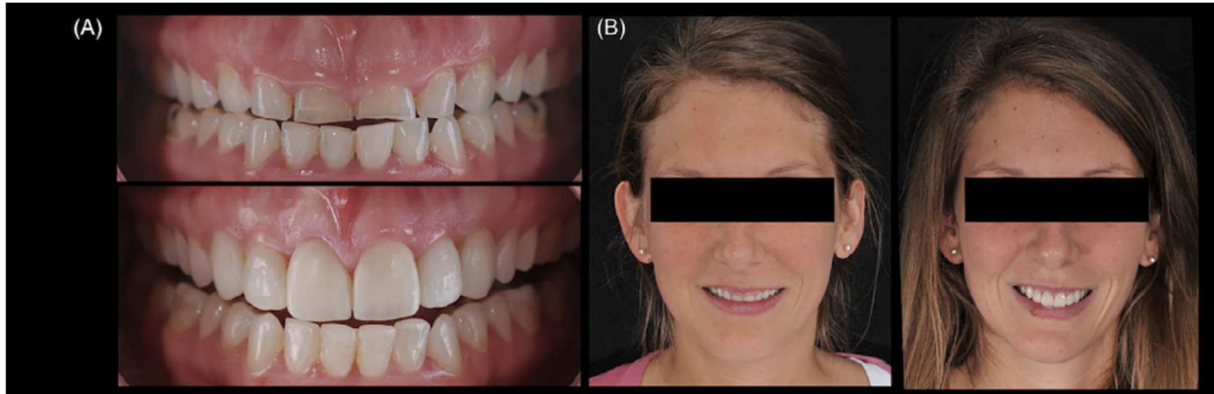
FIGURE 19 - Case #3. A, Frontal view before and after treatment. Bleaching was performed after orthodontic treatment. Mandibular incisors and canines, as the tip of buccal cusps of teeth #5 and #12, were restored with direct composite (Inspiro). B, Face pictures before and after treatment highlighting the improvement in smile aesthetics. Orthodontics: Dr. Jean-Claude Bernard. Prosthodontics: Prof. Amélie Mainjot

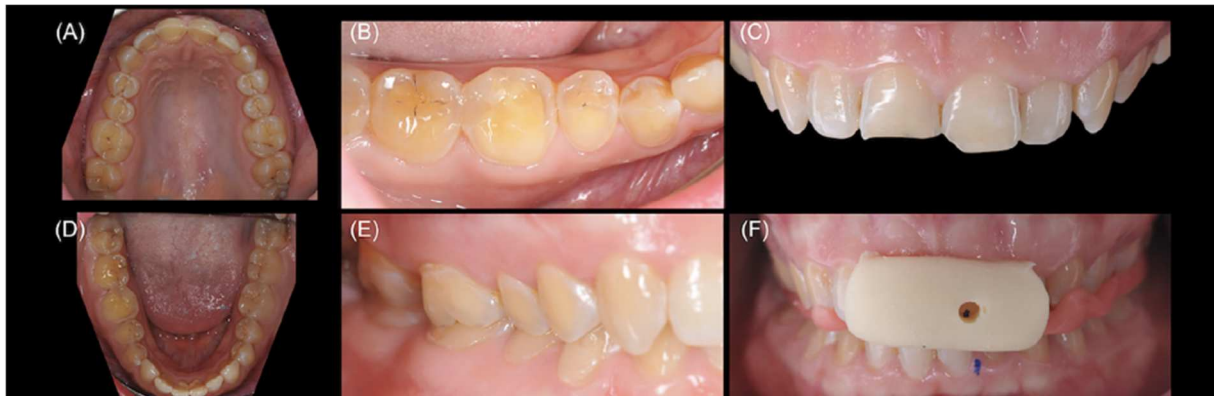
FIGURE 20 - Case #4, a 34-year-old female patient. A, B, and D, Occlusal views showing localized tooth wear of anterior teeth (teeth #8 and #9) and also posterior teeth, but only on the mandibular right side (teeth #29, #30, #31). The particularity of posterior tooth wear is due to soda consumption, with cola stagnation within the right cheek before swallowing. C, Frontal view of the maxillary anterior teeth. E, Lateral view showing the absence of interocclusal space to place restorations on worn posterior teeth. F, Occlusal analysis: occlusal relationships registering using a resin anterior deprogramming device and double layer of wax (Moyco Beauty Wax), additionally a facebow was used (Quick facebow)

in this sextant, that is, tooth dentin exposure with hard tissue loss <50% of the surface area and loss of the clinical crown $\geq 1/3$). Slight tooth wear was also present on the mandibular incisors, but it was decided to leave them untreated (Figure 12). Case #3 presented not only localized severe tooth wear on the maxillary anterior teeth (BEWE score = 3 in this sextant) but also moderate tooth wear (dentin exposure) on teeth #19 and #30 (Figure 16) (BEWE score = 2 in these sextants) and mandibular incisors and canines. In case #4, localized tooth wear was observed on the anterior (teeth #8 and #9) (BEWE score = 2 in this sextant) and posterior teeth, only in the mandibular right side (teeth #29, #30, #31) (BEWE score = 3 in this sextant). The particularity of this posterior tooth wear is due to soda consumption, with cola stagnation within the right cheek before swallowing (Figure 20).

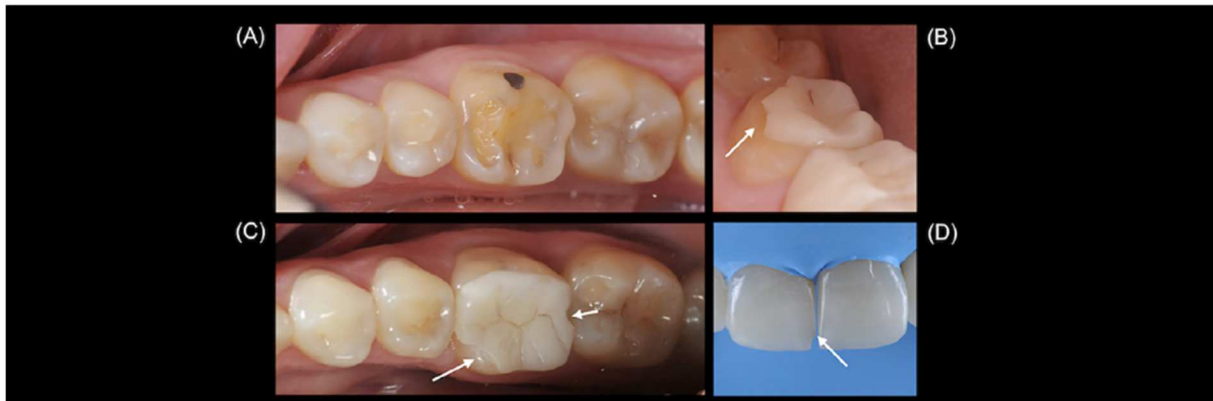
FIGURE 25 Observed technical complications. A and C, In case #3, minor chipping of the extremely thin occlusal borders of the occlusal top on tooth #30 after 21 months. Minor chipping was also observed on tooth #19. B, The same type of failure in case #4, on tooth #31. D, In case #2, fracture of the direct composite added to reshape tooth #8. This failure could have been avoided with a better design of the palatal veneer (a small diastema was present, Figure 15B)

After a follow-up period of 15 (case #1), 21 (case #3), 23 (case #2), and 47 months (case #4), observed complications included minor chipping of the very thin occlusal borders of the occlusal top on tooth #30 after 21 months in case #3 (Figure 25A,C). Minor chipping was also observed on tooth #19 (Figure 25B), and the same type of failure occurred in case #4, on tooth #31 (Figure 25B). These minor chippings were polished. Moreover, in case #2, the mesial part of the direct composite, which was added to reshape tooth #8, was fractured and had to be repaired (Figure 25D).
