## Research article

# Experimental analysis of the cyclic behavior of rammed earth walls reinforced with arundo donax natural fiber

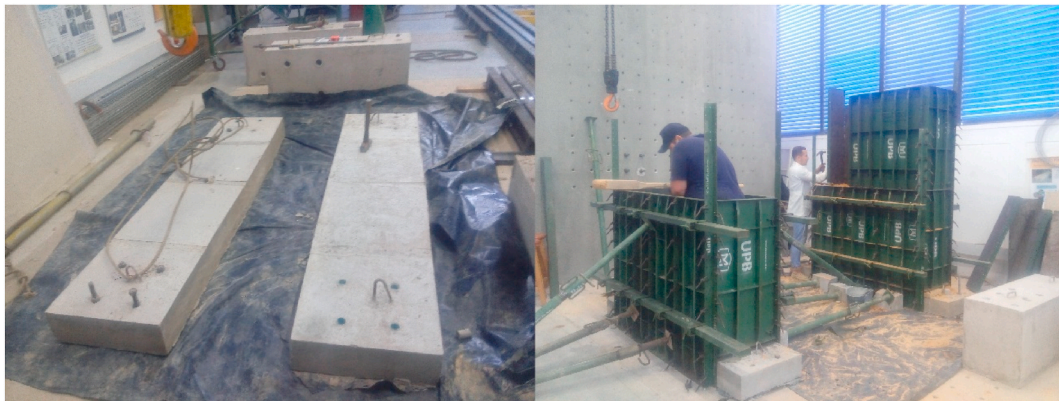
**Fig. 2.** Left: foundation and right: formwork.

Rammed earth walls need foundations to protect them from humidity and prevent displacement [26,39]. In the past, large rocks, lime, sand, and flat stones were used to create a solid and uniform foundation to support loads and prevent settlement [40]. Today, foundation beams constructed of steel-reinforced concrete are used [41]. A 2.10m × 0.15m × 0.5m steel-reinforced foundation plate and 21 MPa concrete were used (Fig. 2 left), with steel formwork placed on top to construct the walls (Fig. 2 right).

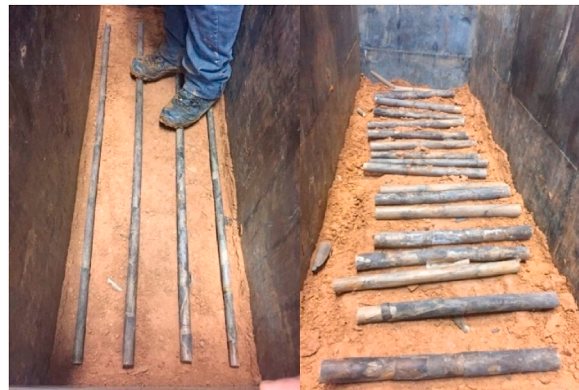
**Fig. 3.** Arundo donax left: Longitudinal sections and right: transversal sections.

The fabrication of the REWC walls followed the same procedure, compacting layers of 10 cm up to 40 cm. Then, 135 cm and 23 mm diameter longitudinal sections of Arundo donax natural fiber were incorporated, with a separation of 10 cm between them (Fig. 3 left). Subsequently, the compaction process was repeated until a height of 40 cm was achieved, including 35 cm and 25 mm diameter cross sections of Arundo donax natural fiber, separated every 10 cm (Fig. 3 right). This procedure was repeated by interspersing longitudinal and transverse sections until a total height of 2 m was reached. The walls were dried for 30 days, which can affect the strength parameters due to temperature and humidity variation [40]. Once the drying period was over, both sides of the walls were covered with lime, and a grid was drawn to detect deformations during the tests.
